INTERSTATE COMMERCE COMMISSION

REPORT OF THE DIRECTOR OF THE BUREAU OF SAFETY CONCERNING
AN ACCIDENT ON THE MISSOURI PACIFIC RAILROAD AT MOARK,
ARK., ON APRIL 20, 1933.

July 20, 1933.

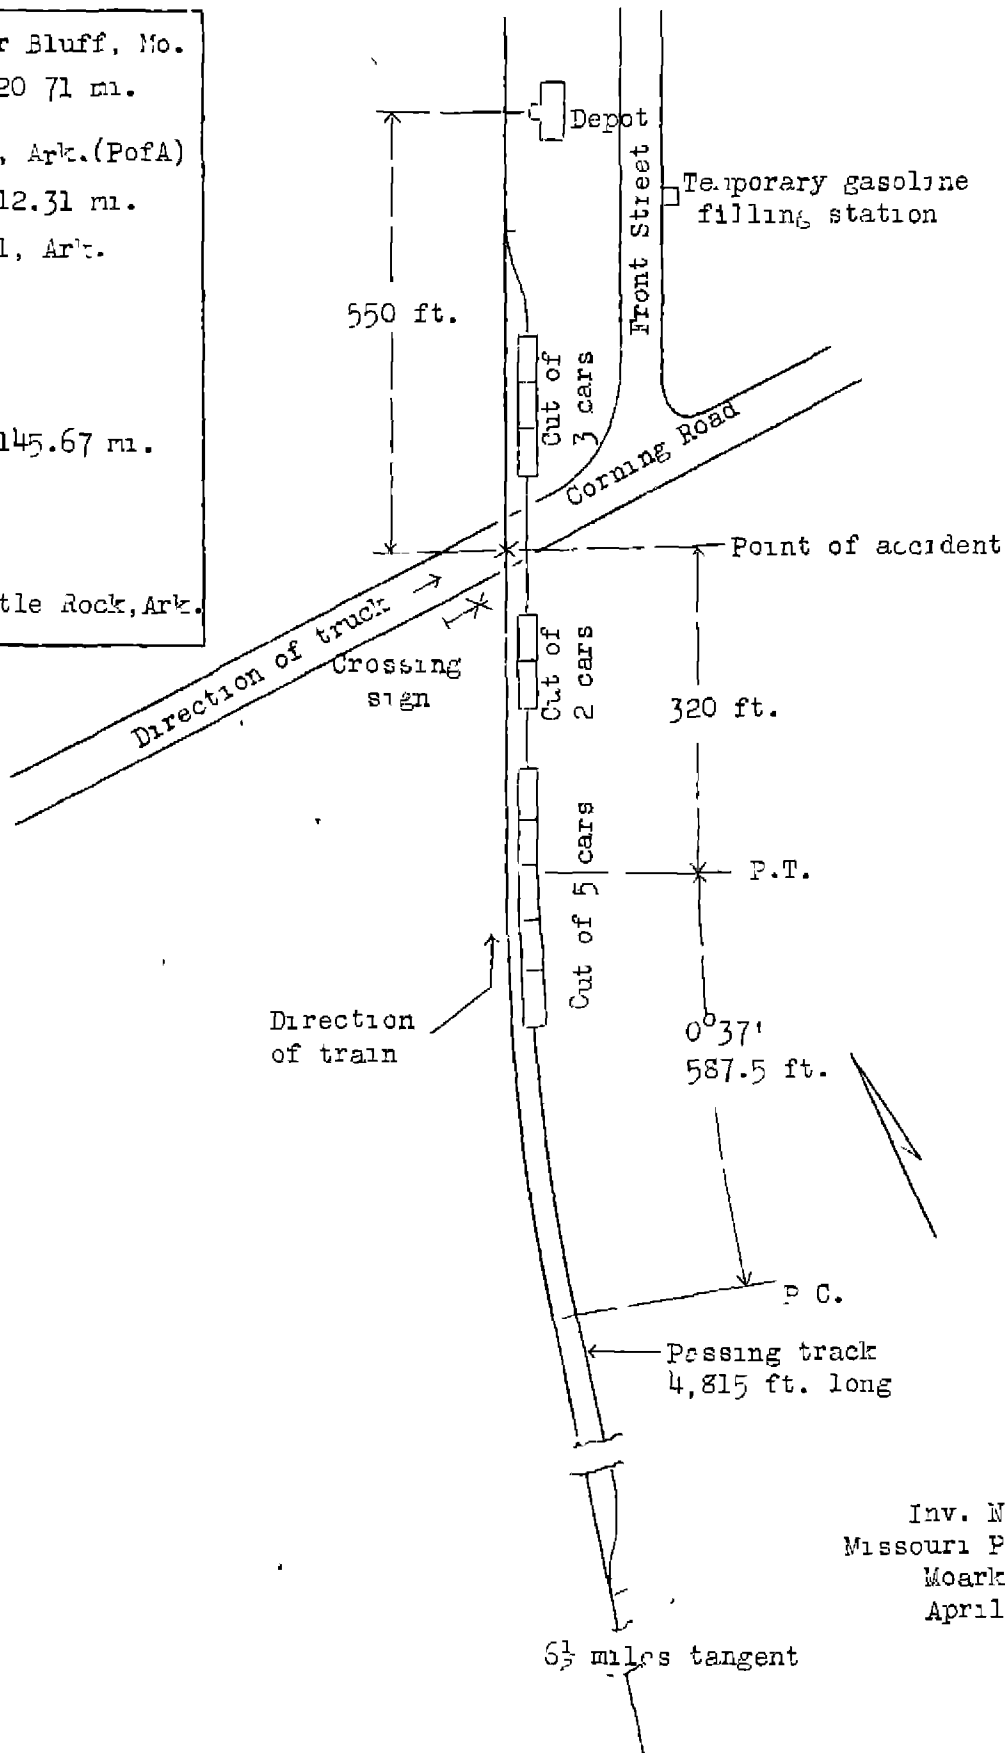
Inv. No. 1821
 Missouri Pacific R.F.
 Moark, Ark.
 April 20, 1933

The passing track is 4,815 feet in length and parallels the main track on the east, the north switch being located 454 feet north of the crossing. At the time of the accident three separate cuts of cars stood on the passing track, a cut of three cars being just north of the crossing, with the south end of the south car about 25 feet north of the center line of the crossing, while the other cuts of cars stood south of the crossing.

The highway extends practically west and east and crosses the track at an angle of $58^{\circ} 40'$, it is an unimproved road and is tangent for a considerable distance in each direction from the crossing. The road is not heavily traveled and the only protection afforded at the crossing is a sign of the cross-bar type, located 25 feet west of the tracks and on the south side of the highway, painted white with black lettering, reading "RAILROAD CROSSING".

From the driver's seat of an east-bound truck on the highway, the view of the railroad tracks was unobstructed, and on reaching a point 325 feet west of the crossing an approaching north-bound train could be seen plainly when it was more than 1,200 feet south of the crossing.
