RAILROAD ACCIDENT INVESTIGATION

Report No 3838

MISSOURI PACIFIC RAILROAD

JANUARY 22, 1959

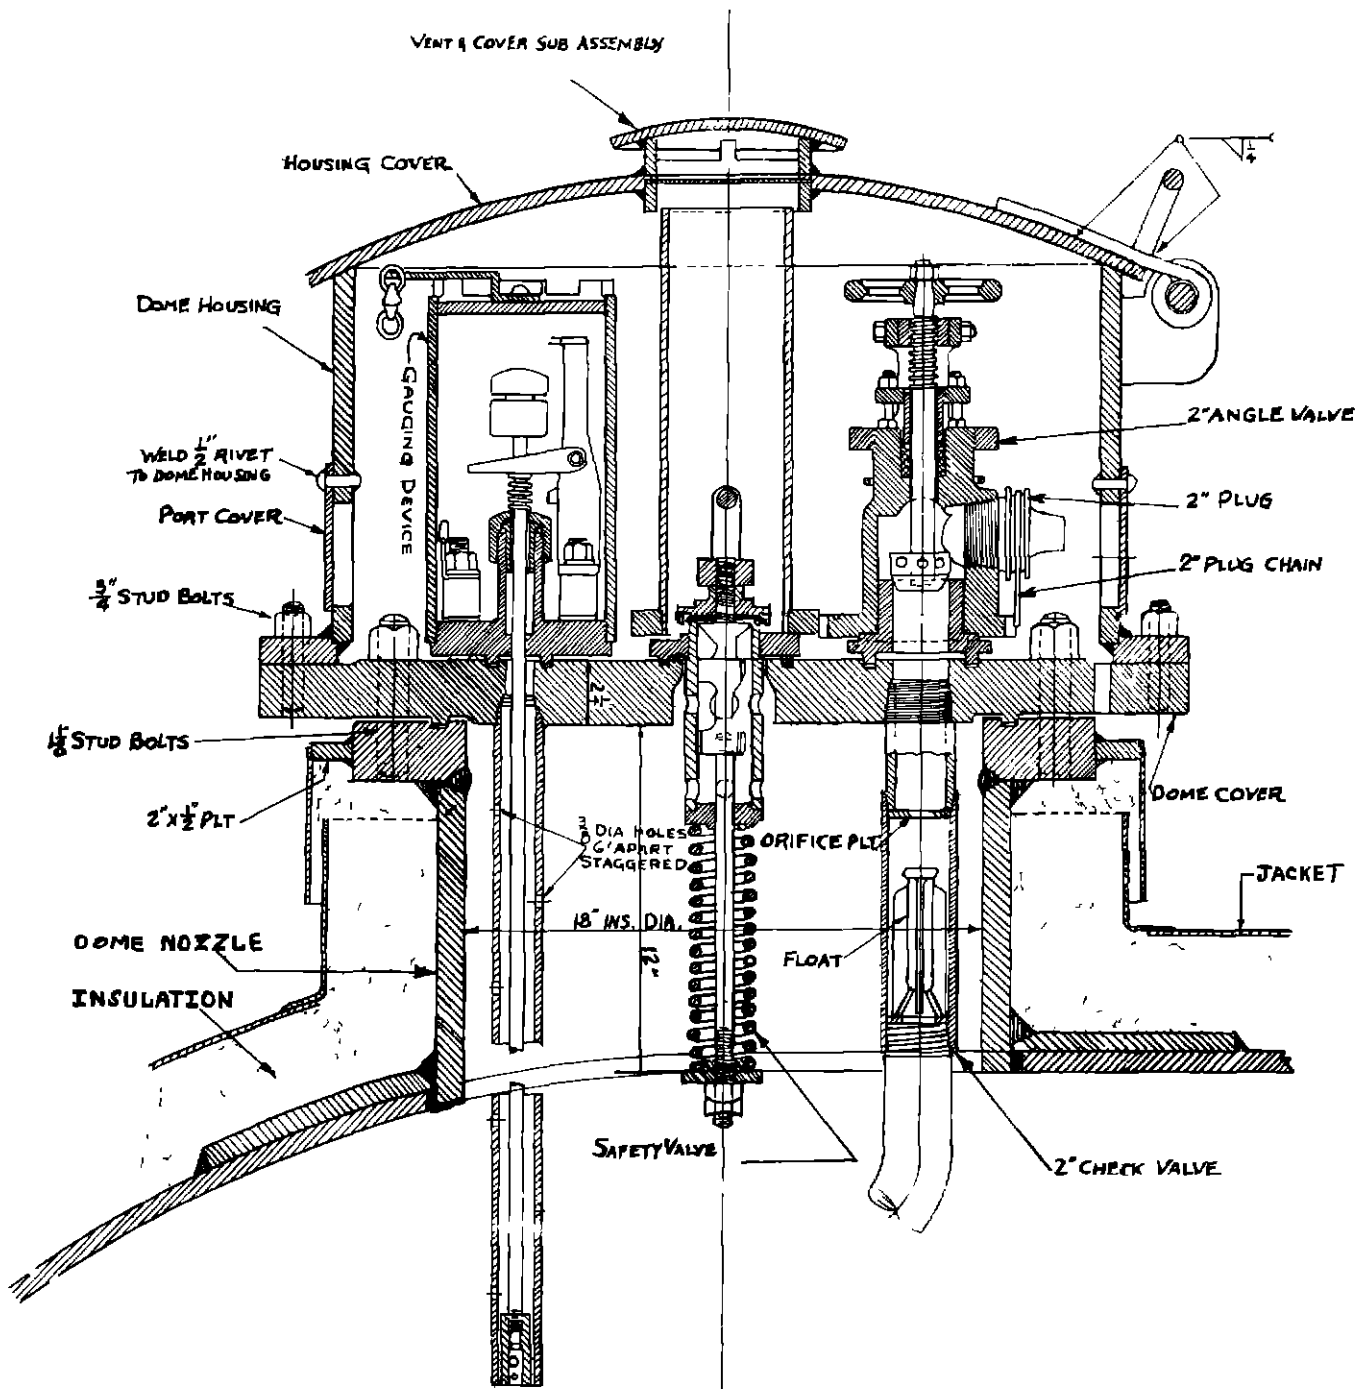
SECT. "A-A"
AT DOME HOUSING

Examination of the dome disclosed that the test tube was broken off flush with the dome cover, that the plug at the top of the thermometer well was loose, and that the vent valve, one reduction valve, and the gauging device were loose on the dome cover. It was found that one reduction valve was open slightly and that the plug was out. The port cover of the dome housing for this valve was missing. The dome cover was loose and a piece of the gasket approximately 6 inches in length was missing. The safety valve was tested after the accident occurred and was found to open at 300 psi. It could not be determined whether the numerous leaks at the dome resulted from the derailment or from the effects of the heat to which that portion of the tank subsequently was subjected.

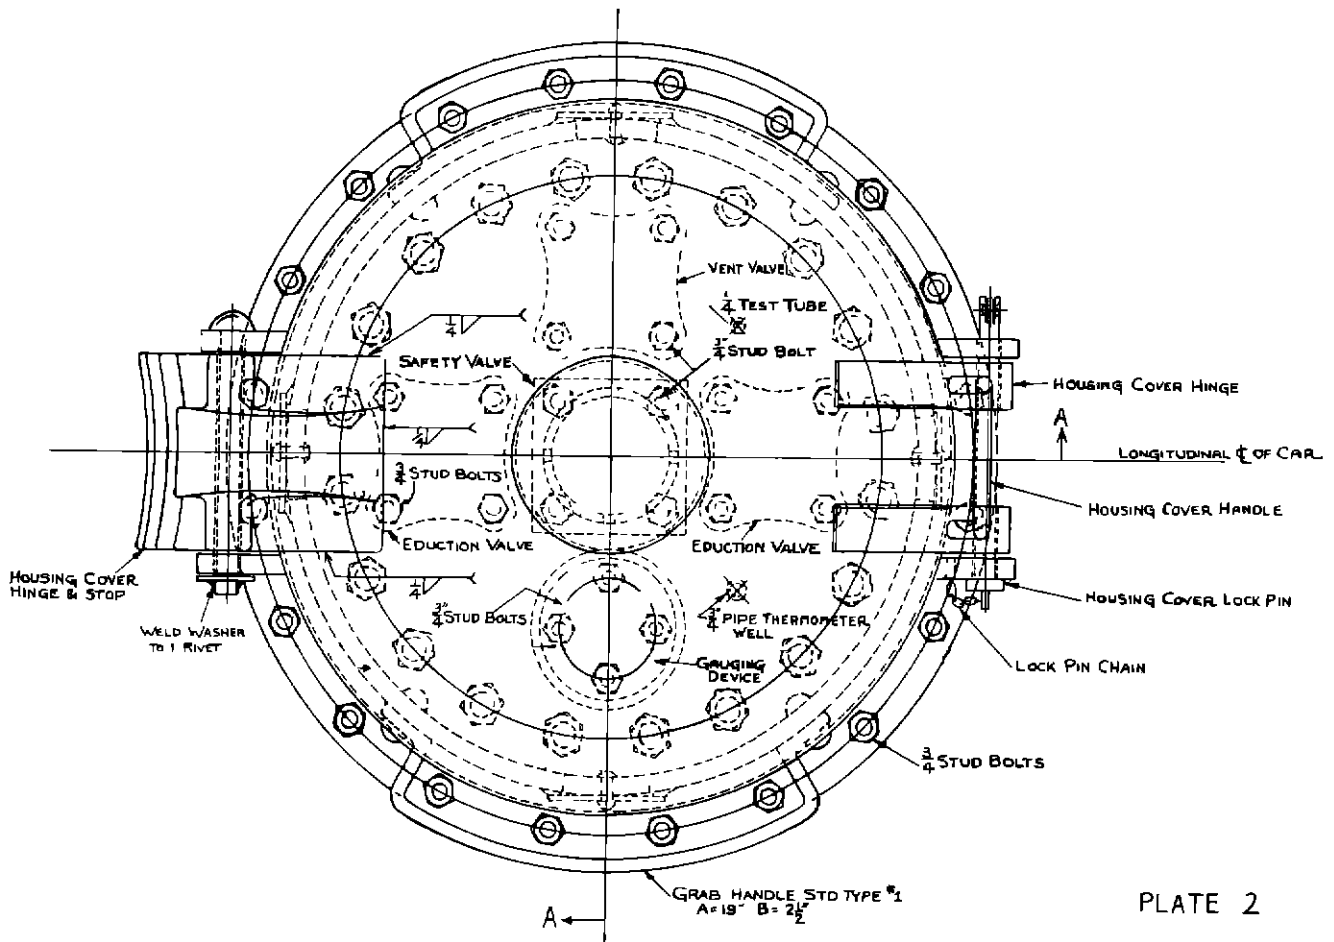
Examination of the shell of SHPX 1828 after the explosion occurred disclosed that it had ruptured and unwrapped throughout a longitudinal distance of approximately 20 feet (PLATE NO 3). An overheated area approximately 7 feet 6 inches in length and of varying width was found in the unwrapped portion of the shell (PLATE NO 4). This area, beginning at a point about 2 feet from the dome, extended toward the damaged end of the shell. The center of this area was at an angle of about 90 degrees to the left of the vertical centerline of the shell when facing the damaged tank head. The thickness of the steel plate at the ends and center of the rupture extending through this area varied from 49/64 inch to 3/16 inch, respectively. The thickness of plate at all points of rupture other than in the overheated area was 25/32 inch. The entire dome was discolored and slightly scaled as a result of overheating.

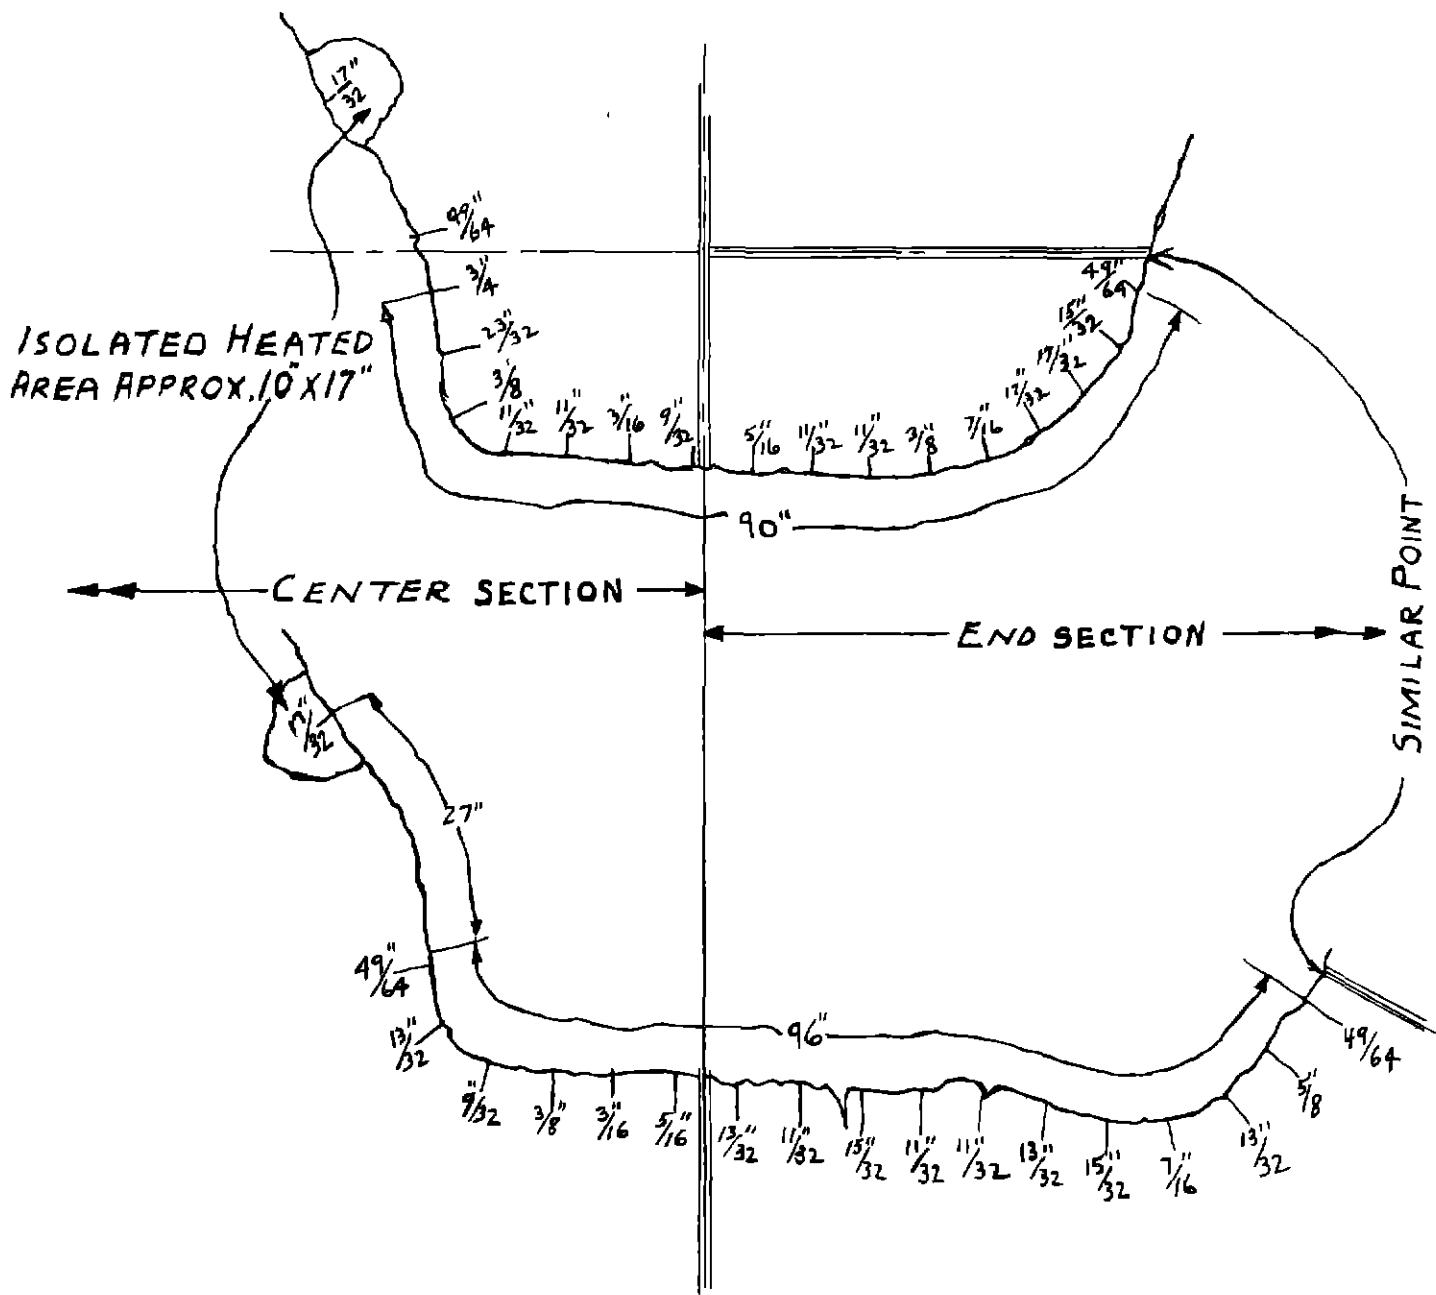
THINNING OF SHEETS IN HEATED AREA
TANK CAR # SHPX 1828

Laboratory analysis of plate sections removed from the shell disclosed that the metal in the overheated area had been subjected to temperatures in excess of 1500° F and was characterized by discoloration and slight scaling. Analysis of the metal of the portion of the shell which was not subjected to overheating disclosed no evidence of laminations, seams or other defects. The welds were found to be clean and sound.

The tank of SHPX 1828 was exposed to the intense heat of the burning wreckage for a considerable period of time. Escaping gas from the car became ignited and burned at the dome throughout the time the car was standing in the wreckage at the point of the general derailment and continued burning until the time of the explosion, about 19 hours 45 minutes after the derailment occurred. When this car was last moved and stopped with the dome in a horizontal position, the intensity of the flames at the dome greatly increased and the heat was directed against the tank. The thickness of the shell plate was greatly reduced in the overheated area, and it is apparent that the pressure within the tank was sufficient to rupture the shell plate in the overheated area, resulting in the explosion.

In the instant case, the carrier followed the recommended good practice for the handling of dangerous articles with the apparent exceptions that adequate measures were not taken to detect the red-hot spot in the shell of the tank of SHPX 1828, and that sufficient effort was not exerted to keep all persons at a safe distance. It is evident that had the overheated area of this tank been observed and adequate measures taken to keep all persons at a safe distance, the heavy casualties would not have resulted from the explosion. If the dome of SHPX 1828 had been maintained in a vertical position after the car was removed from the wreckage, the heating of the shell would have been minimized and it is probable that the explosion would not have occurred.
