**RAILROAD ACCIDENT INVESTIGATION**

**Report No 3940**

MISSOURI PACIFIC RAILROAD COMPANY

JANUARY 31, 1962

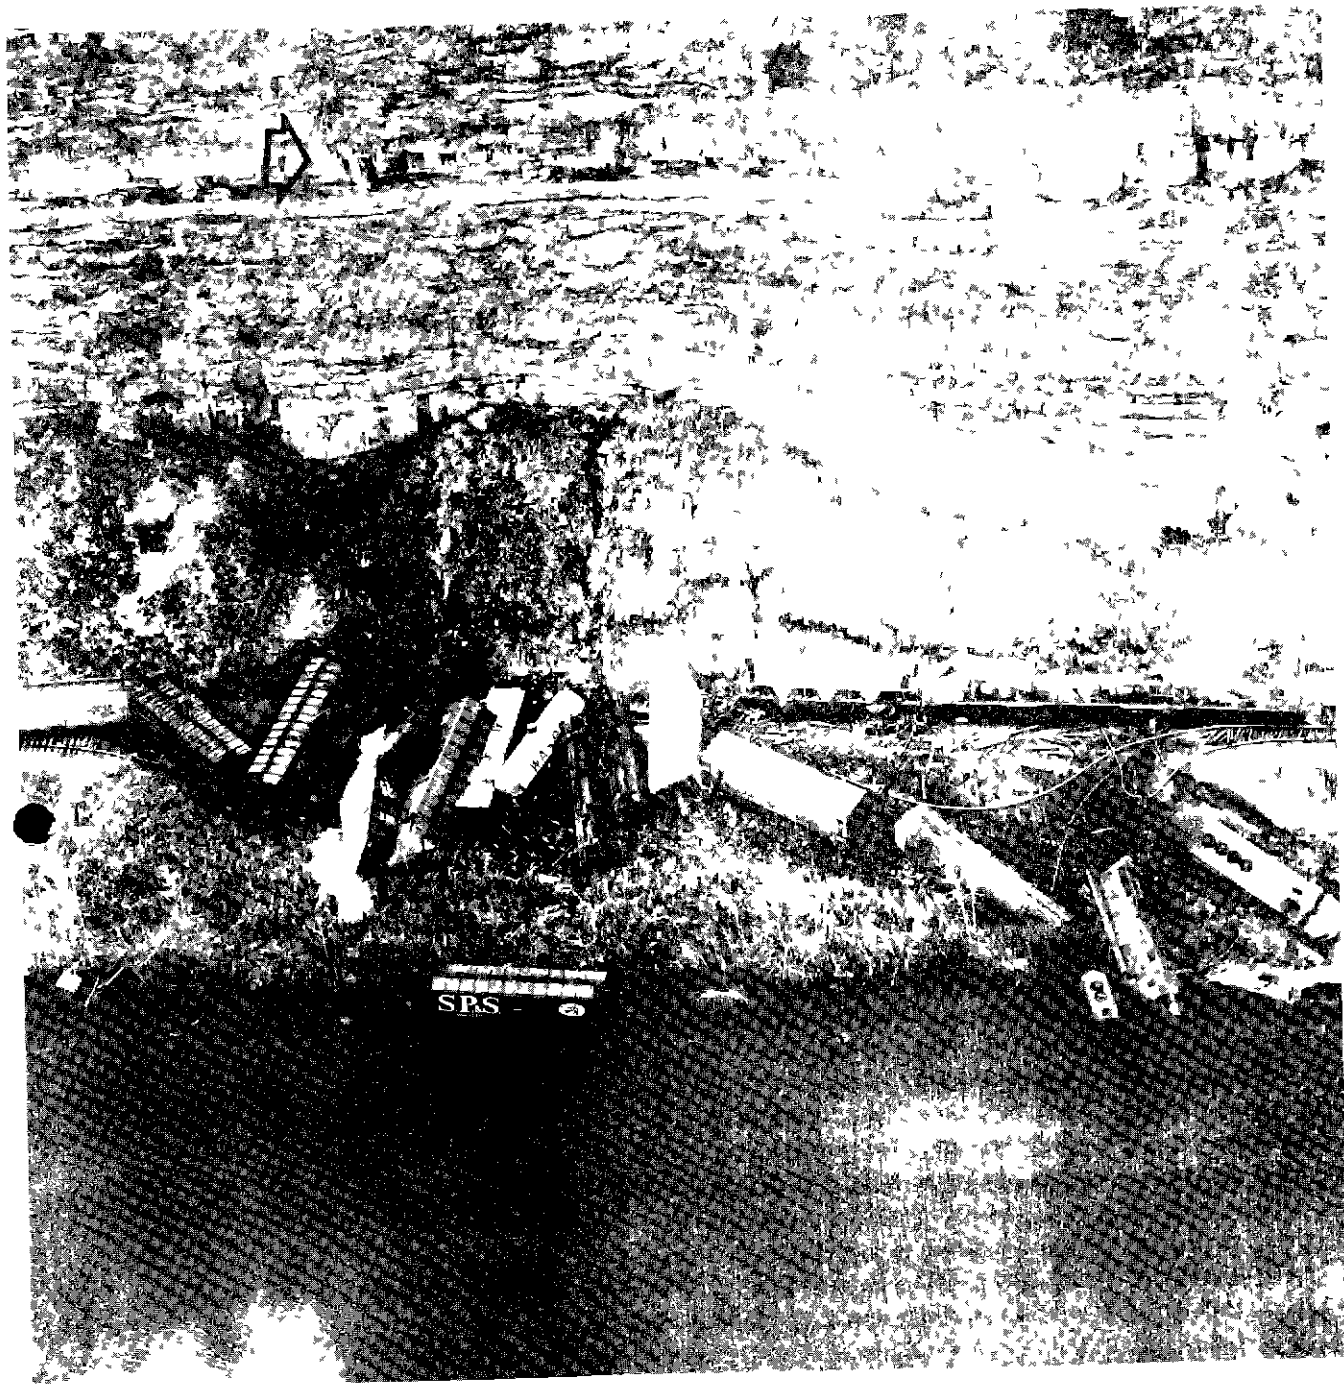
Top arrow points to second vertical out crop of rock Bottom arrow points to crater made by rock involved after falling from second vertical out-crop of rock

Examination of Penter's Bluff in the vicinity of the point of accident disclosed a large fresh cavity in the overhanging rock ledge located 295 feet above the level of, and 162 feet east of, the main track It appeared that the rock which fell upon the track started from this cavity This cavity was somewhat triangular in shape and it measured about 13 feet by 7 feet, with a depth of 3½ feet It is apparent from marks on the slopes and ledges that a rock weighing several tons became dislodged from the overhanging rock ledge then fell and rolled to the bottom of the bluff where it lodged on the rails of the main track, and was struck by No 269

It is recommended that in the area subject to hazards of slides or falling rocks where this accident occurred the carrier take immediate steps to provide suitable slide detection and protective devices, or impose such speed restriction as may be necessary to insure safe passage of trains.

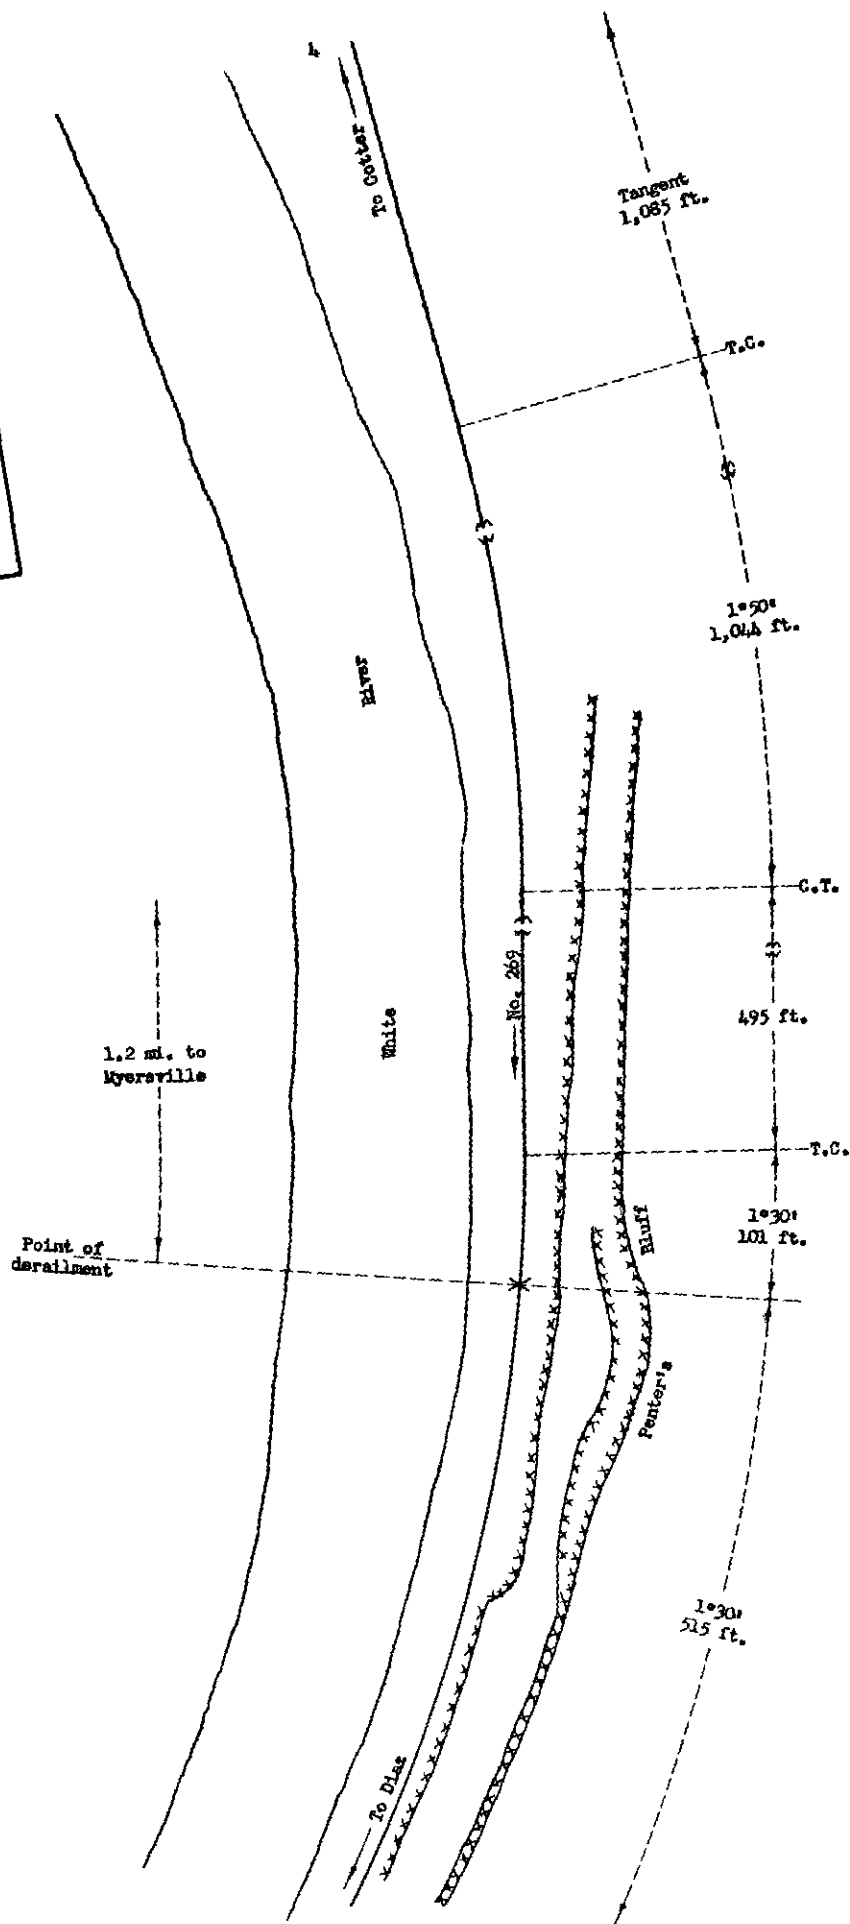
Missouri Pacific Railroad  
 Myersville, Ark.  
 January 31, 1962

The train stopped with the front end 243 feet south of the point of impact. The 4 diesel-electric units and the 1st to the 17th cars, inclusive, were derailed and stopped in various positions as shown in PLATE 1. The 1st and the 4th diesel-electric units were considerably damaged, and the 2nd and 3rd units were heavily damaged. Of the derailed cars, 10 were heavily damaged, 4 were considerably damaged and 3 were somewhat damaged.
