INTERSTATE COMMERCE COMMISSION

REPORT OF THE DIRECTOR OF THE BUREAU OF SAFETY IN RE
 INVESTIGATION OF AN ACCIDENT WHICH OCCURRED ON
 THE MISSOURI PACIFIC RAILROAD NEAR MYRICK, MO.,
 ON NOVEMBER 22, 1931.

December 23, 1931.

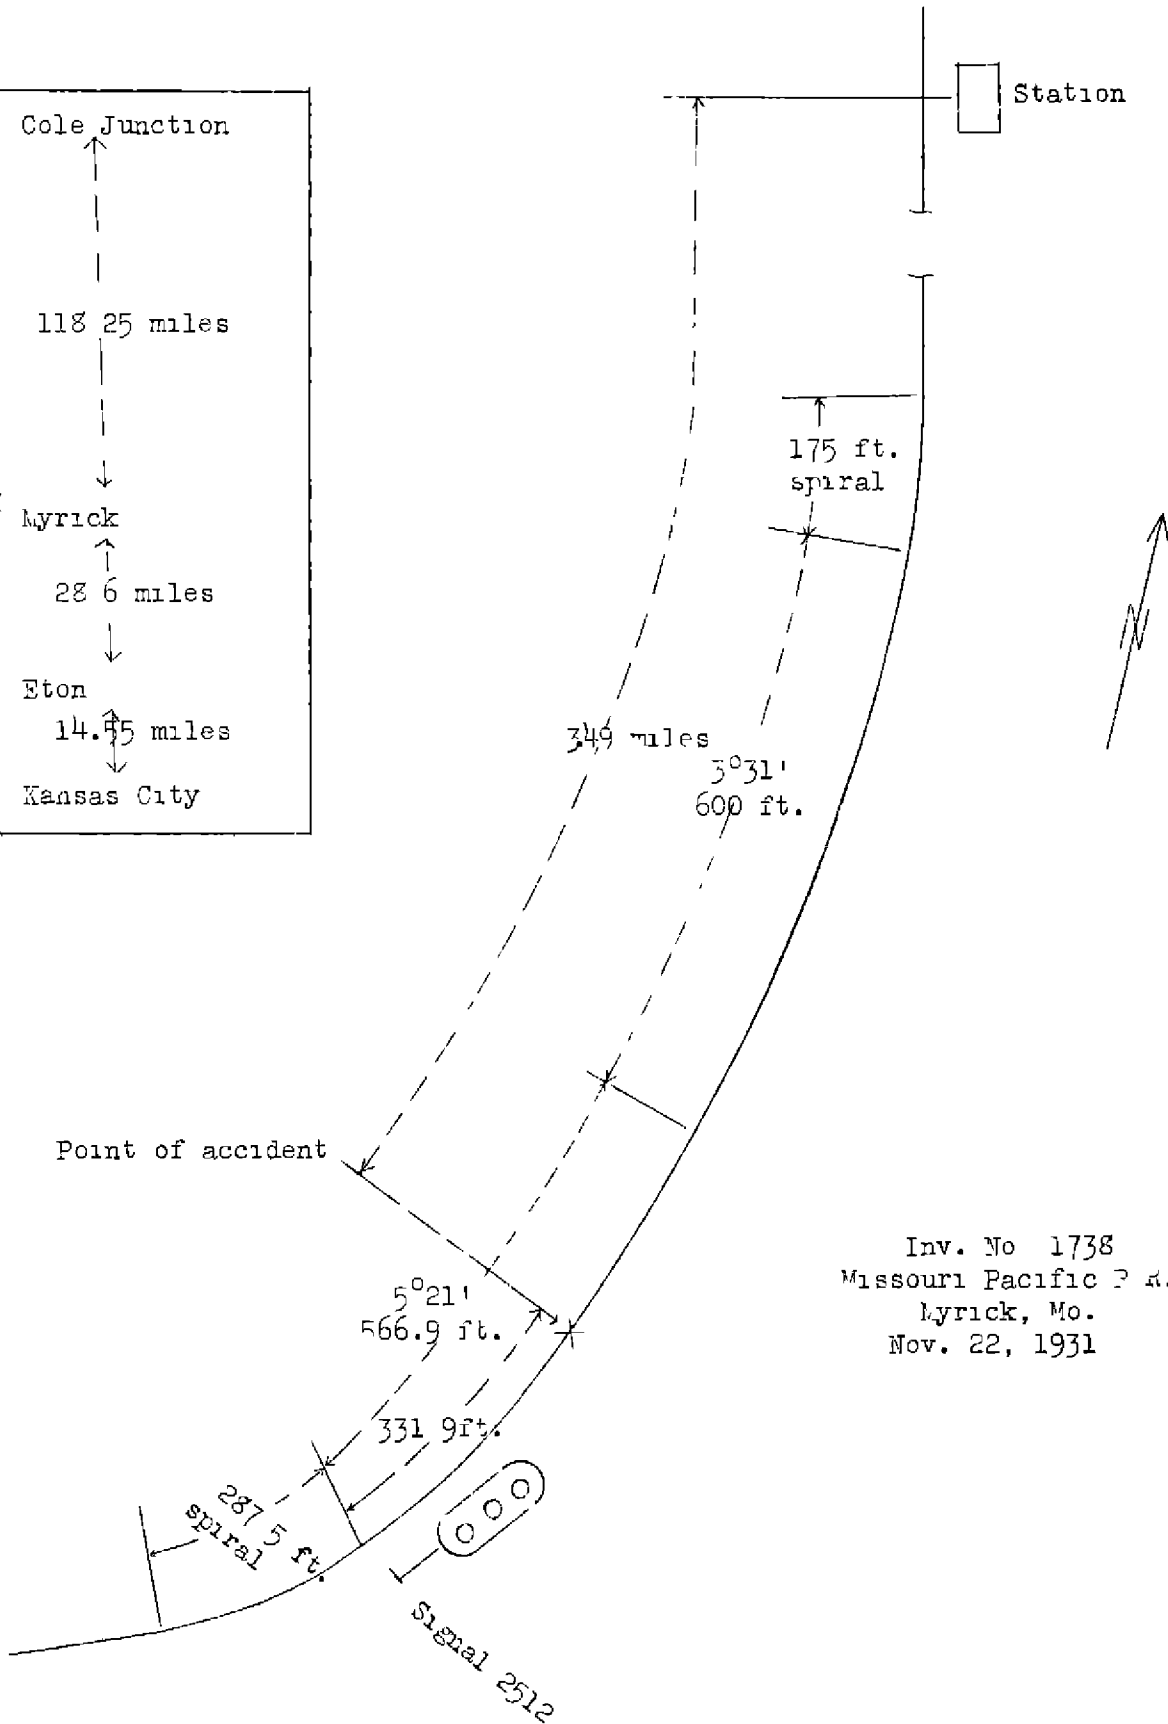
Inv. No 1738
Missouri Pacific R. R.,
Myrick, Mo.
Nov. 22, 1931

The rail involved was on the high or right side of the curve, it was broken at a point 25 feet 9 $\frac{1}{2}$ inches from its receiving end. The broken ends of the rail displayed a transverse fissure and slag inclusion. The nucleus of the fissure was in the lower part of the ball just above the top of the web, and the fissure spread in open-fan formation toward the top of the gauge side of the rail. The silvery luster as seen on the extended area of the majority of fissures, was absent in this case, as also was the discoloration common to many fissures. This rail showed flange wear which extended its entire length, the width on the ball of the rail when new would have been 2 $\frac{1}{4}$ inches, while this rail measured only 2 inches, $\frac{1}{4}$ inch or about 11 per cent of the rail having been worn off on the gauge side. Cross levels taken on the day following the accident, beginning at a point 500 feet west of the point of derailment, showed that the elevation gradually increased from level to a maximum of 5 inches at the point of derailment, and the gauge of this portion of the track varied from standard to a maximum of 1 inch wide. No evidence of derailment was found west of the location of the broken rail.

Examination of the track disclosed a broken rail on the high or south side of the curve, which displayed a transverse fissure and slag inclusion. The fracture occurred at a point 25 feet 9½ inches from the receiving end of the rail, and the remaining 7 feet 2½ inches of rail was intact. The evidence indicated that the initial fracture occurred under the wheels of the engine, and the anchorage of the broken rail then became inadequate to withstand the outward force of the train as it rounded the curve, thus allowing the detached or leaving end of the longer portion of the rail to bend and move outward, separating the fragments and allowing the following wheels to be derailed. The abrasion on the outside rim of right back driving wheel of the engine indicated that it had been derailed, and then dropped inside of the right rail and came in contact with the gauge side of the rail. As the truck wheels and all the driving wheels were on the rails when the engine stopped, however, it is evident that the right back driving wheel rerailed itself during the progress of the accident.
