REPORT OF THE DIRECTOR

MISSOURI PACIFIC RAILROAD

MYRTLE, ARK.

INVESTIGATION NO. 2082

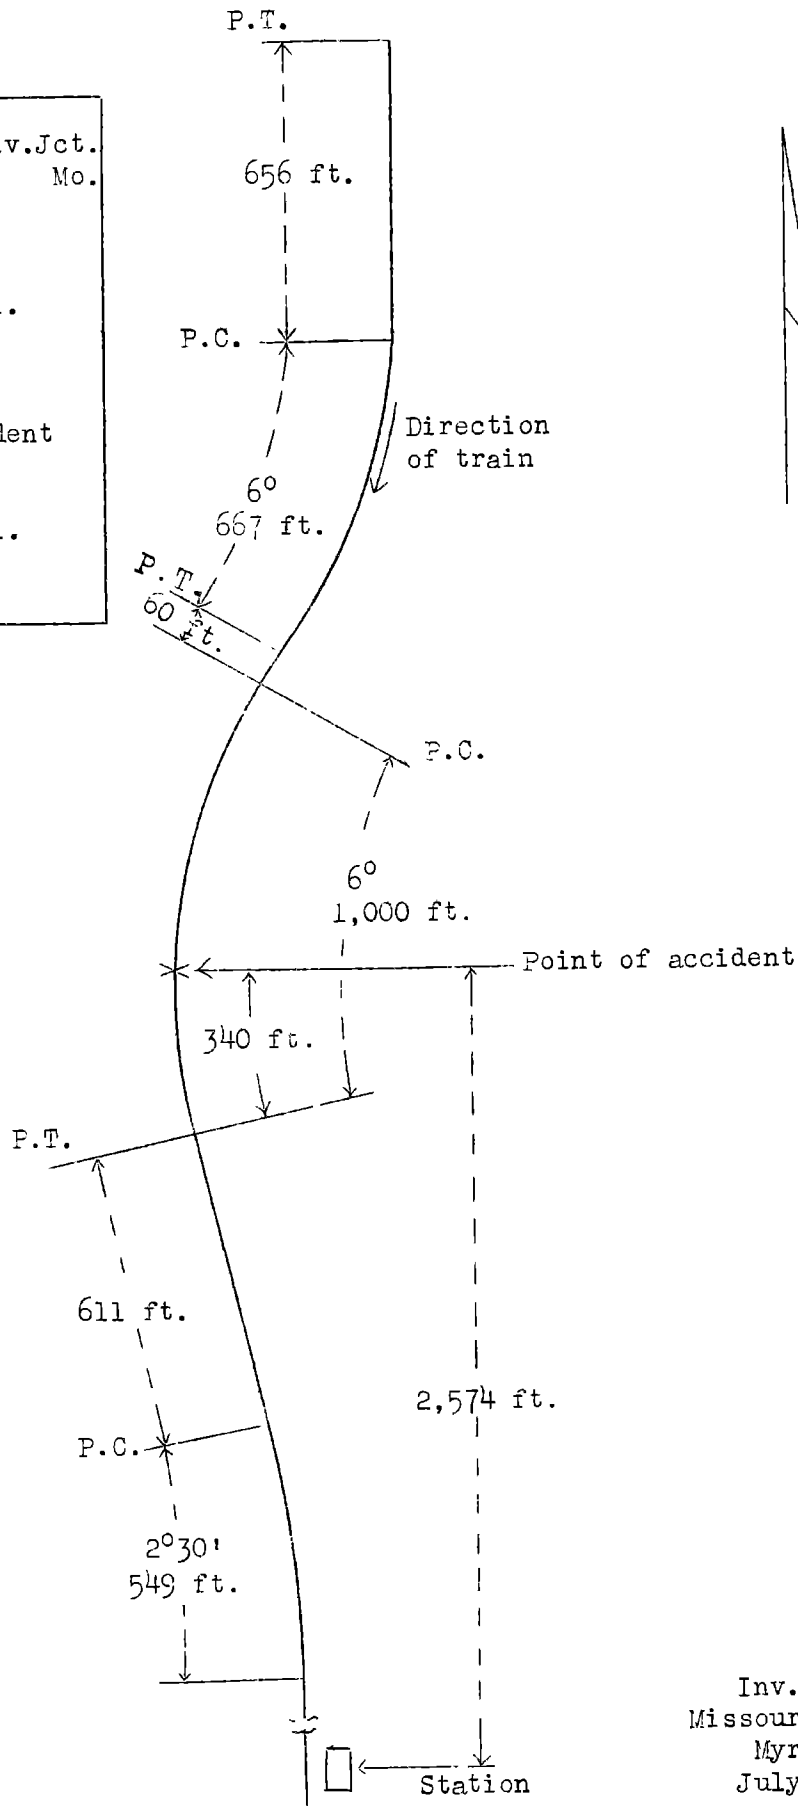
Inv. No. 2082  
Missouri Pacific R.R.  
Myrtle, Ark.  
July 14, 1936

Examination of the track after the accident disclosed that the rail on the west side had broken into approximately 19 pieces, the first break being due to a transverse fissure covering an area of about 20 or 25 percent of the head of the rail. The remaining fractures did not reveal any defects, and it is believed that they were a result of the accident. There appeared to have been some movement between the pieces at the first break as shown by worn spots on the ends, indicating that when the rail broke the ends remained in contact. It is believed that this rail first broke under Train No. 270 when it passed over the track, north-bound, on the evening prior

to the accident, and that this train forced the piece of rail just north of the break slightly out of line, causing a lip at the break, which permitted the right front engine-truck wheel of engine 1567 to mount the rail. A mark across the head of the rail indicated that a wheel had mounted at that point.

This accident was caused by a broken rail, due to a transverse fissure.
