INTERSTATE COMMERCE COMMISSION

ACCIDENT ON THE
MISSOURI PACIFIC RAILROAD

NASHVILLE, ARK.

INVESTIGATION NO. 2173

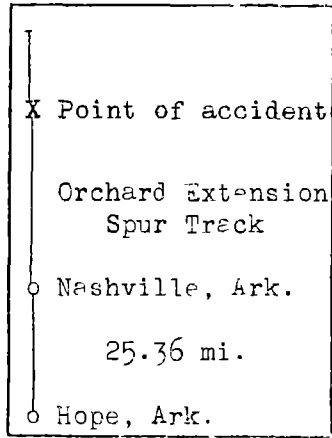
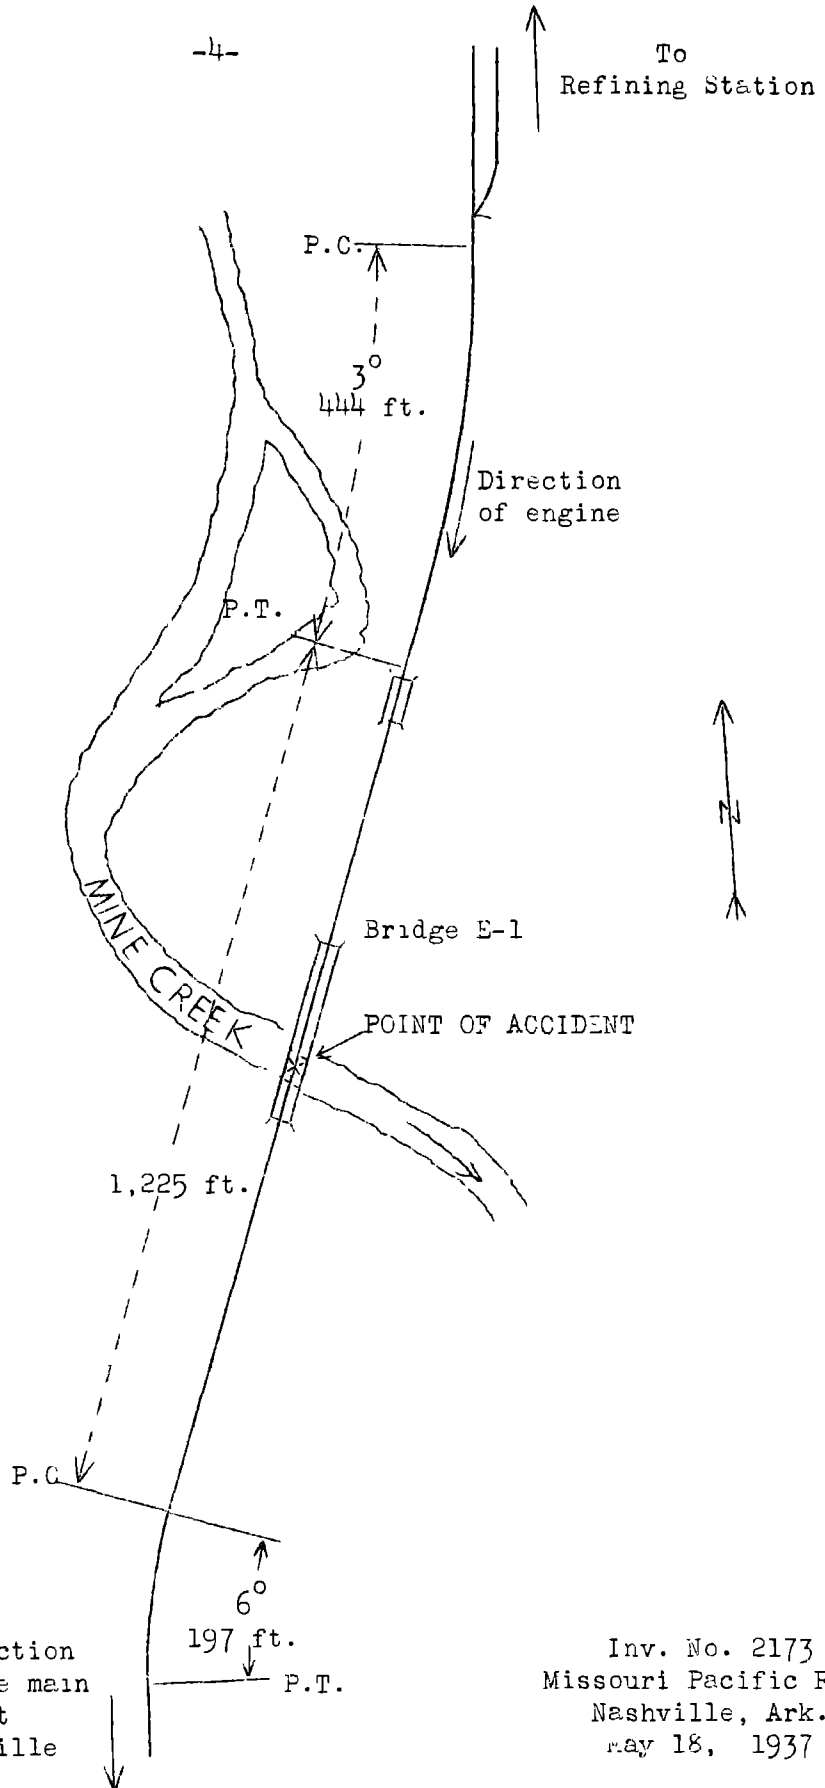
Inv. No. 2173
 Missouri Pacific R.R.
 Nashville, Ark.
 May 18, 1937

Engine 1242 and its tender fell over on their right sides with the forward portion of the engine in the water, but with the tender on the south bank of the creek. The front end of the engine was 46 feet 6 inches north of the south end of the bridge. The two pile piers supporting the steel girder span and the two bents under the south approach broke and fell toward the south, in the direction the engine was moving, and the debris

of the entire structure south of and including the north pile pier was also moved in that direction. The piling broke close to the water line. The decking, stringers, ties and track which were almost intact declined slightly toward the southeast corner of the bridge. The employees killed were the engineman and fireman, and the employee injured was a brakeman.
