MISSOURI PACIFIC RAILROAD COMPANY

NEELYVILLE, MISSOURI

JUNE 16, 1977

Synopsis

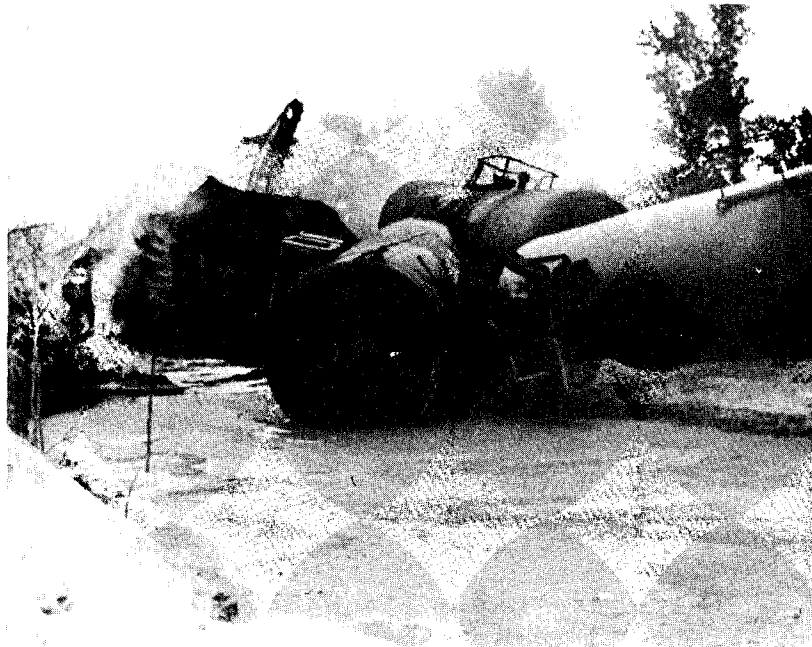
General View Looking Northeast

The first 11 cars behind the locomotives derailed, overturned and stopped at or near the collision point. Among these 11 cars was a car of hydrochloric acid which was punctured; the contents were lost. The 12th through 17th cars did not derail. The 18th through 21st cars jackknifed, derailing to the east into the side of Extra 3211 South. The 22nd through 25th cars did not derail, but the force of the impact caused the type "E" coupler of the 26th car to override the type "F" coupler of the 25th car, puncturing the 25th car. The contents of the 25th car, vinyl chloride, exploded and burned, destroying the 26th car. The explosion and emergency brake application resulted in the derail-

The tank car in the foreground is leaking Hydrochloric acid.

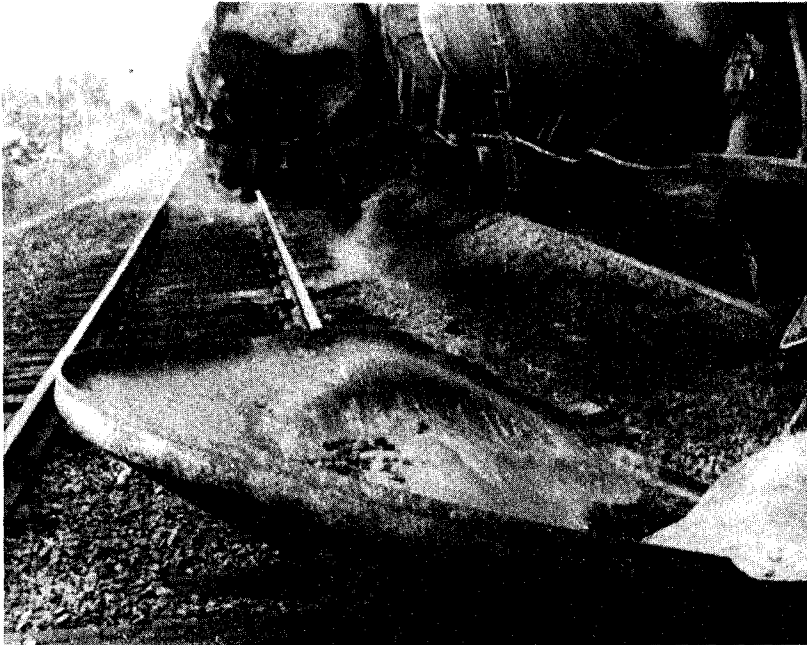
Looking North
Towards
GATX 47545

The vinyl chloride was being transported in a DOT 105A-300W specification tank car from the Great American Chemical Company in Freeport, Texas, to the Great American Chemical Company in Fitchburg, Massachusetts, when it was punctured by an adjacent car, resulting in spillage, fire and toxic fumes. The car was equipped with "F" type couplers and no head shields. Another tank car, also DOT specification 105A-300W, contained Hydrochloric Muratic Acid. The shipper was Morton Chemical Company in Weeks, Louisiana; the consignee, U. S. Steel Corporation in Gary, Indiana. It was punctured in the derailment and leaked its contents. The car had no head shields.
