ACCIDENT ON THE
MISSOURI PACIFIC RAILROAD

NELSON, MO.

AUGUST 7, 1939

INVESTIGATION NO. 2372

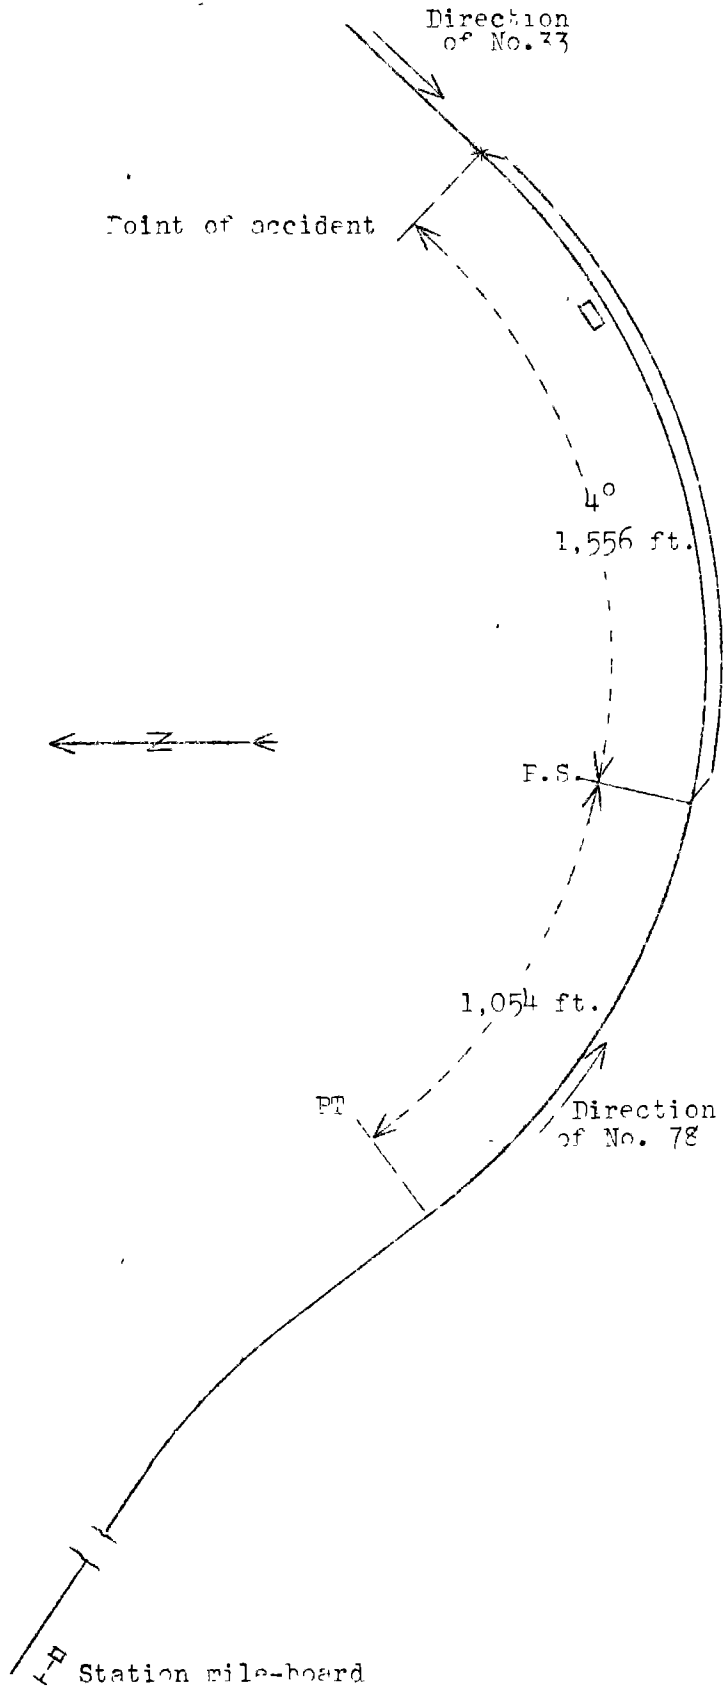
Inv. No. 2374
Missouri Pacific R.R.
Nelson, Mo.
August 7, 1939

Approaching from the west there is a tangent 1,516 feet in length followed by a $30^{\circ}42'$ curve to the right 800 feet in length, a tangent 1,202 feet in length, and a 40° curve to the left 2,605 feet in length to the switch where the accident occurred. Approaching from the east a long tangent is followed by a spiral to the right 267 feet in length extending to the switch where the accident occurred. The grade for east-bound trains is 0.24 percent descending a distance of 1,110 feet and then 0.30 percent descending a distance of 230 feet to the point of accident.
