NATIONAL TRANSPORTATION SAFETY BOARD

RAILROAD ACCIDENT REPORT

SIDE COLLISION OF
TWO MISSOURI PACIFIC RAILROAD COMPANY
FREIGHT TRAINS
AT GLAISE JUNCTION,
NEAR POSSUM GRAPE, ARKANSAS
OCTOBER 3, 1982

NTSB/RAR-83/06

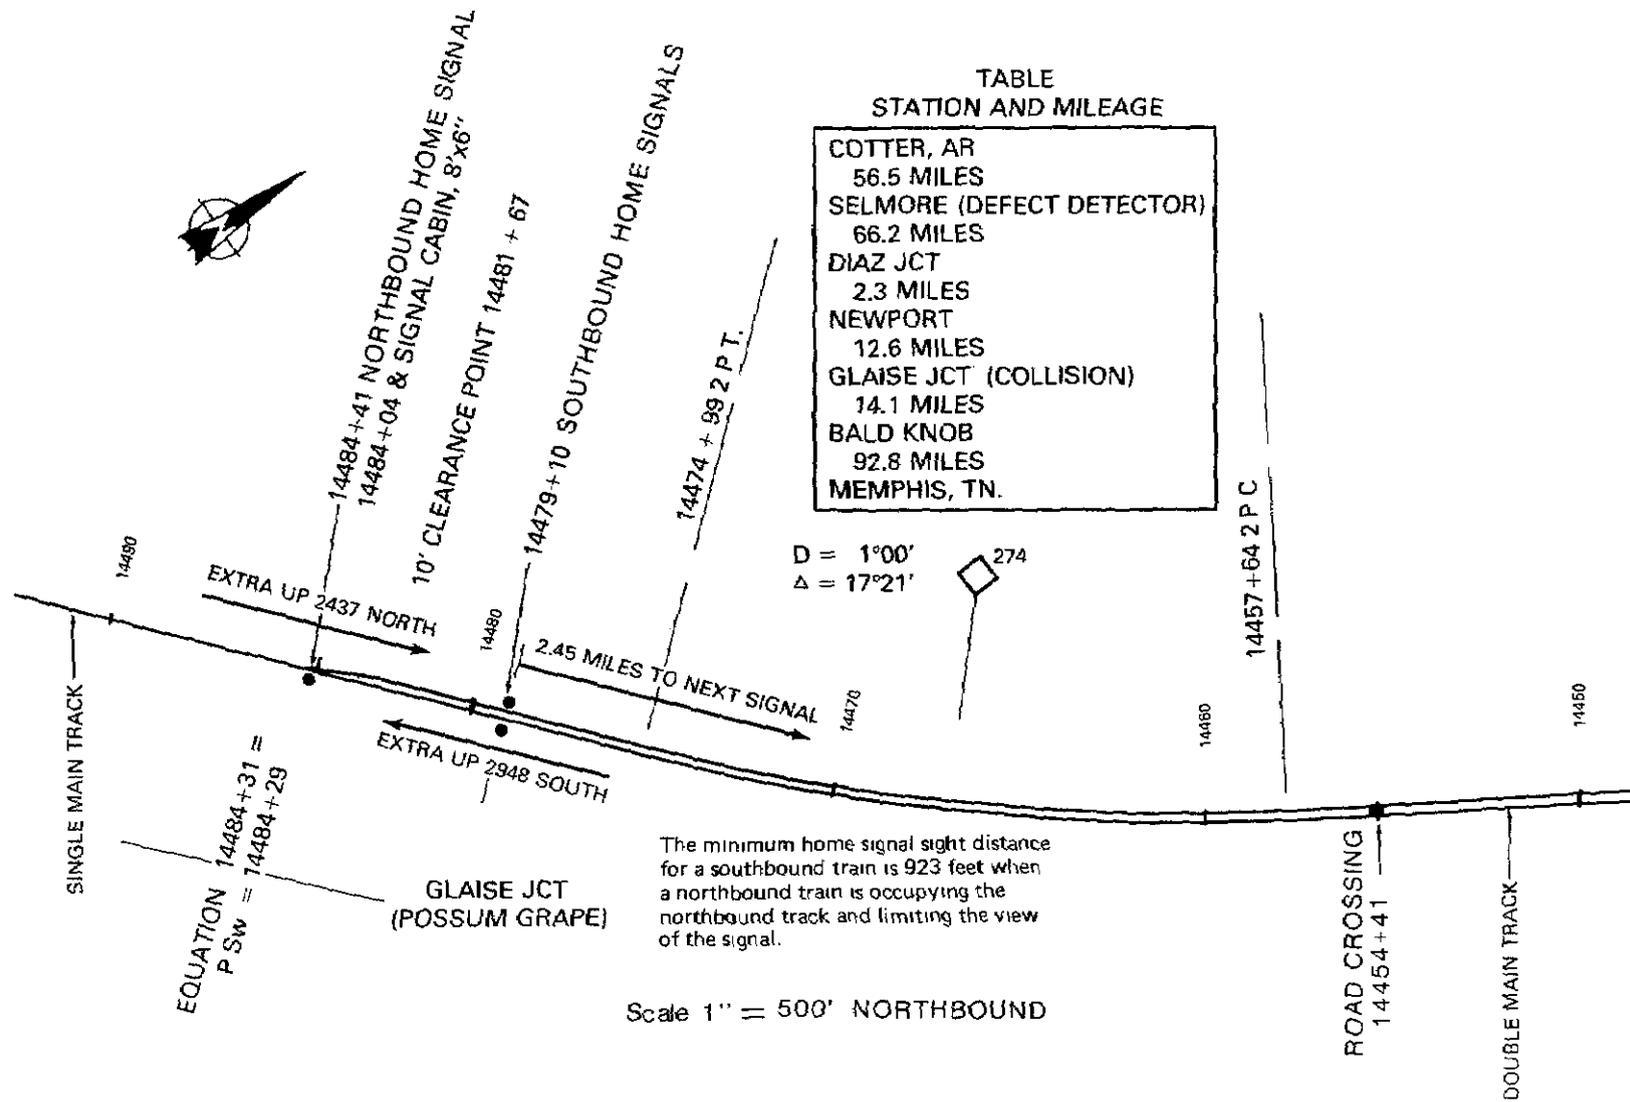
Figure 1.--Plan view of track at accident site.

initial terminal air brake test and was operated to Glaise Junction, Arkansas, a distance of 107 miles, without incident. The engineer was seated at the controls of the lead locomotive unit, and the fireman and head brakeman were seated in their respective positions on the left side of the same cab as the train approached Glaise Junction. The conductor and rear brakeman were in the caboose. About 4:13 a.m., as Extra UP 2437 North approached the Glaise Junction switch, the train dispatcher aligned the remotely controlled switch and signal to enable Extra UP 2437 North to exit the single main track and enter onto the west track of the two-track system north of that location. (See drawing, figure 1.)

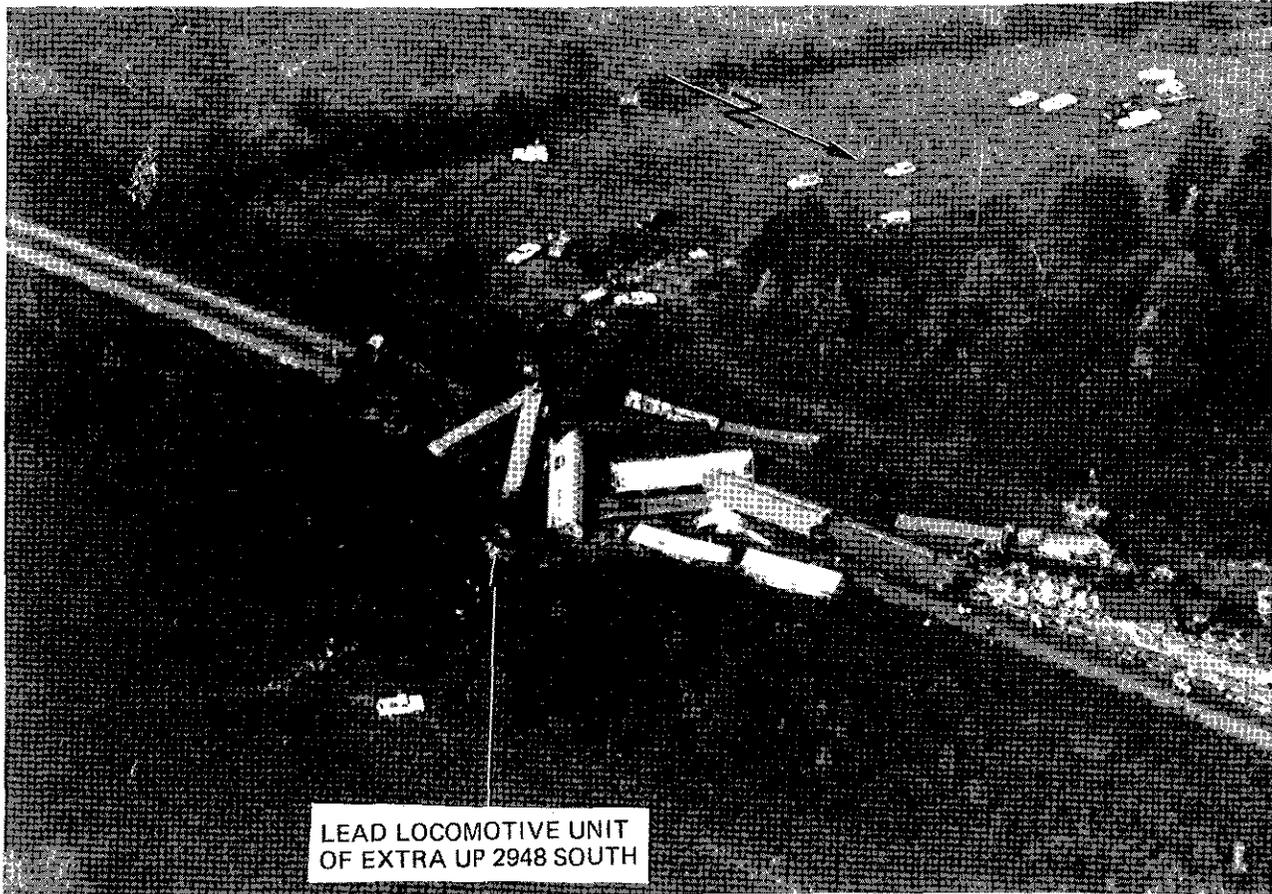
Figure 2.—Overview of collision/derailment site.

Trains.--The cab of the lead locomotive unit of Extra 2948 South was severely deformed during the collision and was deformed further as it rolled down the embankment on the east side of the fill supporting the track. Fuel oil leaked from the overturned unit's damaged fuel supply tanks and was ignited. The other locomotive units and nine following freight cars were damaged heavily. Damage to the train was estimated to be \$646,000. The eighth car from the rear and the following six cars in Extra UP 2437 North were damaged heavily as a result of the collision. The caboose and the car immediately ahead were not damaged. Damage to the train was estimated to be \$131,000. The combined loss of lading for both trains amounted to \$165,000.

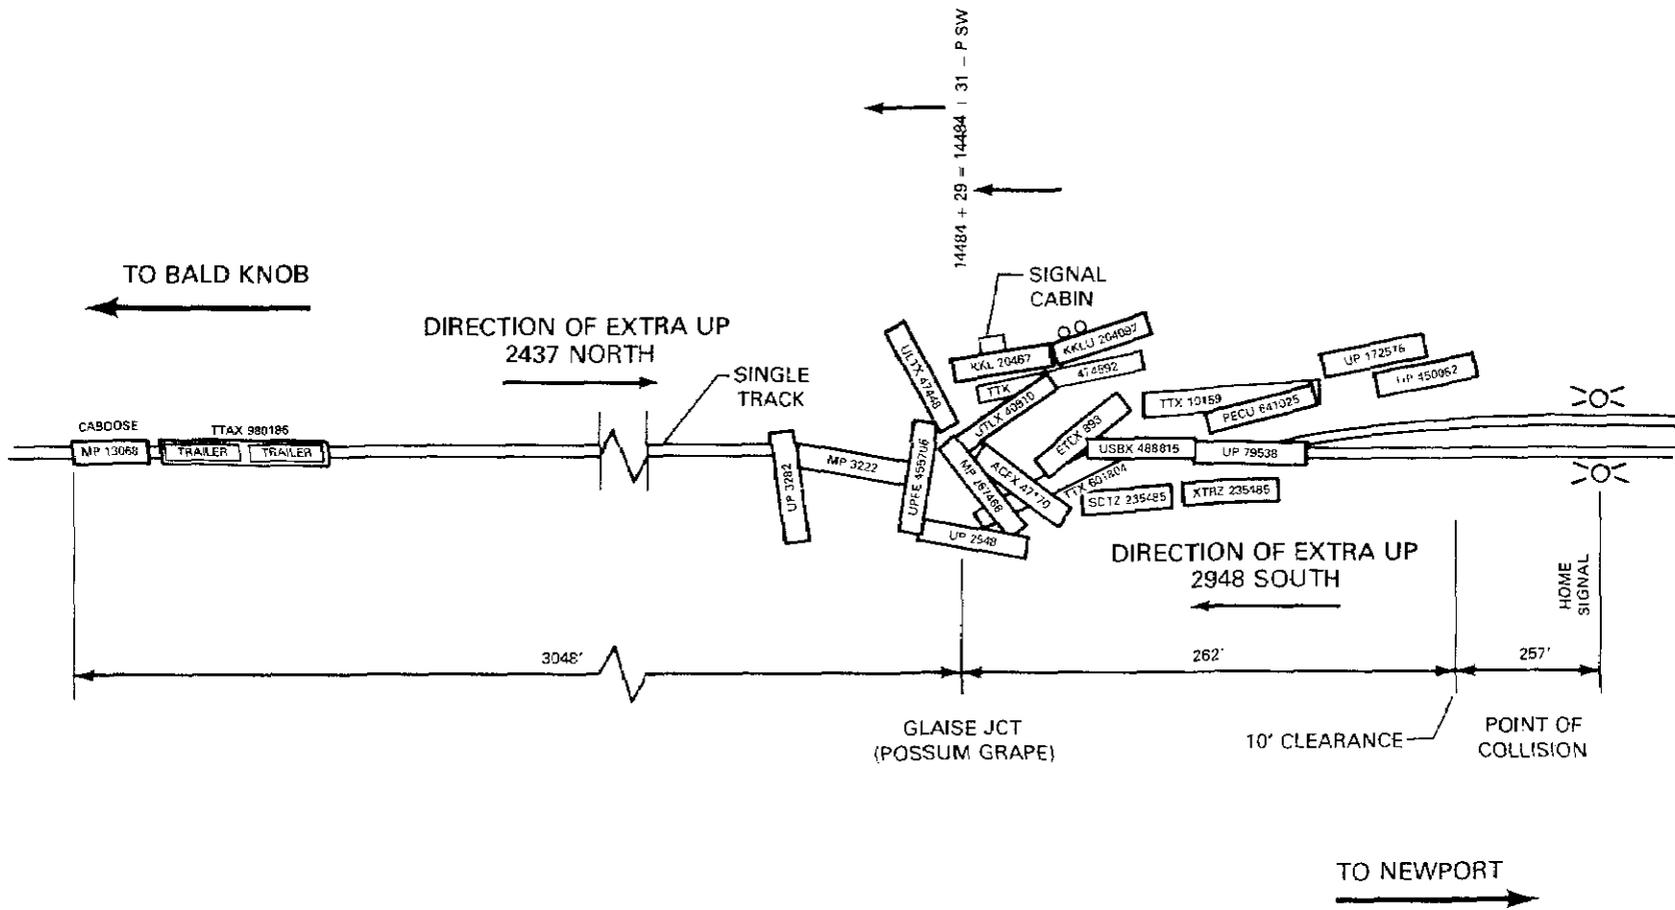
Figure 4.--Derailed equipment.
(Not to Scale)

When Extra UP 2437 North was stopped as a result of the emergency application of the air brakes, the head brakeman and fireman proceeded toward the rear of their train. Upon their arrival, they observed that Extra UP 2948 South had collided with the eighth car ahead of their caboose. (See figure 2.) The Extra UP 2948 South's lead locomotive unit had derailed, rotated 180°, and turned over before it came to rest at the foot of an embankment and about 30 feet from the track where it was engulfed in a fire fed by diesel fuel and oil. (See figure 3.) The caboose of Extra UP 2437 North and car ahead rolled backward on the track about 0.4 mile before they stopped. (See figure 4.)
