RAILROAD ACCIDENT INVESTIGATION

Report No 3765

MISSOURI PACIFIC RAILROAD COMPANY

SHERIDAN LAKE, COLO

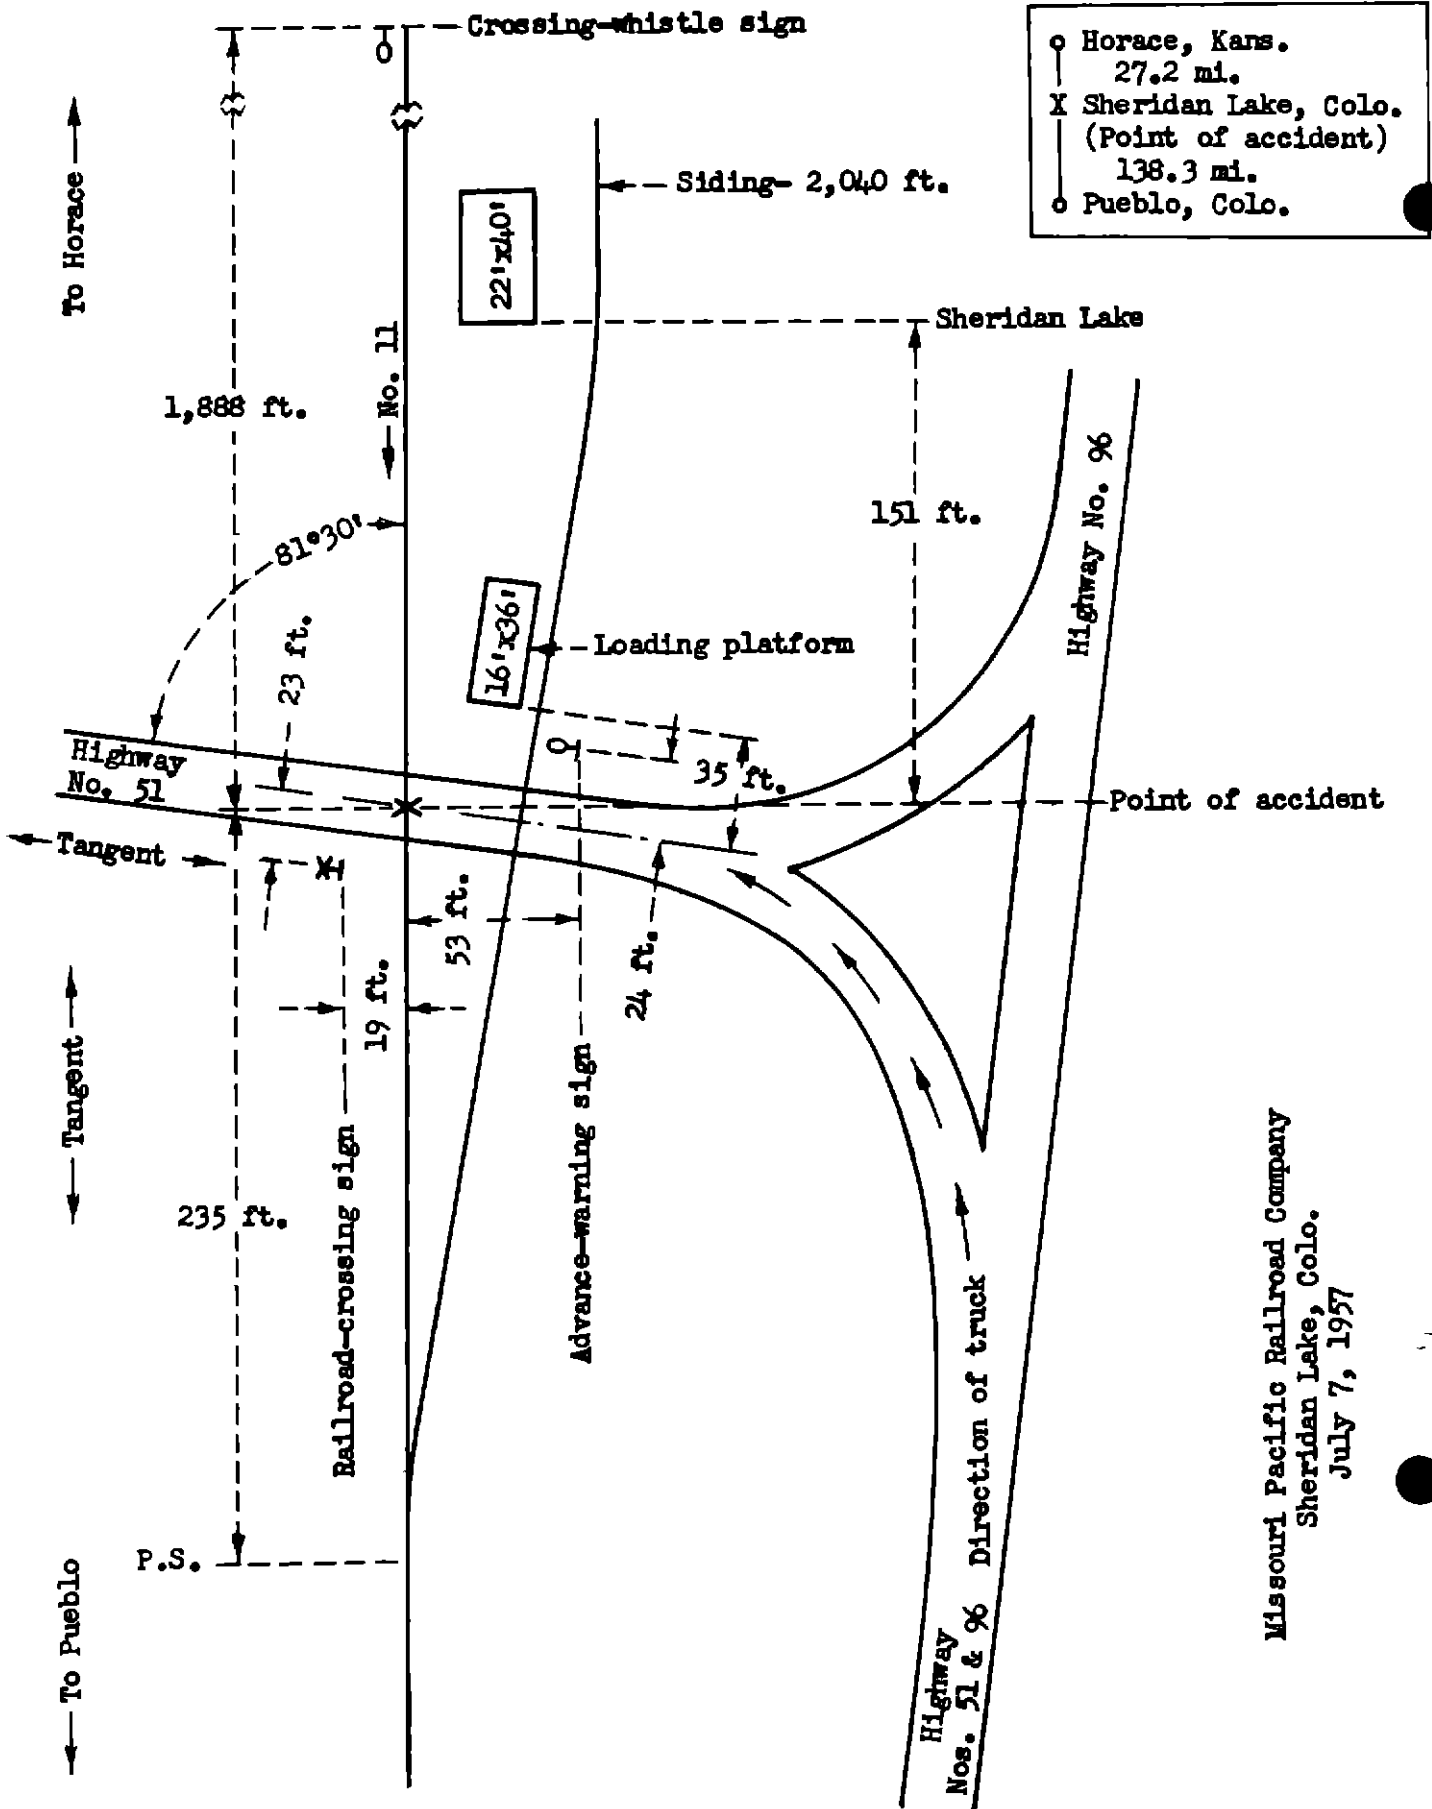
Missouri Pacific Railroad Company
 Sheridan Lake, Colo.
 July 7, 1957

This accident occurred on that part of the Colorado Division extending between Horace, Kans , and Pueblo, Colo , 165.5 miles. In the vicinity of the point of accident this is a single-track line over which trains are operated by timetable, train orders, and an automatic block-signal system. The accident occurred on the main track at a point 27.2 miles west of Horace and 151 feet west of the station at Sheridan Lake, Colo , where the railroad is crossed at grade by Colorado State Highway No. 51. In the vicinity of the point of accident Colorado State Highway No. 96 parallels the main track on the south. West of Sheridan Lake, Highway No. 51 is combined with Highway No. 96. At Sheridan Lake, Highway No. 51 diverges to the left from the combined highway and crosses the main track at an angle of 81°31'. A siding 2,040 feet in length parallels the main track on the south and is located between the main track and Highway No. 96. The west switch of this siding is located 235 feet west of the center-line of the crossing. The main track is tangent throughout a distance of several miles immediately east of the point of accident and a considerable distance westward. The grade for west-bound trains is 0.62 percent descending at the point of accident.

Highway No. 51 is surfaced with gravel to a width of 20 feet on each side of the crossing. Planking is laid along each side of each rail at the crossing. The portions of the highway extending throughout a distance of 2 feet south of the south planking and between the inside planking are surfaced with bituminous material. From the south on Highway No. 51 there are, in succession, a curve to the left approximately 285 feet in length, and a tangent approximately 35 feet to the crossing and a considerable distance northward. From the south the grade is, successively, 0.80 percent ascending a distance of 100 feet, 6.03 percent ascending 68 feet, and 3.75 percent ascending 32 feet to the center-line of the main track.

A loading platform 16 feet in width and 36 feet in length and the station 22 feet in width and 40 feet in length are located between the main track and the siding. The west end of the loading platform is located 35 feet east of the center-line of the highway.

A circular railroad-crossing advance-warning sign is located 24 feet east of the center-line of the highway and 53 feet south of the main track. It bears one vertical and two horizontal lines and the letters "RR" in black. A standard crossbuck railroad-crossing sign is located 23 feet west of the center-line of the highway and 19 feet north of the main track. This sign is mounted on a mast approximately 9 feet 8 inches above the level of the highway and bears the words "RAILROAD CROSSING" in black letters on a white background. A sign bearing the numeral "2" and the word "TRACKS" in black on a white background is mounted on the mast immediately below the crossbuck. A crossing-whistle sign for west-bound trains is located 1,888 feet east of the crossing.

As the vehicle involved in the accident proceeded northward on Highway No. 51, the driver's view of No. 11 was obstructed by the loading platform, the station, and cars standing on the siding. At a point 54 feet south of the crossing the approaching train could be seen only throughout a distance of 221 feet immediately east of the crossing.
