INVESTIGATION NO. 2713  
THE MISSOURI PACIFIC RAILROAD COMPANY  
REPORT IN RE ACCIDENT  
NEAR VAUGHN, LA., ON  
JULY 19, 1943

Railroad: Missouri Pacific  
Date: July 19, 1943  
Location: Vaughn, La.  
Kind of accident: Derailment  
Train involved: Freight  
Train number: 807  
Engine number: 25  
Consist: 48 cars, caboose  
Speed: 30 m. p. h.  
Operation: Timetable and train orders  
Track: Single; tangent; level  
Weather: Clear  
Time: About 1:30 p. m.  
Casualties: 1 killed; 1 injured  
Cause: Kinked track

Accident near Vaughn, La., on July 19, 1943, caused by  
kinked track.

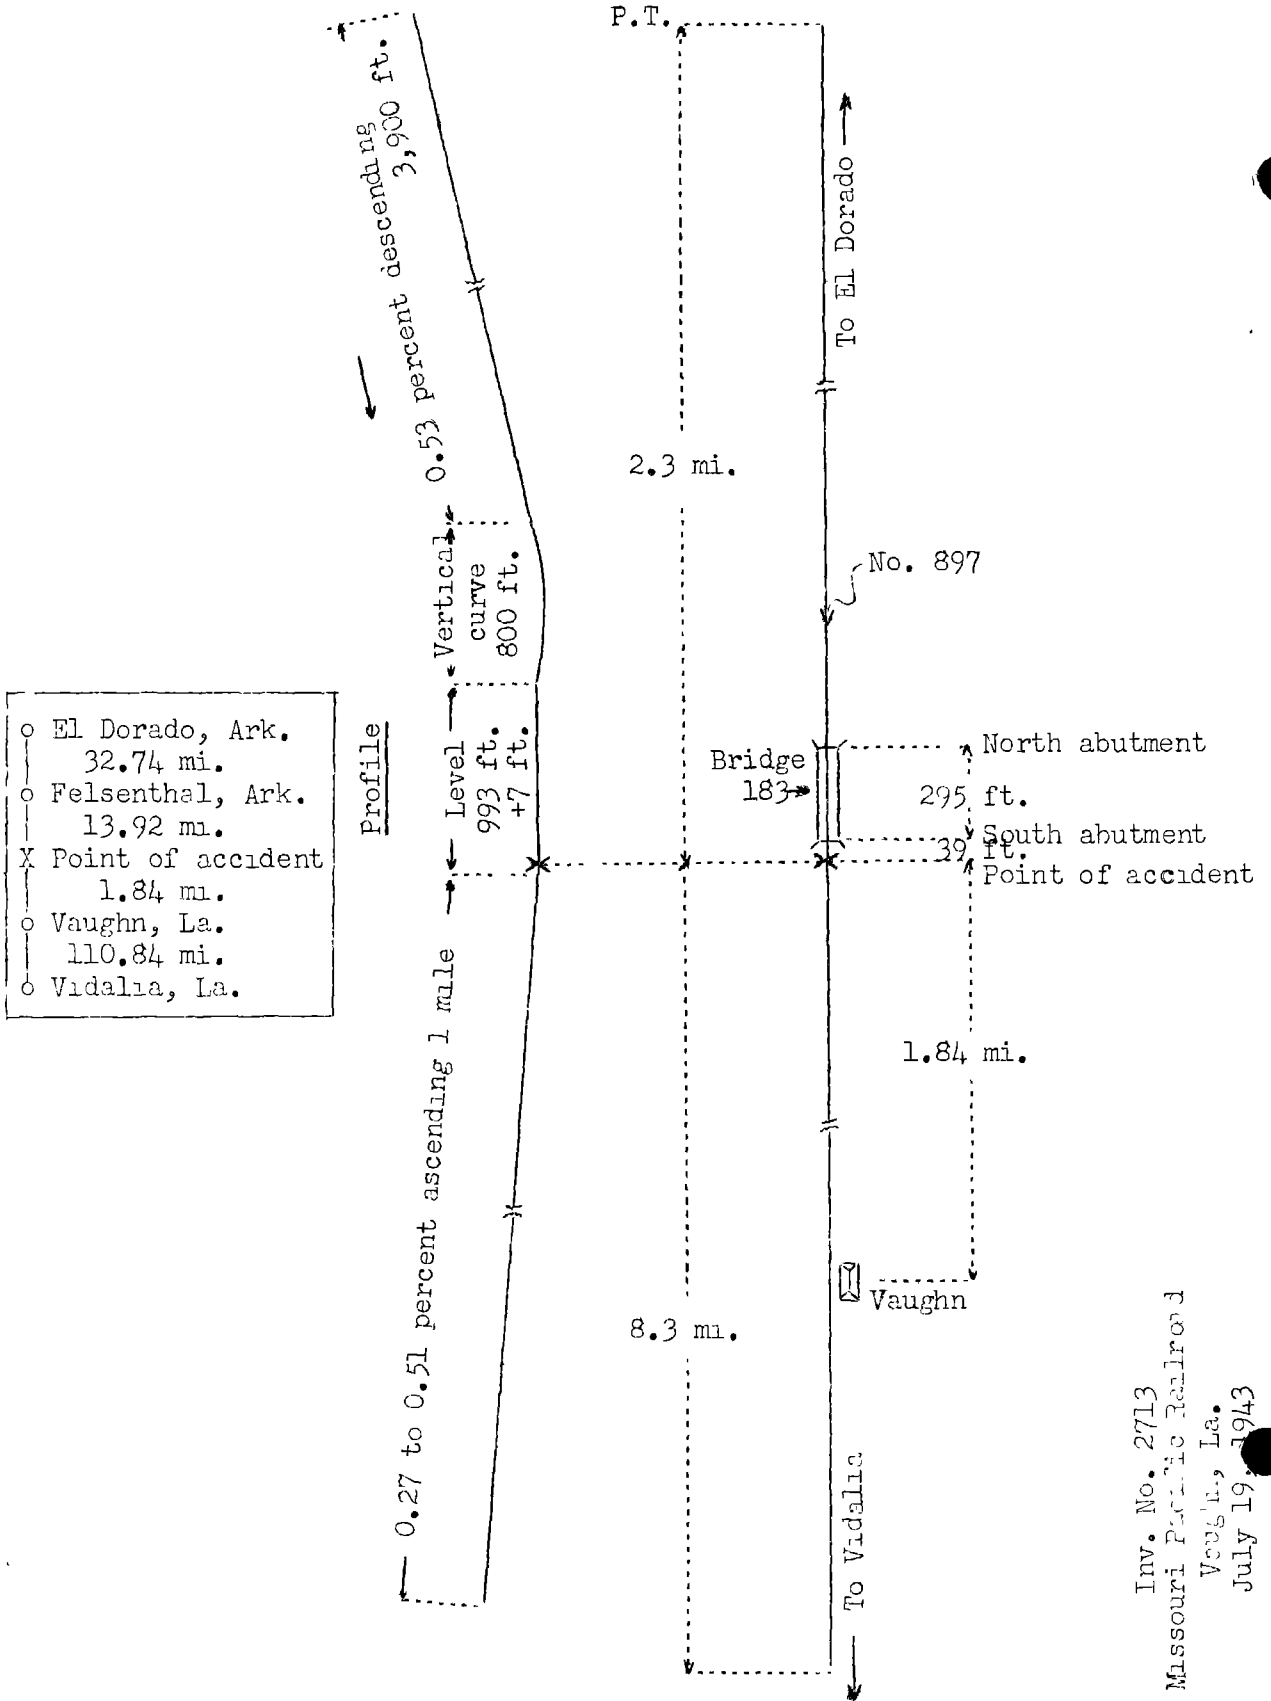
Inv. No. 2713  
 Missouri Pacific Railroad  
 Vaughn, La.  
 July 19, 1943

After the accident a section of track about 25 feet long, beginning at a point 31 feet south of the south abutment of Bridge 183, was found to be deflected to the left. The maximum deflection, which was 11-1/2 inches, was located midway of this section, and it formed at least a 45-degree curve to the right. Beginning at a point 8 feet south of the north end of the displaced track, a flange mark appeared on the outside edge of the base of the east rail. Throughout a distance of about 200 feet southward from this mark, the ties bore wheel marks outside the east rail and inside the west rail. From this point southward a distance of about 200 feet to the point where the rear three cars and the caboose overturned to the west, wheel marks appeared on the ties outside the west rail and inside the east rail. Marks on the base of the rails on the bridge and north of it indicated that the rails had crept.

The displacement of the track occurred on level tangent track. Beginning at a point 5,793 feet north of the point of derailment, there was a 0.53 percent descending grade southward 3,900 feet. South of the foot of this grade there was a vertical curve 800 feet in length, and south of this the track was level 993 feet to the point where the displacement occurred and 7 feet beyond, then there was a 0.27 percent to 0.51 percent ascending grade southward. The rails on the gradients would have a tendency to creep downward toward the bottoms of the grades and thereby cause the rails at the lower ends of the grades to be compressed. Rail anchors were not provided throughout a distance of approximately 2,000 feet north of the point where the displacement occurred, and an average of only 8 rail anchors per rail length was provided south of that point. This condition, combined with high temperature and ballast that offered very little resistance to lateral movement resulted in the track being kinked.
