INVESTIGATION NO. 3001
MISSOURI PACIFIC RAILROAD COMPANY
REPORT IN RE-ACCIDENT
AT WASHINGTON, MO., ON
JULY 10, 1946

Accident at Washington, Mo., on July 10, 1946, caused by
an engine fouling the main track immediately in
front of an approaching train.

Inv. No. 3001
 Missouri Pacific Railroad
 Washington, Mo.
 July 10, 1946

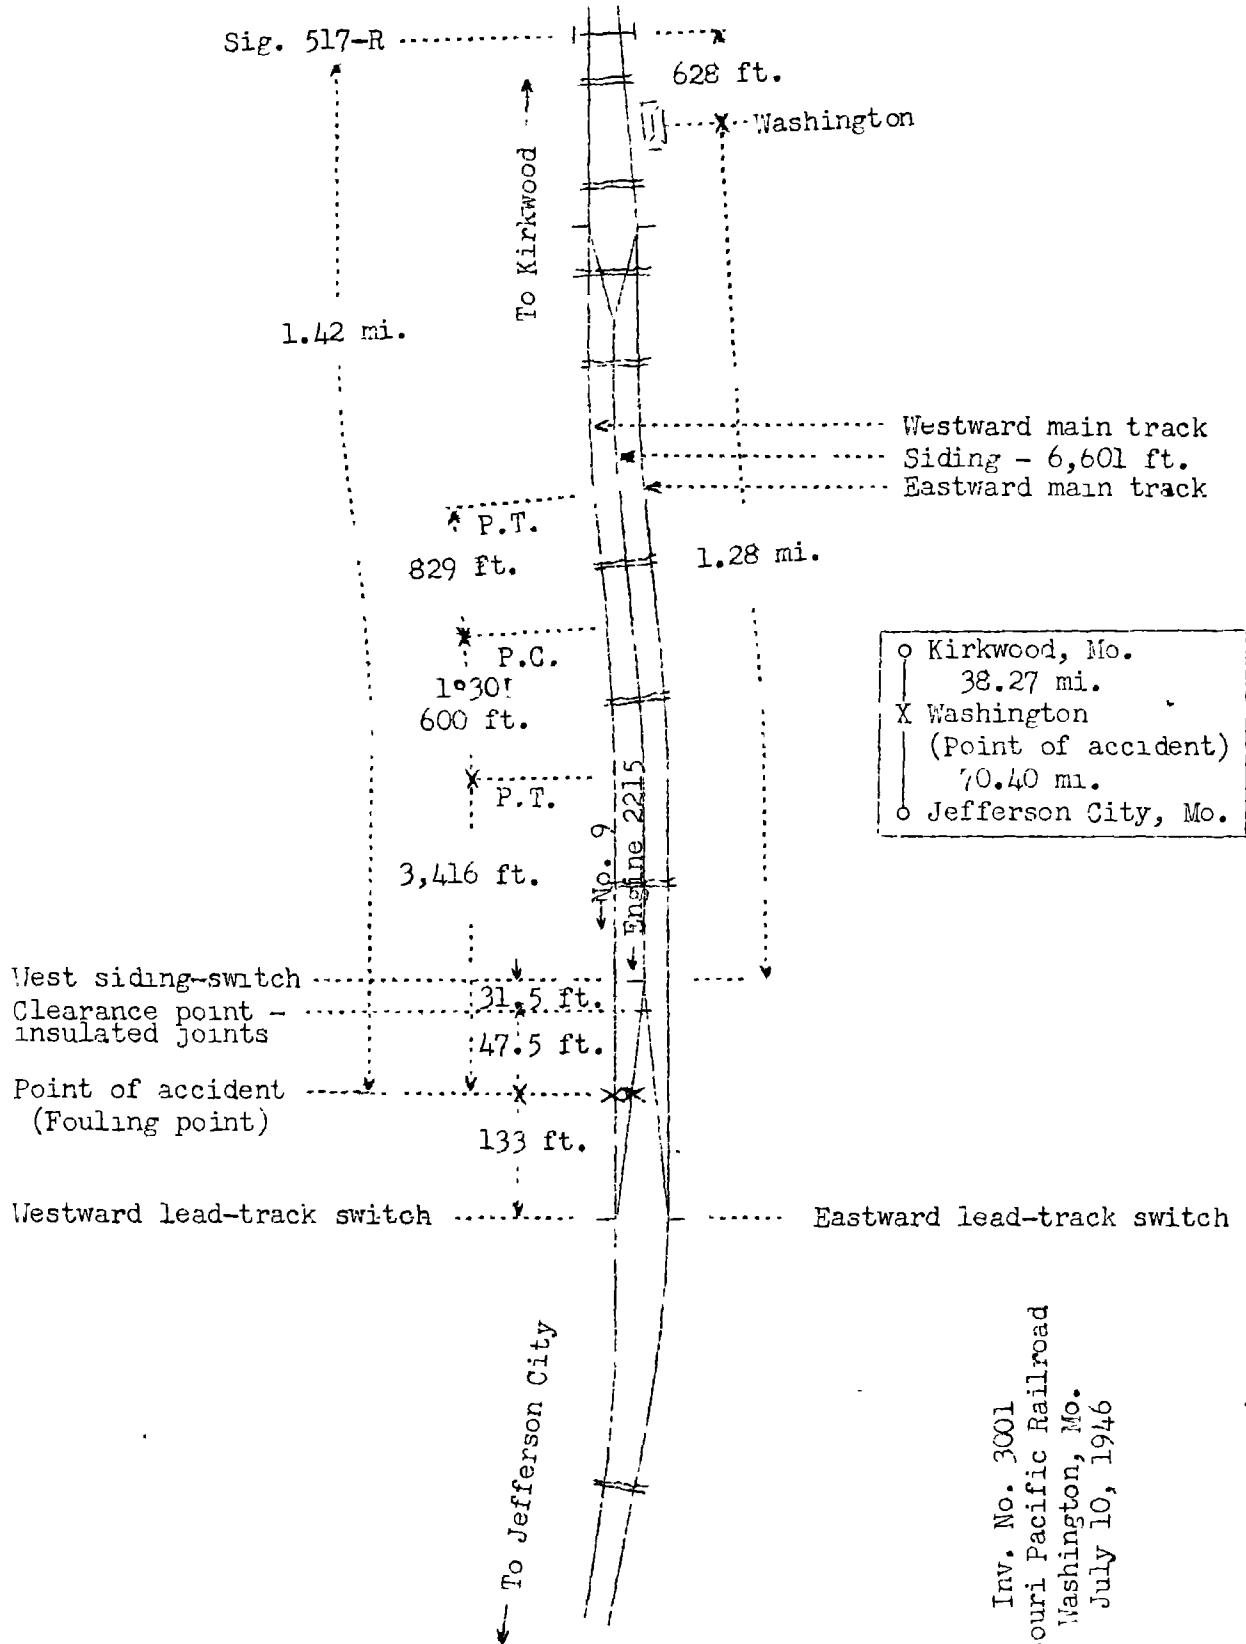
This accident occurred on that part of the Eastern Division extending between Kirkwood and Jefferson City, Mo., 108.67 miles. In the vicinity of the point of accident this is a double-track line over which trains moving with the current of traffic are operated by signal indications. At Washington, 38.27 miles west of Kirkwood, a siding 6,601 feet long lies between the main tracks. The west switch of the siding is 1.28 miles west of the station. Two lead tracks, each of which is 212 feet long, extend from the west end of the siding to the main tracks. The siding turnouts are No. 7 and the main-track turnouts are No. 10. The clearance point at the east end of the westward lead track is 31.5 feet west of the west siding-switch. The accident occurred at the fouling point of the westward main track and the westward lead track, at a point 47.5 feet west of the clearance point and 133 feet east of the westward lead-track switch. From the east on the westward main track there are, in succession, a tangent 829 feet in length, a 1°30' curve to the right 600 feet, and a tangent 3,416 feet to the point of accident and some distance westward. The grade is 0.05 percent descending westward.

The switch-stand of the west siding-switch is between the south rail of the westward main track and the north rail of the siding and is of the hand-operated two-position ground-throw low-stand type. It is not provided with a target, a switch lamp or a lock. The switch-stands of the lead-track switches are of the hand-operated ground-throw low-stand type, and each is provided with one red oval-shape target. When the lead-track switches are lined for entry to the main track the targets are displayed at right angles to the track.

Automatic signal 517-R, governing west-bound movements on the westward main track, is 1.42 miles east of the point of accident. This signal is of the color-light type. The track circuit of the fouling section of the westward lead track extends 180.5 feet east of the lead-track switch. The controlling circuits of the automatic signals are so arranged that when any portion of the fouling section of the westward lead track is occupied signal 517-R displays stop.

It is recommended that the Missouri Pacific Railroad Company install electric switch-locking at hand-operated switches controlling movements between sidings and main tracks on lines where trains are operated by signal indication only. An order to show cause why it should not do so will be served on said carrier.
