REPORT NO. 3434

MISSOURI-KANSAS-TEXAS RAILROAD COMPANY OF TEXAS IN RE ACCIDENT
NEAR RAY, TEX., ON OCTOBER 19, 1951

January 8, 1952

Accident near Ray, Tex., on October 19, 1951, caused by failure properly to control the speed of the following train moving within yard limits.

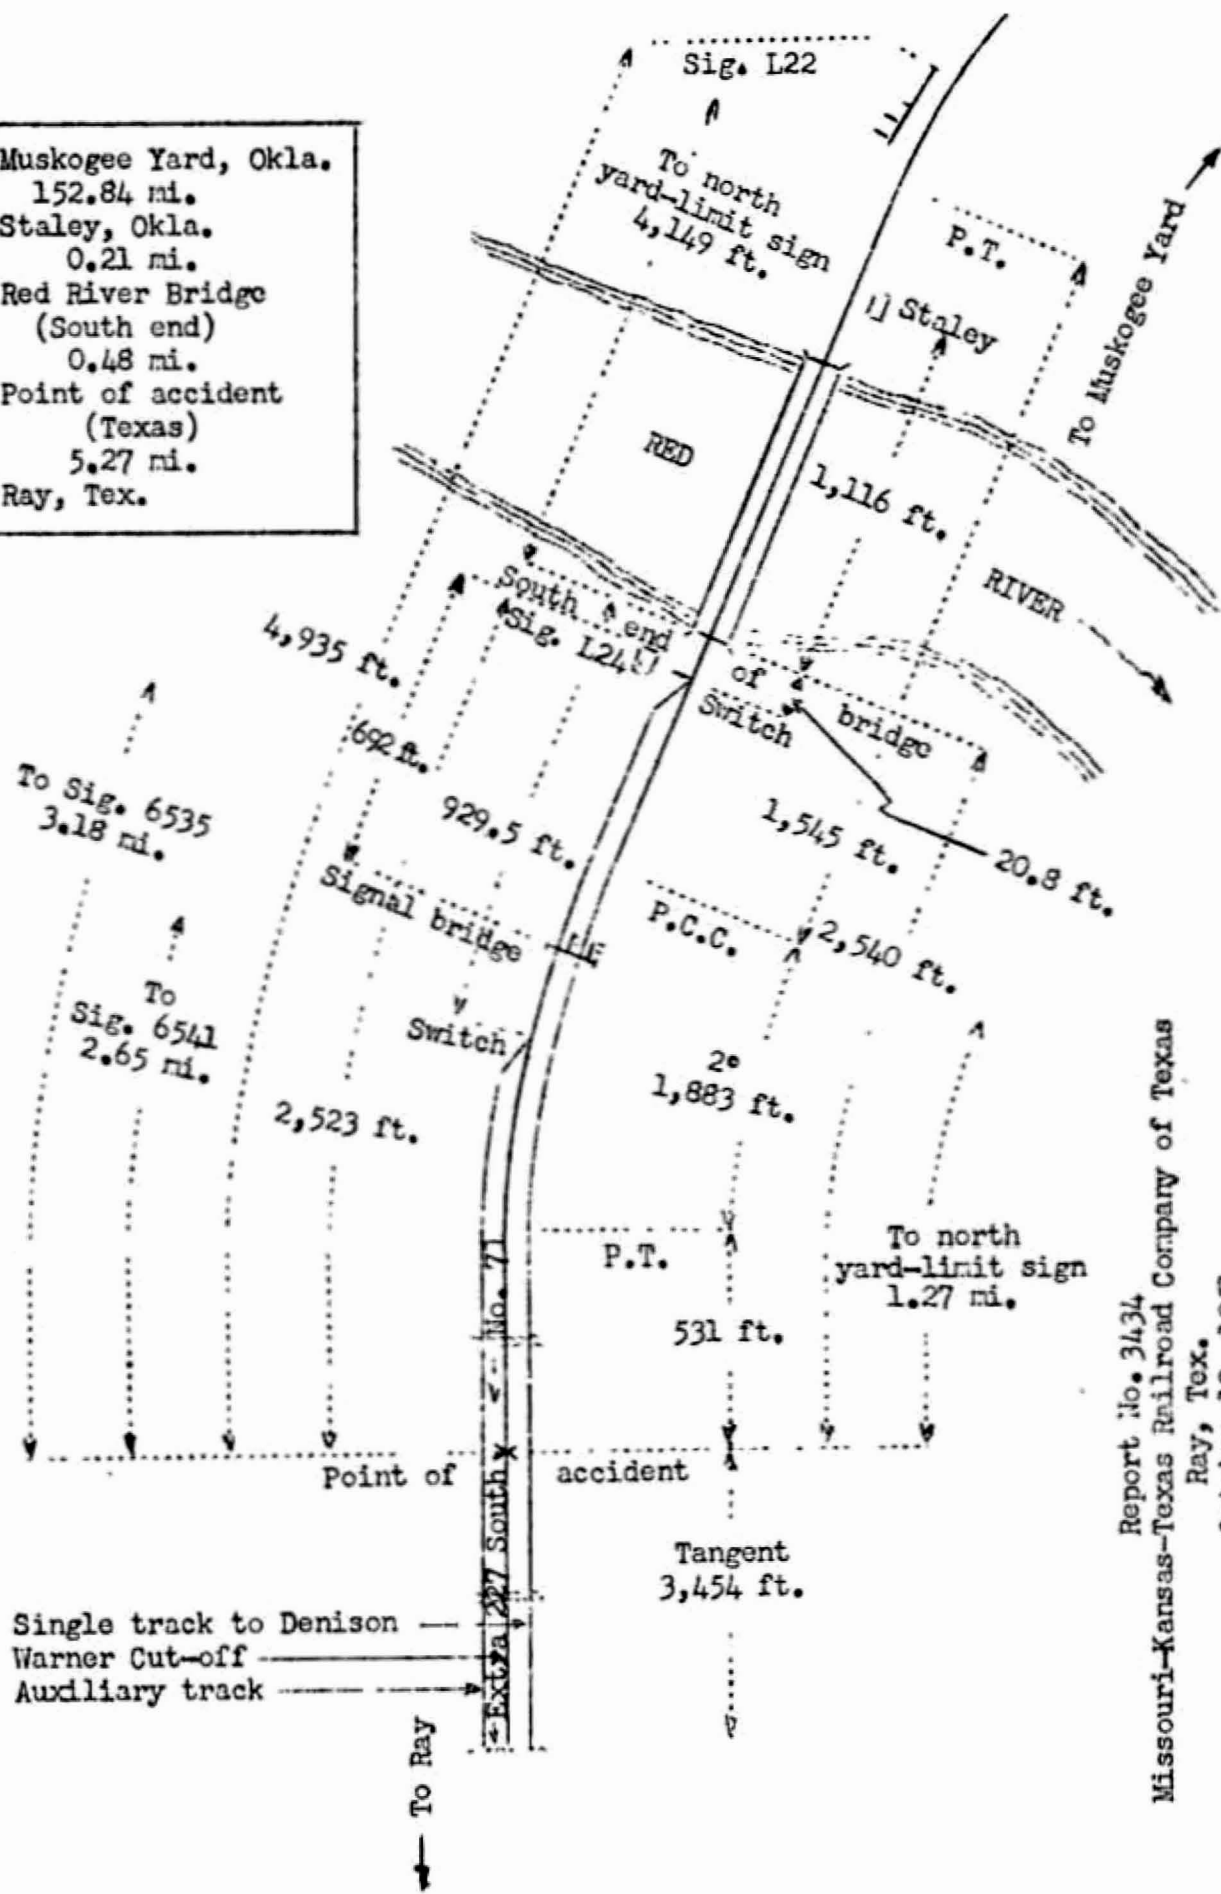
Report No. 3434
 Missouri-Kansas-Texas Railroad Company of Texas
 Ray, Tex.
 October 19, 1951

- o Muskogee Yard, Okla.
152.84 mi.
- o Staley, Okla.
0.21 mi.
- o Red River Bridge
(South end)
0.48 mi.
- X Point of accident
(Texas)
5.27 mi.
- o Ray, Tex.
