ACCIDENT ON THE

MISSOURI-KANSAS-TEXAS RAILROAD

STARK, KANS.

INVESTIGATION NO. 2168

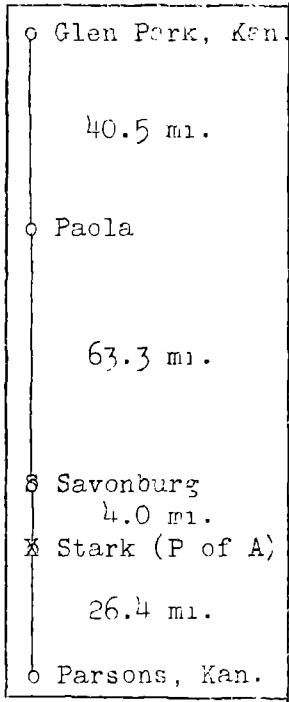
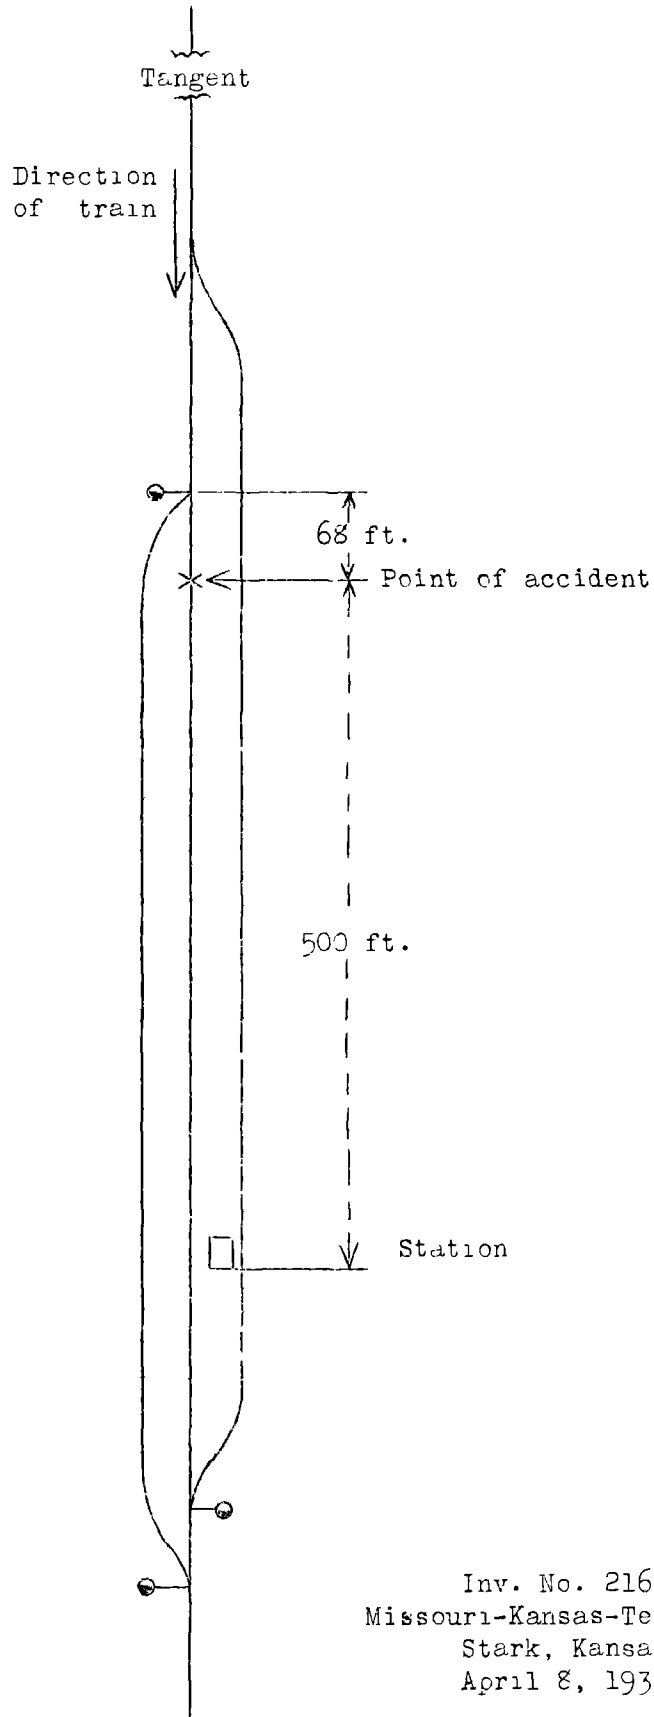
Inv. No. 2168
Missouri-Kansas-Texas R.R.
Stark, Kansas
April 8, 1937

Car Foreman Allen arrived at the scene of accident at 3:25 p.m. and found the rear truck of B. & O. 181062 a short distance north of the car, in badly damaged condition. The lead pair of wheels were detached and both arch bars and the tie bar on the west side were each broken in two places. All of these fractures were new; a break in the bottom arch bar at the bend just back of the front journal box, presented a comparatively smooth appearance while the other breaks appeared to have been pulled and twisted. It was his opinion that the initial failure occurred at the smooth appearing fracture in the bottom arch bar. There was no evidence of old breaks.

The report of Engineer of Tests Boughton was to the effect that the fracture in the bottom bar, which appeared to have been the original break, seemed to have occurred suddenly rather than progressively. It contained two irregularities which indicated defects in the steel. One piece of the arch bar was cut in two at the laboratory about an inch from the fracture, and after polishing and etching in hot sulphuric acid, it showed that the steel contained two inclusions of foreign matter which probably caused the bar to break at that locality. These impurities were near the wide surfaces of the bar and therefore were subjected to maximum stresses and acted much like nicks, thus weakening the bar at this locality; one was located near the top side and one near the bottom side of the bar. The one at the top extended horizontally for about $19/32$ inch and was about $3/32$ inch from the top side. It was about $2-3/16$ inches from one edge and about $2-1/16$ inches from the other edge of the bar. The thickness of the foreign matter was about $3/64$ inch at its greatest part and tapered toward each edge. The one near the bottom of the bar extended in a plane nearly vertical to the width of the bar and at a slight angle to the center line and was about $11/32$ inch long and about $3/32$ inch wide. It was located about $1-9/16$ inch from one edge and about $3-3/8$ inches from the other edge, and extended to about $9/64$ inch from the side of the bar.

arch bars were $1\frac{1}{4}$ " by 5", and the tie bars $\frac{5}{8}$ " by 5"; the journals were 5" by 9". The top bar was broken at each column bolt hole, and the bottom bar at the bend, 3 inches back of the second journal-box bolt hole and also 3 inches in front of the leading column bolt hole, all fractures being new breaks. Examination by the engineer of tests indicated that the original break occurred in the bottom bar, and that it broke suddenly rather than progressively, apparently due to impurities in the metal.

1. That arch bar trucks be removed from service at the earliest practicable date.
2. That until arch bar trucks can be eliminated from service, a reduction sufficient to guarantee safety of operation should be made in the permissible load limit on cars equipped with such trucks.
3. That inflammables, explosives or other dangerous articles should not be transported in cars which are equipped with arch bar trucks.
4. That provision be made in interchange rules whereby a receiving line may refuse to accept from a connecting line any car equipped with arch bar trucks.
