REPORT OF THE DIRECTOR

ACCIDENT ON THE

MISSOURI-KANSAS-TEXAS RAILROAD OF TEXAS

INVESTIGATION NO. 2216

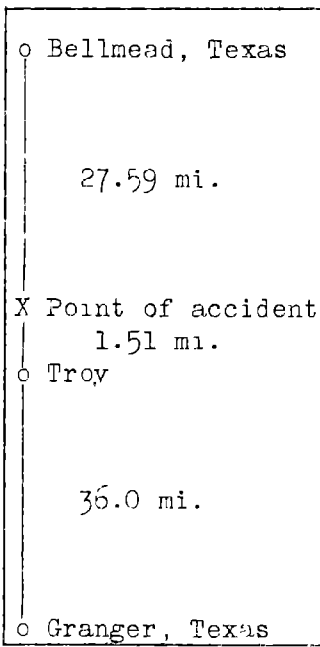
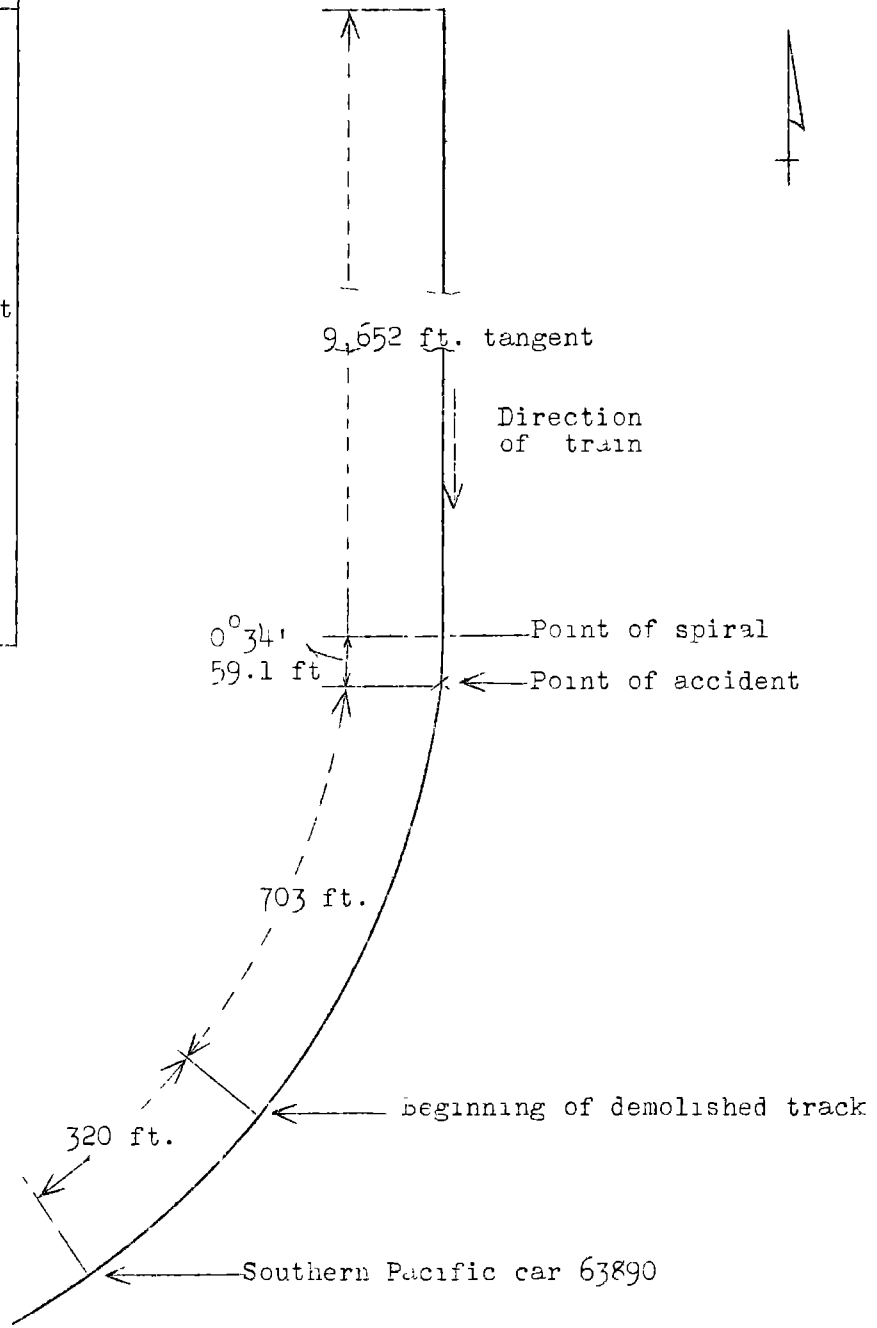
Inv. No. 2216  
 Missouri-Kansas-Texas  
 Railroad of Texas  
 Troy, Texas  
 October 26, 1937

The first indications of the derailment were two flange marks on the gauge side of the ball of the outside rail of the curve; these marks indicated the left wheels of a truck rocked down upon the ball of the rail and then continued to travel diagonally across the rail a distance of about 21 feet and then flange marks appeared on spike heads and on the ends of the ties; companion marks appeared on the inside of the west rail from the point where the wheels dropped to the outside of the east rail.

The evidence indicates that the front truck of the seventeenth car, S. P. 63890, was the first to be derailed; this truck apparently ran approximately parallel with the rails a distance of 630 feet and then it began to slide crosswise the track, turning the left rail over, followed by the derailment of the rear truck. The front truck continued in this position to a point about 703 feet south of the point of derailment where it began to bunch and tear out the ties, shoved left rail from ties, and then demolished the track for a distance of 177 feet. The car then turned over to the left and stopped at the foot of the 6-foot embankment, carrying the rail with it; this pulled the sixteenth car down the fill which in turn pulled the fifteenth car down and derailed the rear truck of the fourteenth car. Apparently the leading truck of the seventeenth car slued to the left since the ballast was banked against the outside of the west wheels and the inside of the east wheels; also, the right-front journal box appeared to have been dragged practically crosswise the track and where this truck dropped off the rail the inside of the west-side frame appeared to have chafed the right or west rail some distance; this was the only truck showing such evidence. In addition the demolished track did not extend south of the point of where the seventeenth car stopped. South of the car in question flange marks appeared on the ends of the ties on the east side for a distance of 71 feet and from this latter point to the location of the fifteenth car, a distance of about 750 feet, only the left ends of the ties were scraped. It appeared that during the derailment the two wheels on the rear axle of the leading truck of the seventeenth car were shifted inward on the axle, and indications that the truck side had sustained a severe blow provided an explanation of this movement.
