RAILROAD ACCIDENT INVESTIGATION

Report No. 4121

MISSOURI-KANSAS-TEXAS RAILROAD COMPANY

JUNE 3, 1967

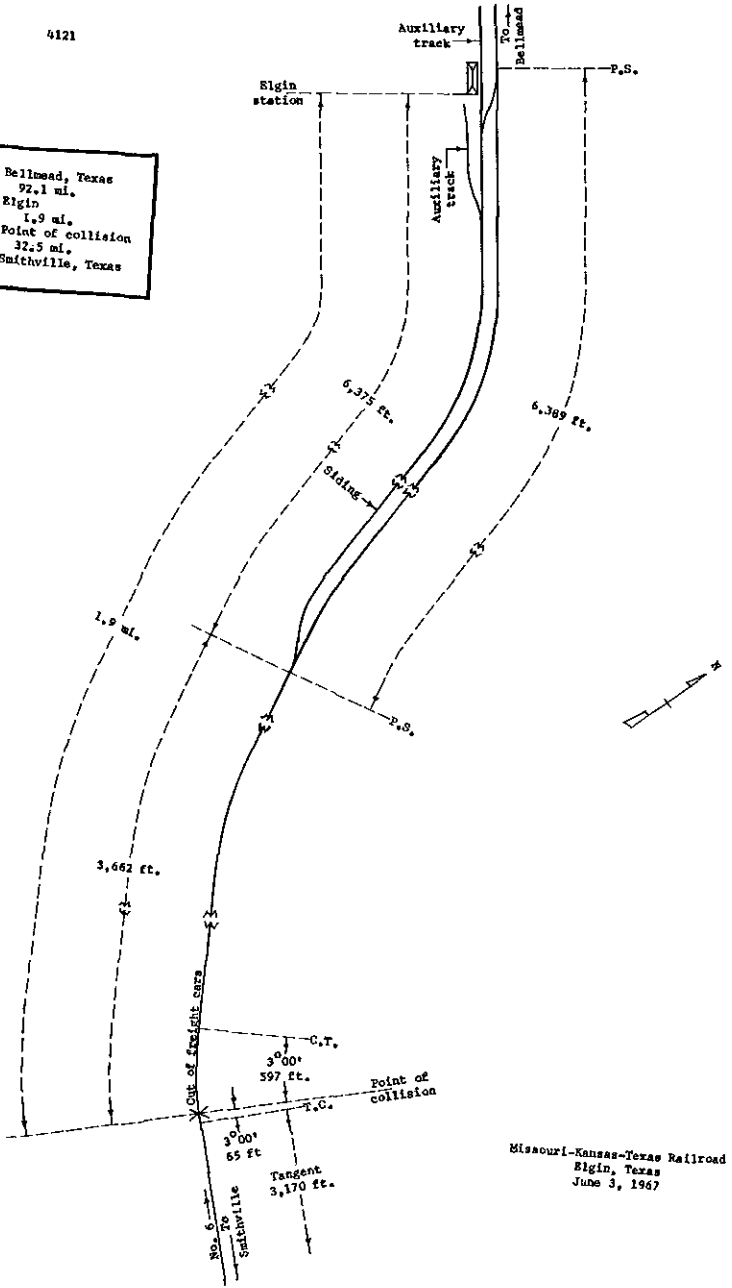
Missouri-Kansas-Texas Railroad
Elgin, Texas
June 3, 1967

The accident occurred on that part of the Southern Division extending between Smithville and Bellmead, Texas, a distance of 126.5 miles. In the accident area this is a single-track line over which trains operate by timetable and train orders. There is no block-signal system in use at Elgin, 34.4 miles north of Smithville, a siding 6,389 feet long parallels the main track on the west. The south switch of the siding is 6,375 feet south of the station. Two auxiliary tracks are connected to the siding near its north end, as indicated in the sketch appended to this report.

The collision occurred on the main track, 1.9 miles south of the Elgin station and 3,662 feet south of the south siding-switch.

Between a point near the Elgin station and the south siding-switch, the grade of the main track and siding averages 0.68 percent descending southward. It is 1 00 percent descending southward throughout 2,150 feet north of the south siding-switch.
