RAILROAD ACCIDENT REPORT

**COLLISION OF MISSOURI-KANSAS-TEXAS
RAILROAD COMPANY TRAIN NO. 103
WITH STANDING FREIGHT CARS
NEAR TEMPLE, TEXAS
MARCH 17, 1983**

NTSB/RAR-83/08

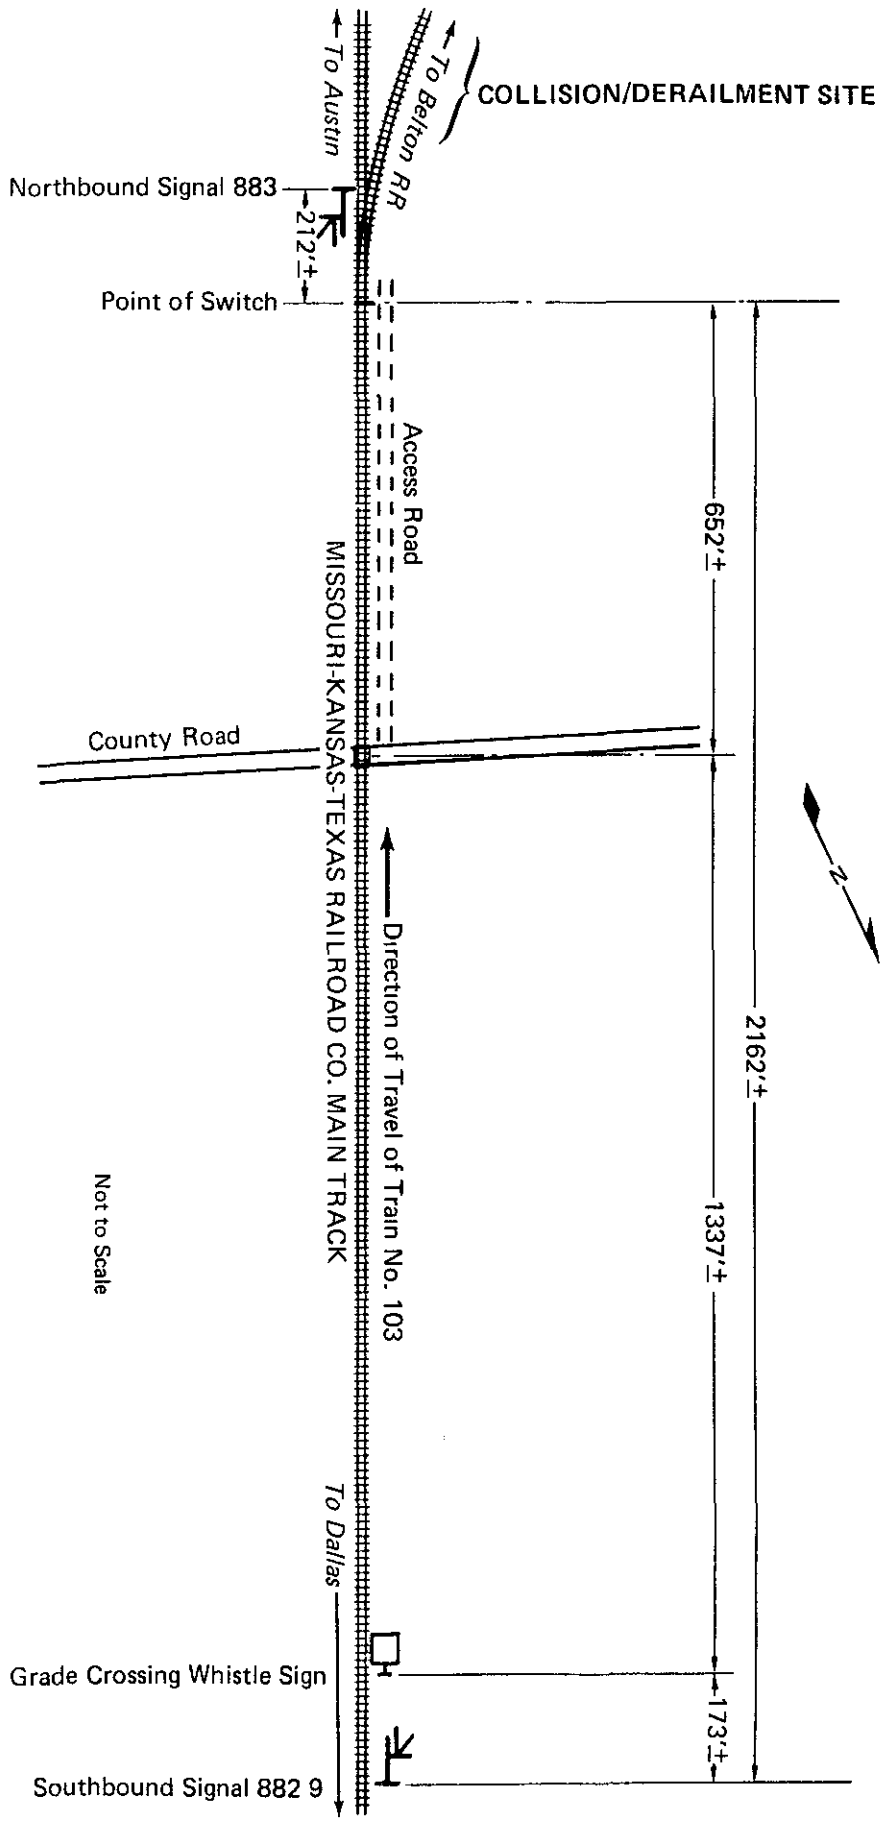
Figure 1. --- Accident site.

About 9:30 a.m., c.s.t. 1/ on March 17, 1983, a Missouri-Kansas-Texas Railroad Company (MKT) signal maintainer arrived at a main track switch which leads from the MKT to an interchange track to the Belton Railroad Company (BRR) outside the city limits of Temple, Texas. (See figure 1.) The signal maintainer had been instructed to relocate the switch circuit controller, 2/ which was located on the adjacent tie to the headblock tie. 3/ Relocation of the switch circuit controller involved removal and replacement of the shunt wires 4/ leading from the switch circuit controller to the rails of the main track.

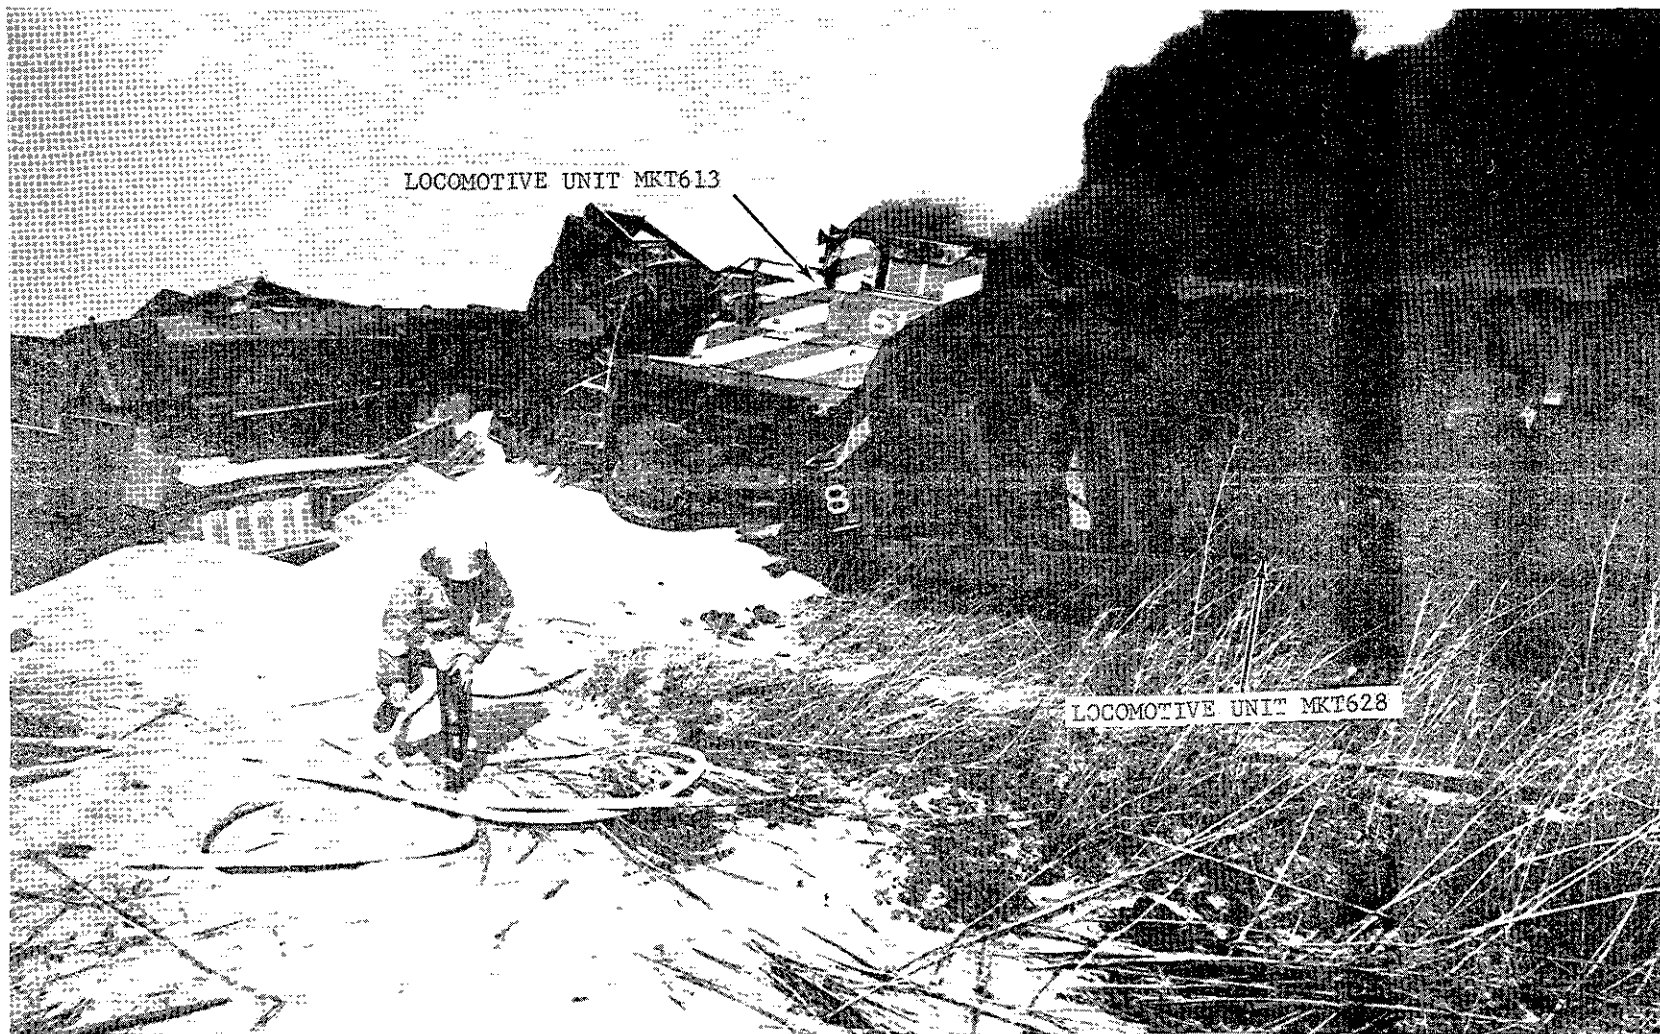
The last two units of the four-unit locomotive sustained extensive damage in the collision and ensuing fire, and were considered destroyed. (See figure 4.) The operating compartment of the third unit was crushed, and the fuel tank on the fourth unit was torn open about one-half of the circumference of the tank. The pilot and front platform of the leading unit were damaged and the underframe, electrical, and air brake equipment of the first two units were damaged. (See figure 5.)

Figure 4.—Last two locomotive units of train No. 103.

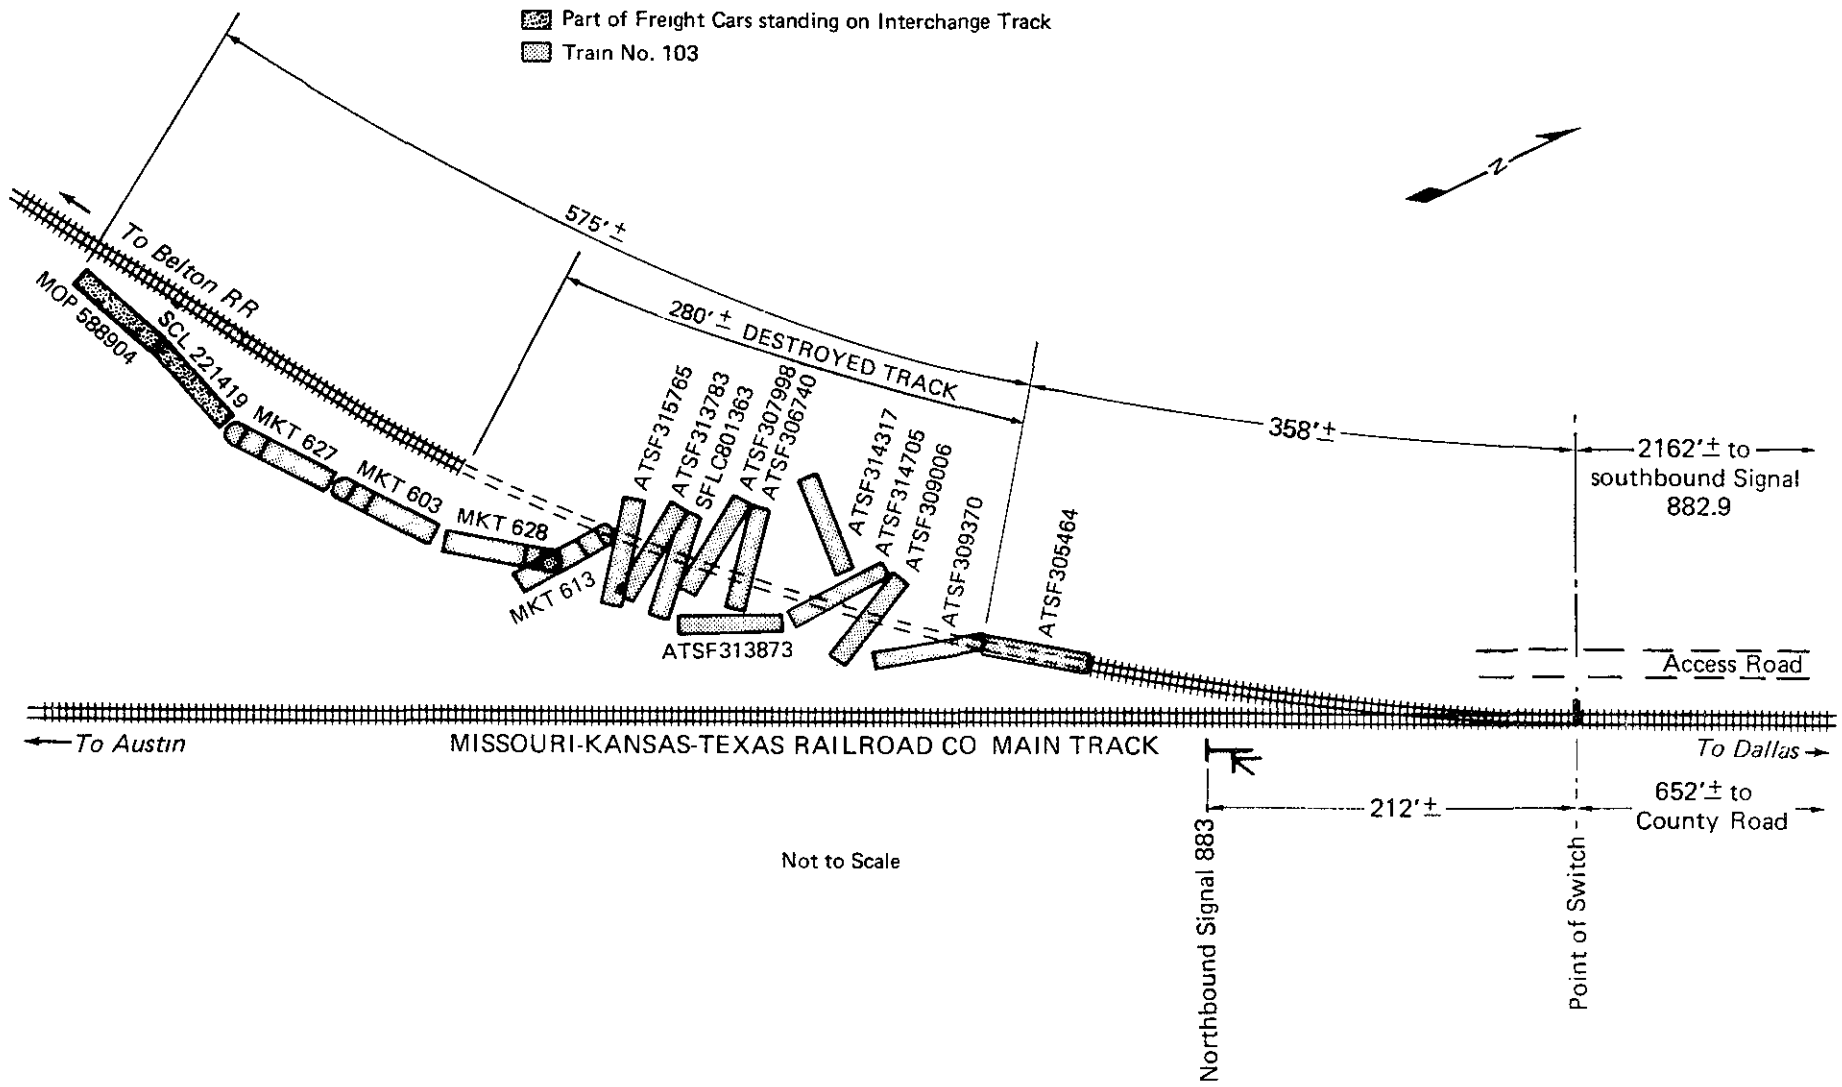
About 4:10 p.m., train No. 103 entered the switch leading to the interchange track and collided with the standing freight cars. The four locomotive units derailed to the east of the interchange track, but clear of the MKT main track. The fourth unit jackknifed, bypassed, and subsequently overrode and crushed the operating compartment end of the third unit. The fuel tank on the fourth unit was torn open, and the spilled diesel-fuel-oil was ignited; the ensuing fire destroyed the third and fourth locomotive units. The ten cars behind the locomotive derailed and jackknifed; the eleventh car did not derail, but sustained damage.

The most northerly of the standing freight cars was destroyed and the car behind it was damaged; the remaining five cars rolled south on the interchange track. The hand brakes had been set on the two most northerly of the seven cars, and also on the most southerly car. (See figure 3.) The engineer sustained serious injuries, and the fireman, and a brakeman who was on the second locomotive unit, sustained minor injuries; the other brakeman was not injured. The conductor, who was riding in the caboose, also was not injured.

Figure 3.—Plan view of the accident site.

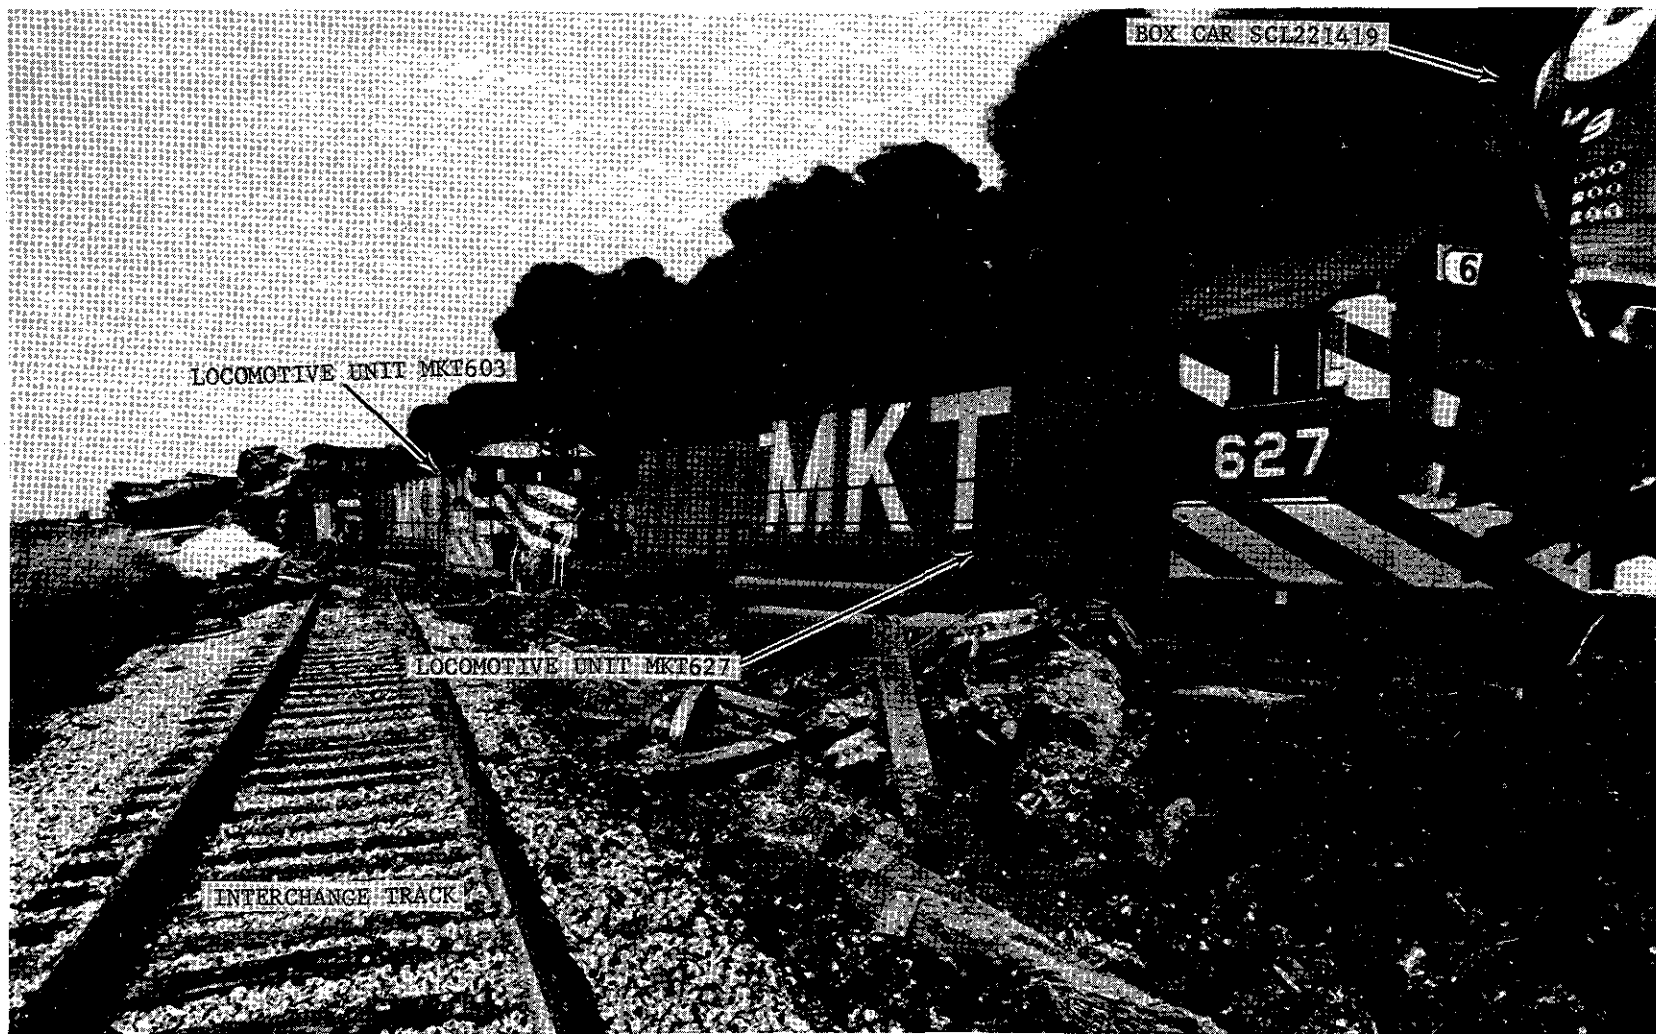
Figure 5.--First two locomotive units of train No. 103.

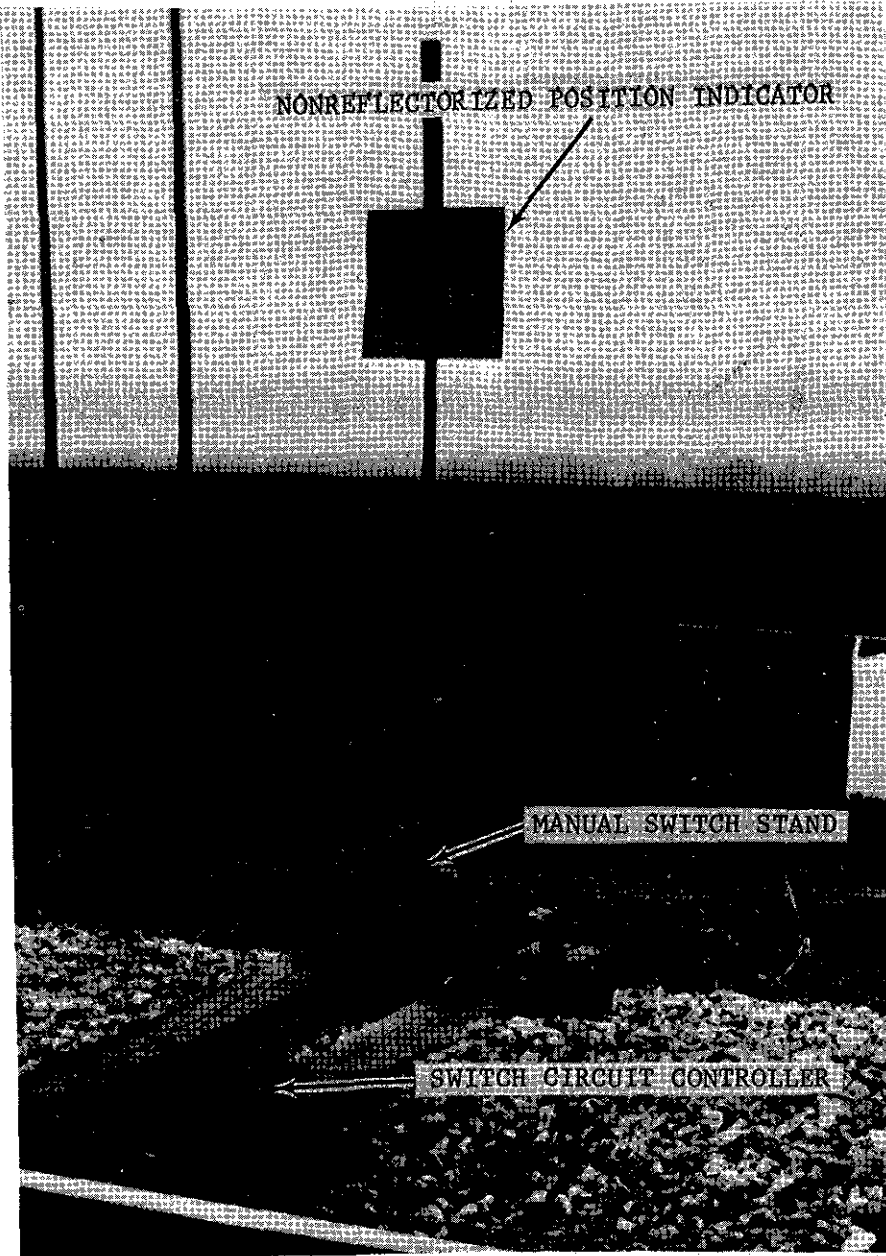
Figure 6.--Switch position indicator at switch to interchange track, with switch set in normal position.

The alignment of the main track switch for a diverging movement to the interchange track should result in a shunt of the signal circuit between the two rails of the track. The track shunt removes voltage from the track relay which, in turn, affects the signal circuit and causes the signal to display the red (stop and proceed) aspect. The shunt is imposed by the closure of electrical contacts within the switch circuit controller. A connecting rod between the near switch point and the switch circuit controller mechanically activates the closure of the electrical contacts. (See figure 8.) The shunt circuit path proceeds from four shunt wires, which are connected to the rails of the track, through the electrical contacts within the switch circuit controller. Tapered rail

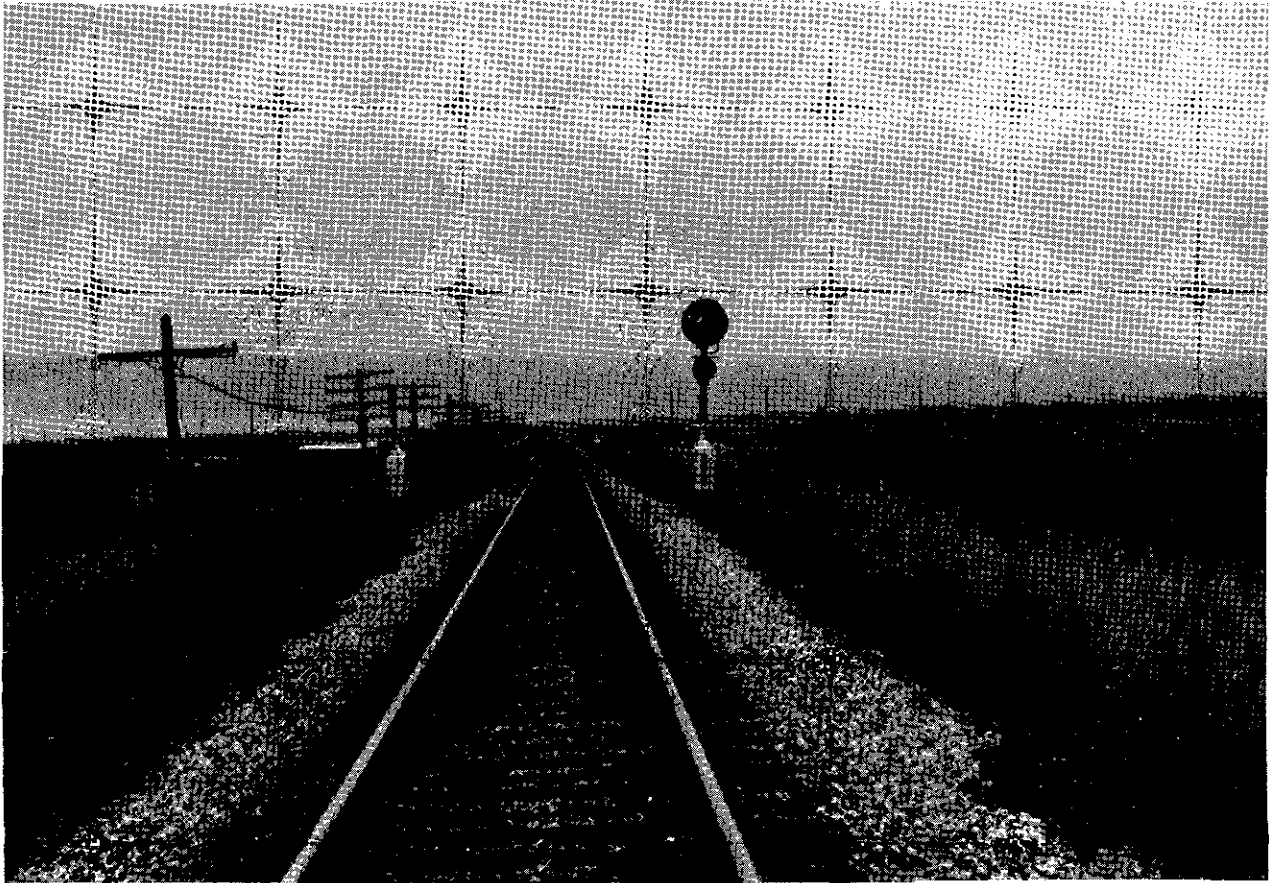
Automatic signal No. 8829, a color light signal, governs southbound movements on the MKT main track through the signal block in which the interchange track is located. (See figure 7.) Signal No. 8817 is located in approach to signal No. 8829, and signal No. 8809 is located in approach to signal No. 8817. According to the MKT's senior signal supervisor, if the signal block governed by signal No. 8829 is occupied, or if the main track switch is not fully closed in its normal position for a main track movement, signal Nos. 8829 and 8817 should display red (stop and proceed) aspects, and signal No. 8809 should display a yellow (approach) aspect, which requires the engineer to reduce train speed and be prepared to stop for the next signal.

Figure 7.--Signal No. 8829 displaying a green (clear) aspect.

The fireman and engineer were operating train No. 103 in accordance with applicable rules and regulations. Although the fireman and engineer saw the misaligned switch when the lead locomotive unit was at or near the at-grade county road crossing and the fireman immediately initiated an emergency brake application, there was insufficient distance to stop or slow the train sufficiently to lessen the effect of the accident. Automatic signal No. 8829 was displaying a green (clear) aspect despite the misaligned main track switch since the shunt wires, which would have caused the signal to display a red (stop and proceed) aspect, had not been connected to the rails. Therefore the Safety Board concludes that the signal was displaying a false proceed 12/ aspect.
