RAILROAD ACCIDENT INVESTIGATION

Report No 4119

CAPHEAD, TEXAS

APRIL 6, 1967

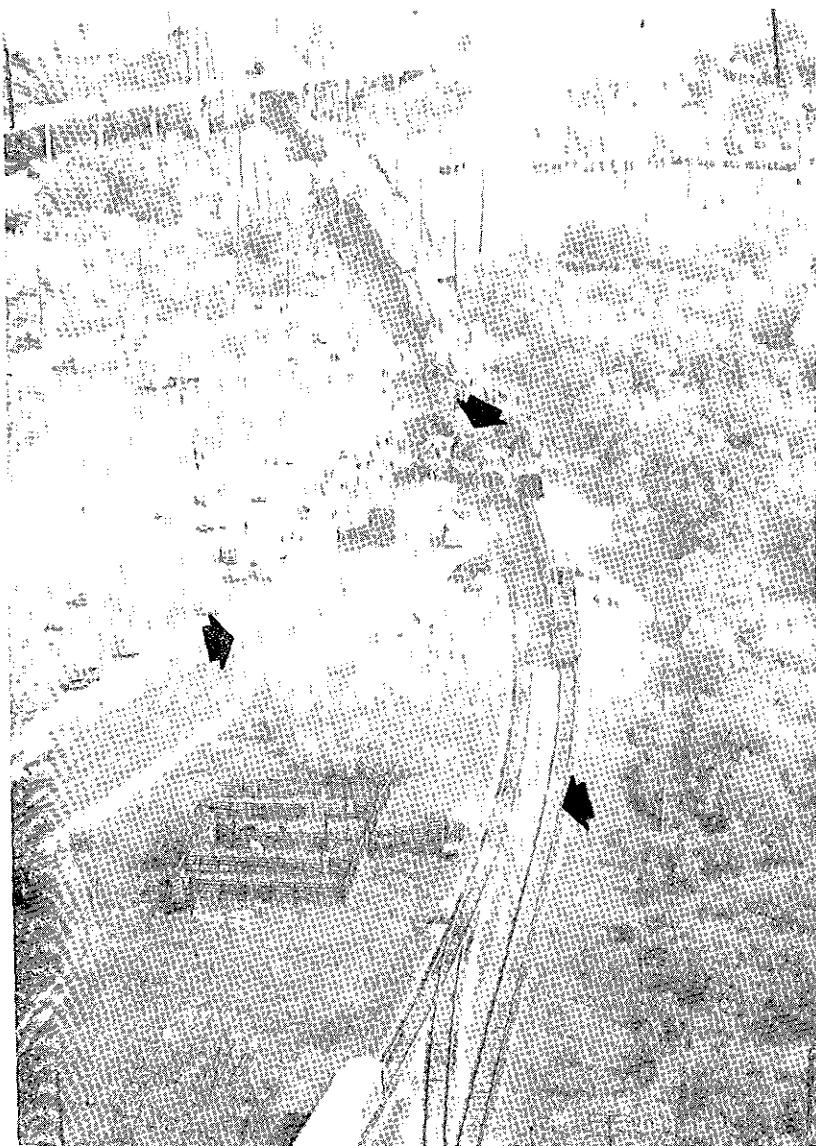
View northward with collision point shown by arrow at center. Lower arrows point to MKT main track at right and Bellmead yard lead track at left. Photo shows wrecking train occupying MKT main track between arrows.

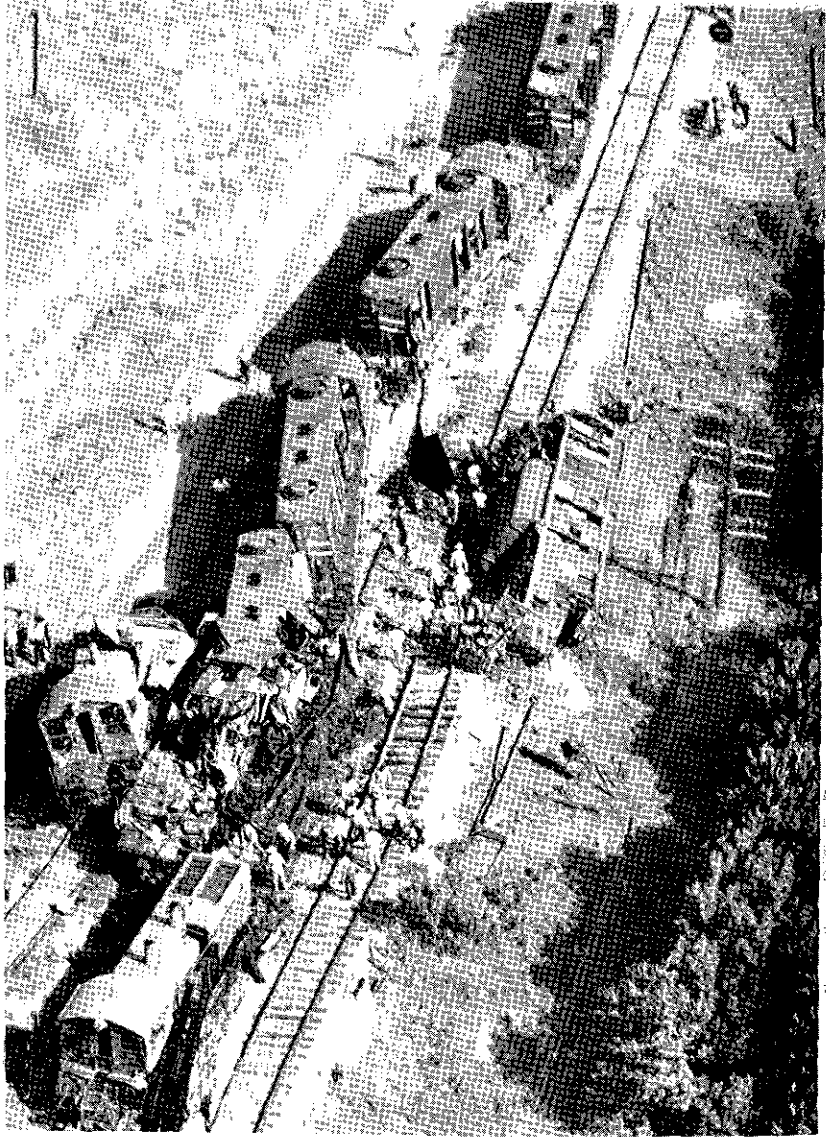
Both diesel-electric units and the first car of the MKT yard movement were derailed and heavily damaged (see Photo).

Extra MP 467 South stopped with the front end 71 feet south of the collision point. All five diesel-electric units, the first and second cars, and the eighth to fourteenth cars, inclusive, were derailed. They stopped in various positions on or near the structures of the MKT main track and the lead track. The first and second diesel-electric units were destroyed, and the other three units were heavily damaged. Of the nine derailed cars, two were destroyed, three were heavily damaged, and three were slightly damaged.

Collision point shown by arrow. MKT diesel-electric units 13 and 4 at bottom left and left, respectively. Overturned first unit of Extra MP 467 South shown at right of arrow. Second MP unit (destroyed) is adjacent to MKT unit 4. Third MP unit is at left of arrow.
