REPORT NO. 3551
MISSOURI-KANSAS-TEXAS RAILROAD COMPANY
OF TEXAS
IN RE ACCIDENT
AT ROYSE CITY, TEX., ON
DECEMBER 13, 1953

Accident at Royse City, Tex., on December 13, 1953, caused
by an automobile station wagon occupying a rail-
highway grade crossing immediately in front of an
approaching train.

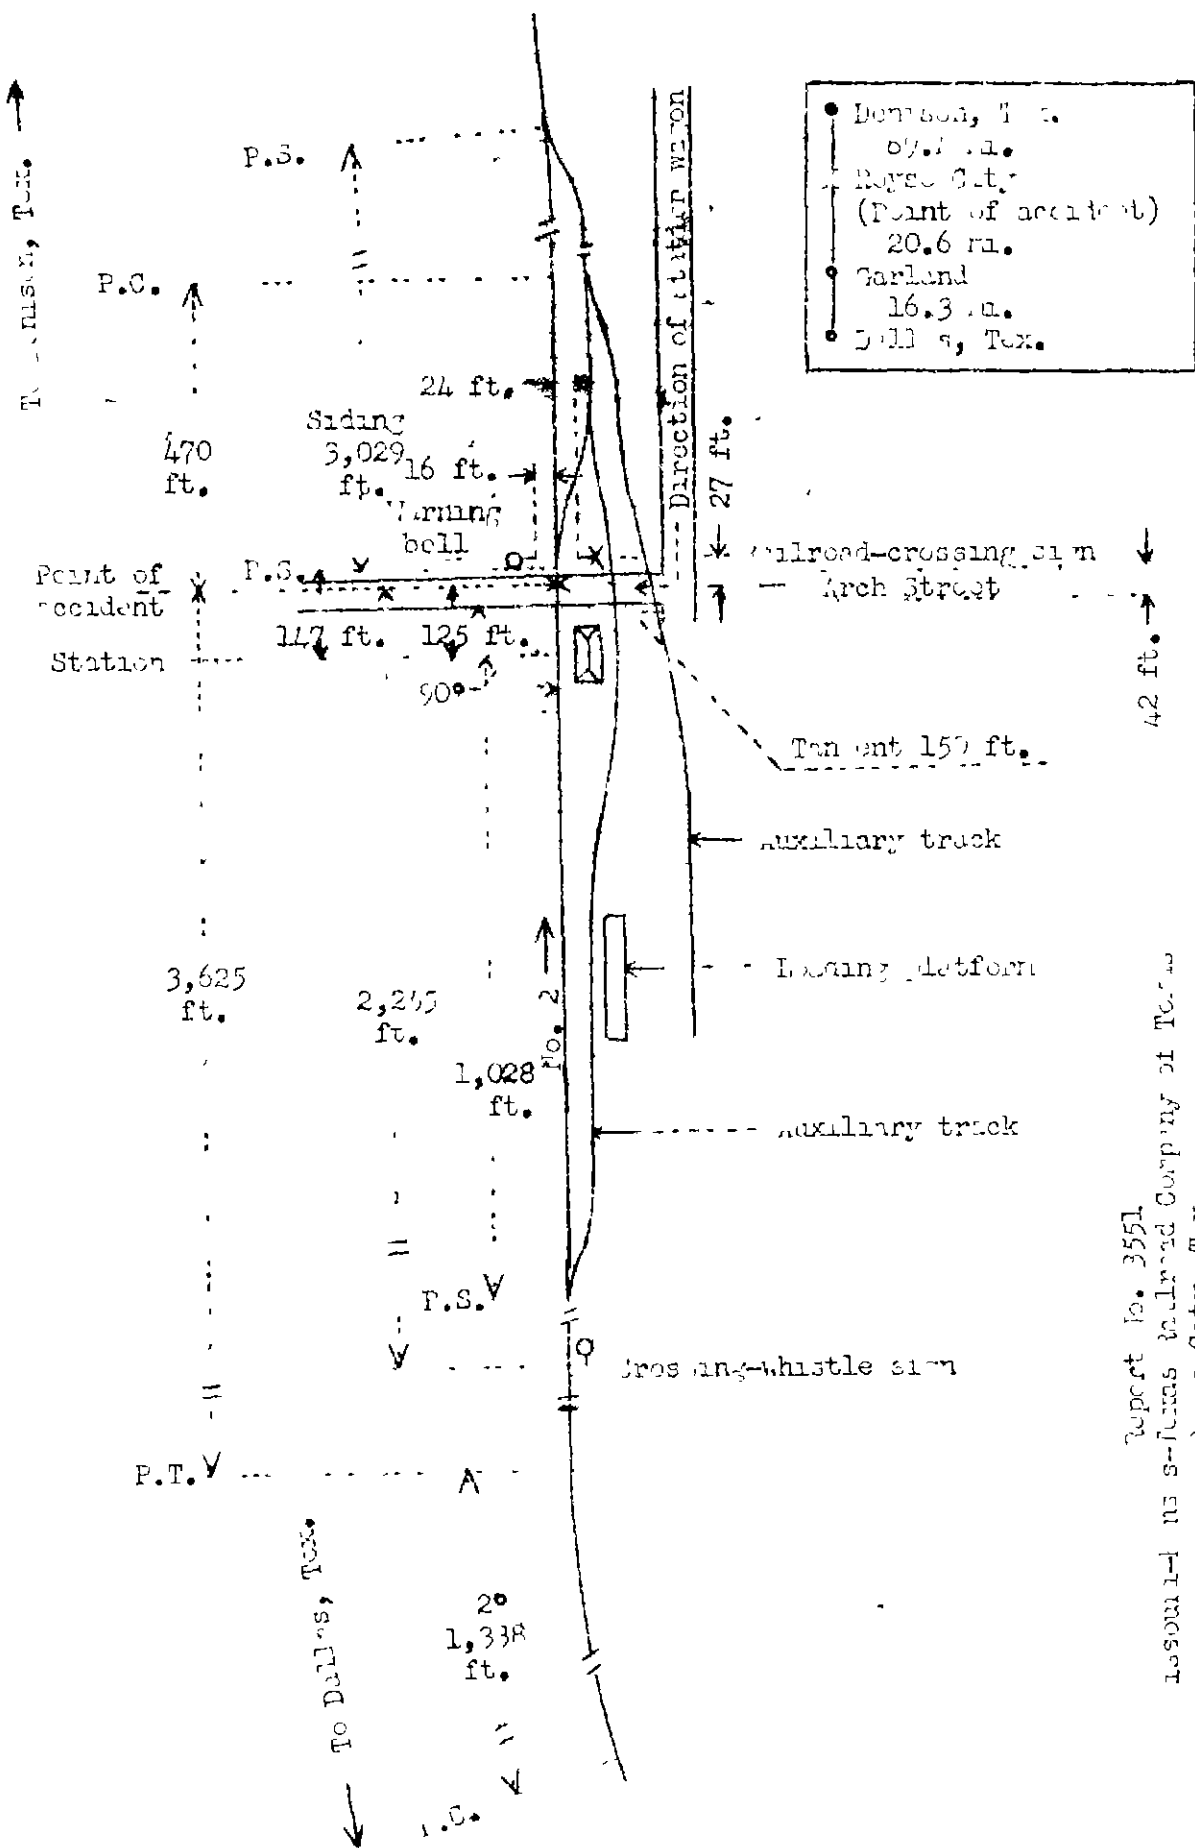
Report No. 3551
 Texas Railroad Company of Texas
 Royse City, Tex.
 December 13, 1953
