INTERSTATE COMMERCE COMMISSION  
WASHINGTON

-----  
ACCIDENT ON THE  
MOBILE AND OHIO RAILROAD

-----  
MURPHYSBORO, ILL.

-----  
INVESTIGATION NO. 2250

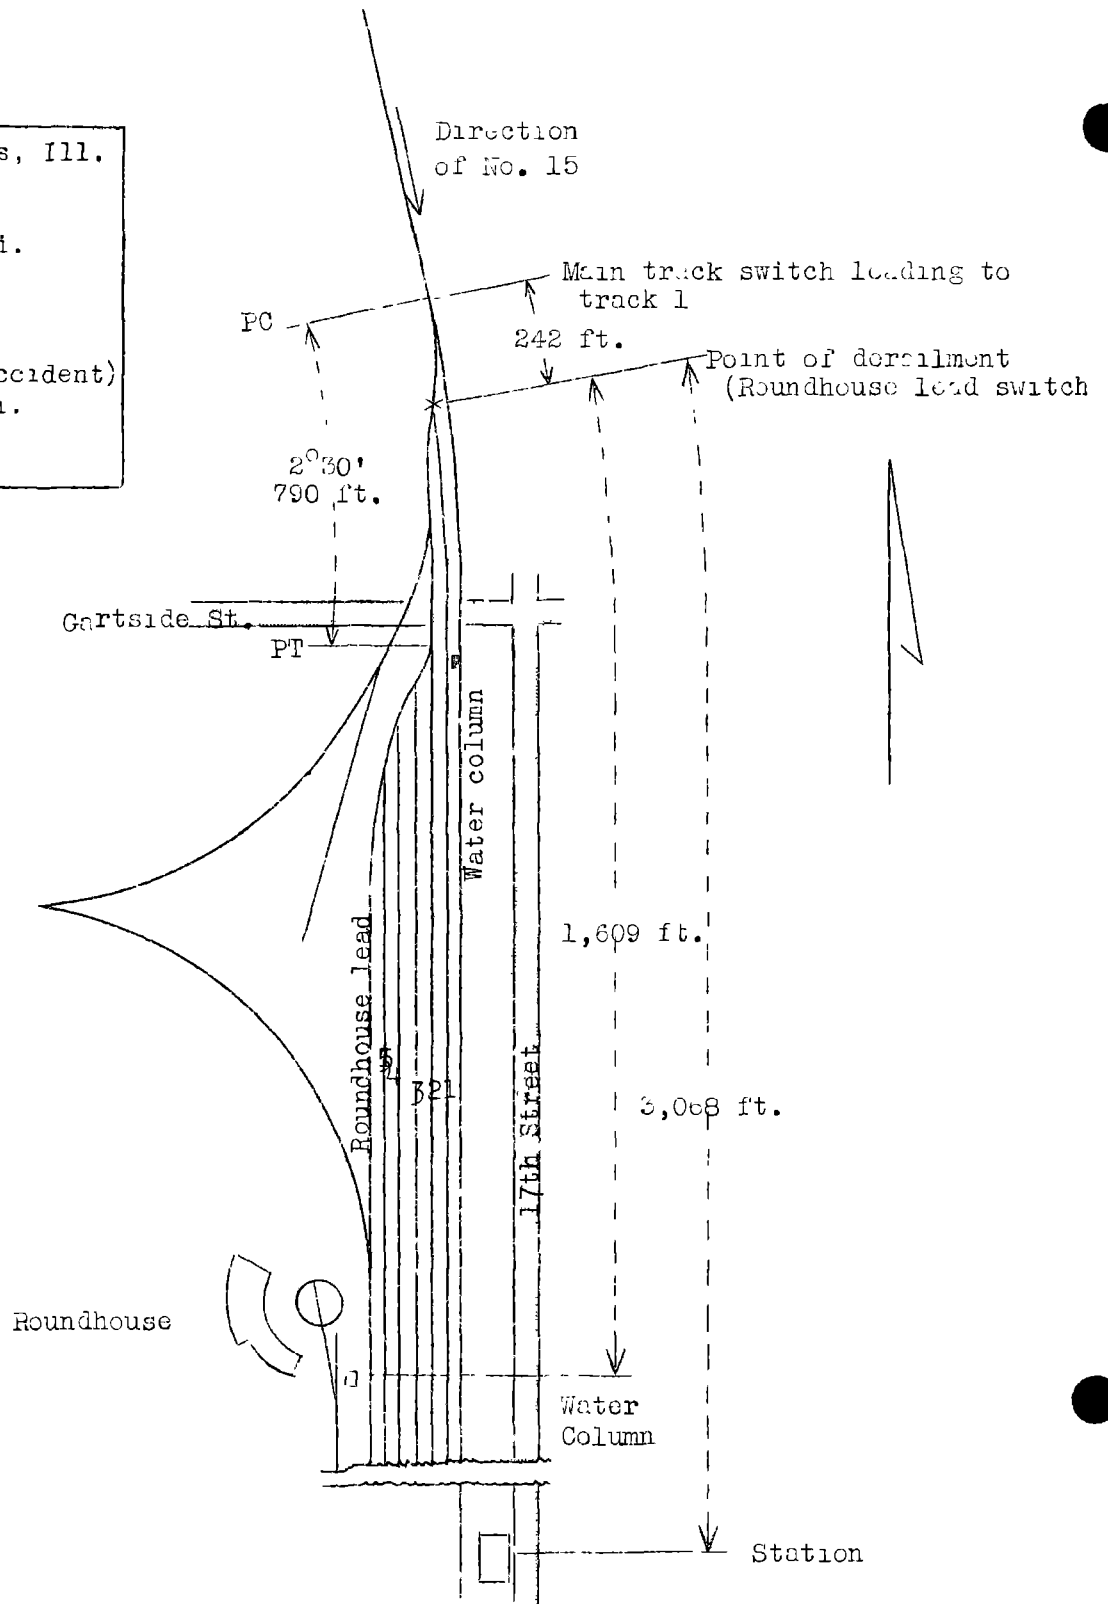
Inv. No. 2250  
Mobile & Ohio R.R.  
Murphysboro, Ill.  
Feb. 12, 1938

The main-line switch involved is equipped with a Ramapo ground-throw type switch stand; the target shaft, which is located on the east side of the main track, is provided with a single target 5 feet 8 inches above the head block, and above the target an oil lamp which displays a green light when the switch is closed and a red light when open. The switch leading from track 1 to the roundhouse lead is in normal position when set for movements to the roundhouse lead.

The train had traveled a short distance on track 1 when it became derailed. The engine and tender stopped on their left sides, fouling the main track and track 1, the front end of the engine being approximately 515 feet south of the main-track switch. The first three cars were derailed but remained in upright positions at various angles across the tracks. The employee killed was the engineman, and the employees injured were the fireman and the baggageman.

Inspection of the track disclosed flange marks on ties on the inside of the west rail of the main track near the frog of the main-line switch; these marks apparently were made by one of the cars that climbed the rail as a result of the impact caused by the derailment of the engine. At the time of this inspection the track had been repaired sufficiently to enable the wrecking train to work at both ends of the wreckage. The damage observed, to both track and equipment, was apparently the result of and not the cause of derailment. Cross levels taken on track 1 showed only a slight variation from level from the point of main-track switch to the point of frog of the lead track. From this point southward the track was destroyed for a distance of 273 feet to the point at which the engine stopped.
