INVESTIGATION NO. 9091
THE MONONGAHELA CONNECTING RAILROAD COMPANY
REPORT IN RE ACCIDENT
NEAR ELBA TOWER, PITTSBURGH, PA., ON
MAY 6, 1946

June 14, 1946.

Accident near Elba Tower, Pittsburgh, Pa., on May 6, 1946,
caused by failure to provide adequate safeguards for
movements involved.

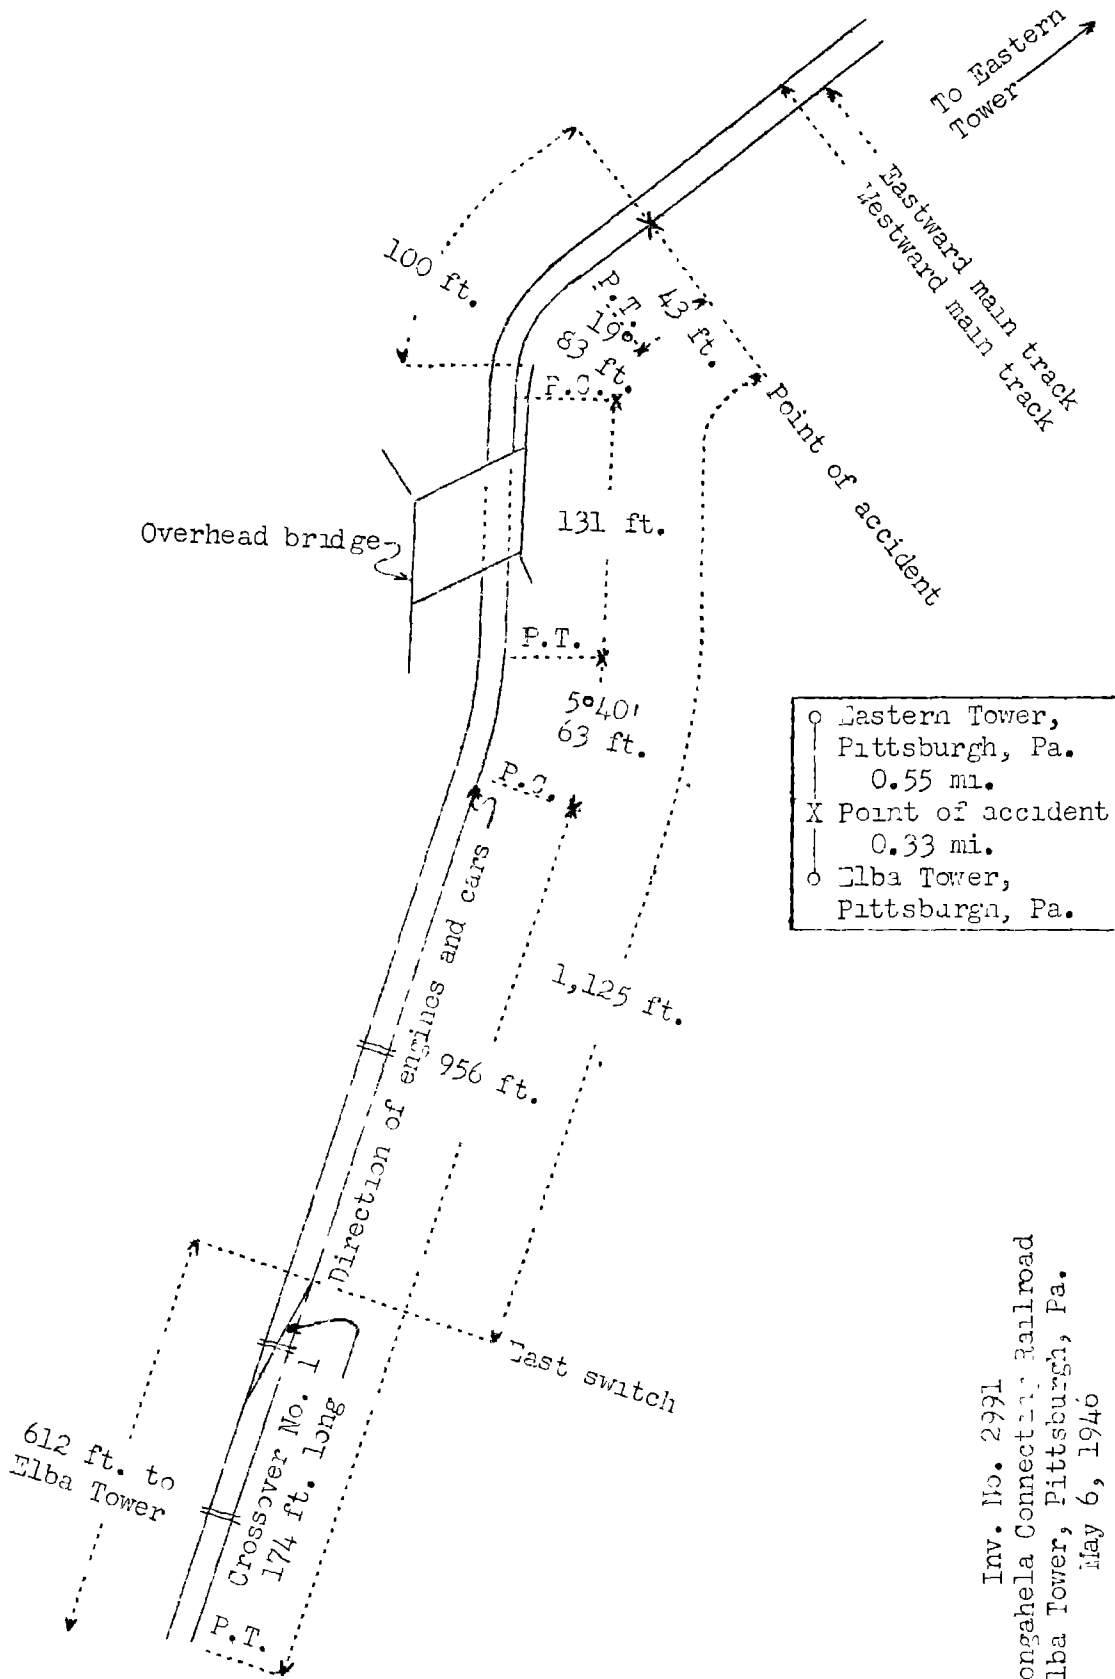
Inv. No. 2991
Monongahela Connecting Railroad
Elba Tower, Pittsburgh, Pa.
May 6, 1946

This accident occurred on that part of the railroad which extends between Elba Tower and Eastern Tower, Pittsburgh, Pa., 0.88 mile. Between these points and between industrial yards which lie to the north and to the south, there are two tracks designated as the eastward and the westward main tracks, over which yard movements are authorized by operating rules and oral instructions. There are no time-table schedules in effect, and there is no block system in use. The accident occurred on the eastward main track 0.33 mile east of Elba Tower. From the west there are, in succession, a tangent 956 feet in length, a $5^{\circ}40'$ curve to the left 63 feet, a tangent 131 feet, a 19° curve to the right 83 feet, and a tangent 43 feet to the point of accident and some distance eastward. At the point of accident, the grade for east-bound movements is 1 percent ascending.

Crossover No. 1, a trailing-point crossover, connects the two main tracks and is 174 feet in length. Its east switch is 612 feet east of Elba Tower and 1,125 feet west of the point of accident. The south abutment of an overhead bridge parallels the eastward main track on the south, and is 10 feet horizontally distant. The east end of the abutment is 100 feet west of the point of accident.

Yard engine 175, which was pushing a cut of 18 cars, stopped on the eastward main track about 11:45 p. m., with the rear of the engine standing 1,737 feet east of Elba Tower, and 43 feet east of a 19° curve to the right. About 10 minutes later the rear of the engine was struck by wrecking equipment.
