NATIONAL TRANSPORTATION SAFETY BOARD

RAILROAD ACCIDENT REPORT

COLLISION AND DERAILMENT
OF MONTANA RAIL LINK FREIGHT TRAIN
WITH LOCOMOTIVE UNITS
AND HAZARDOUS MATERIALS RELEASE
HELENA, MONTANA
FEBRUARY 2, 1989

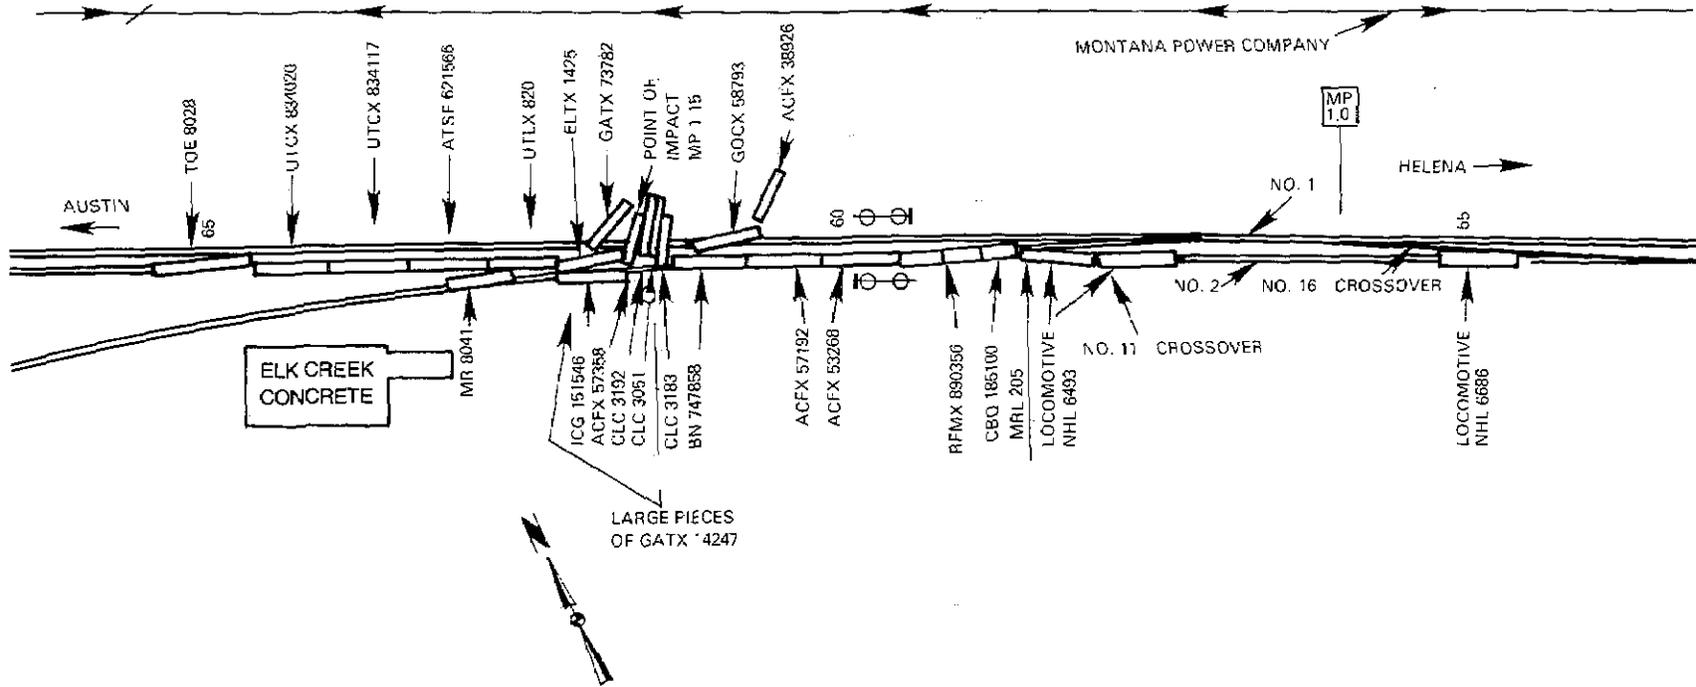
ACCIDENT SITE BENTON AVE. CROSSOVER
 (NOT TO SCALE)

Collision.--The engineer of Helper 1 overheard the emergency radio communication between train 121 and the MRL dispatcher about a runaway at Austin, but stated he didn't give it much thought because "...that was quite a ways away...." He started to release the independent brake to move eastward, "...when the train hit us...." The Helper 1 UOE, who was on the ground, radioed the MRL dispatcher at 04:30:46 and reported that "...we've just had a train hit us...We have some serious damage..." The engineer described the collision as "...it hit pretty hard...I think it was at least 25 miles an hour...." At the time, the MRL dispatcher did not know if the crew of train 121 had lost all or part of their train. He advised the Helper 1 UOE to be alert for more cars. Of the 49 cars of train 121 that collided with the standing Helper 1, 21 cars, of which 15 derailed, were involved.²¹ Only the west locomotive, MRL 205, of Helper 1 was derailed. The east locomotive, NHL 6686, was separated from the Helper 1 consist in the collision and came to rest about 400 feet east of the general derailment area. (See figure 3.)

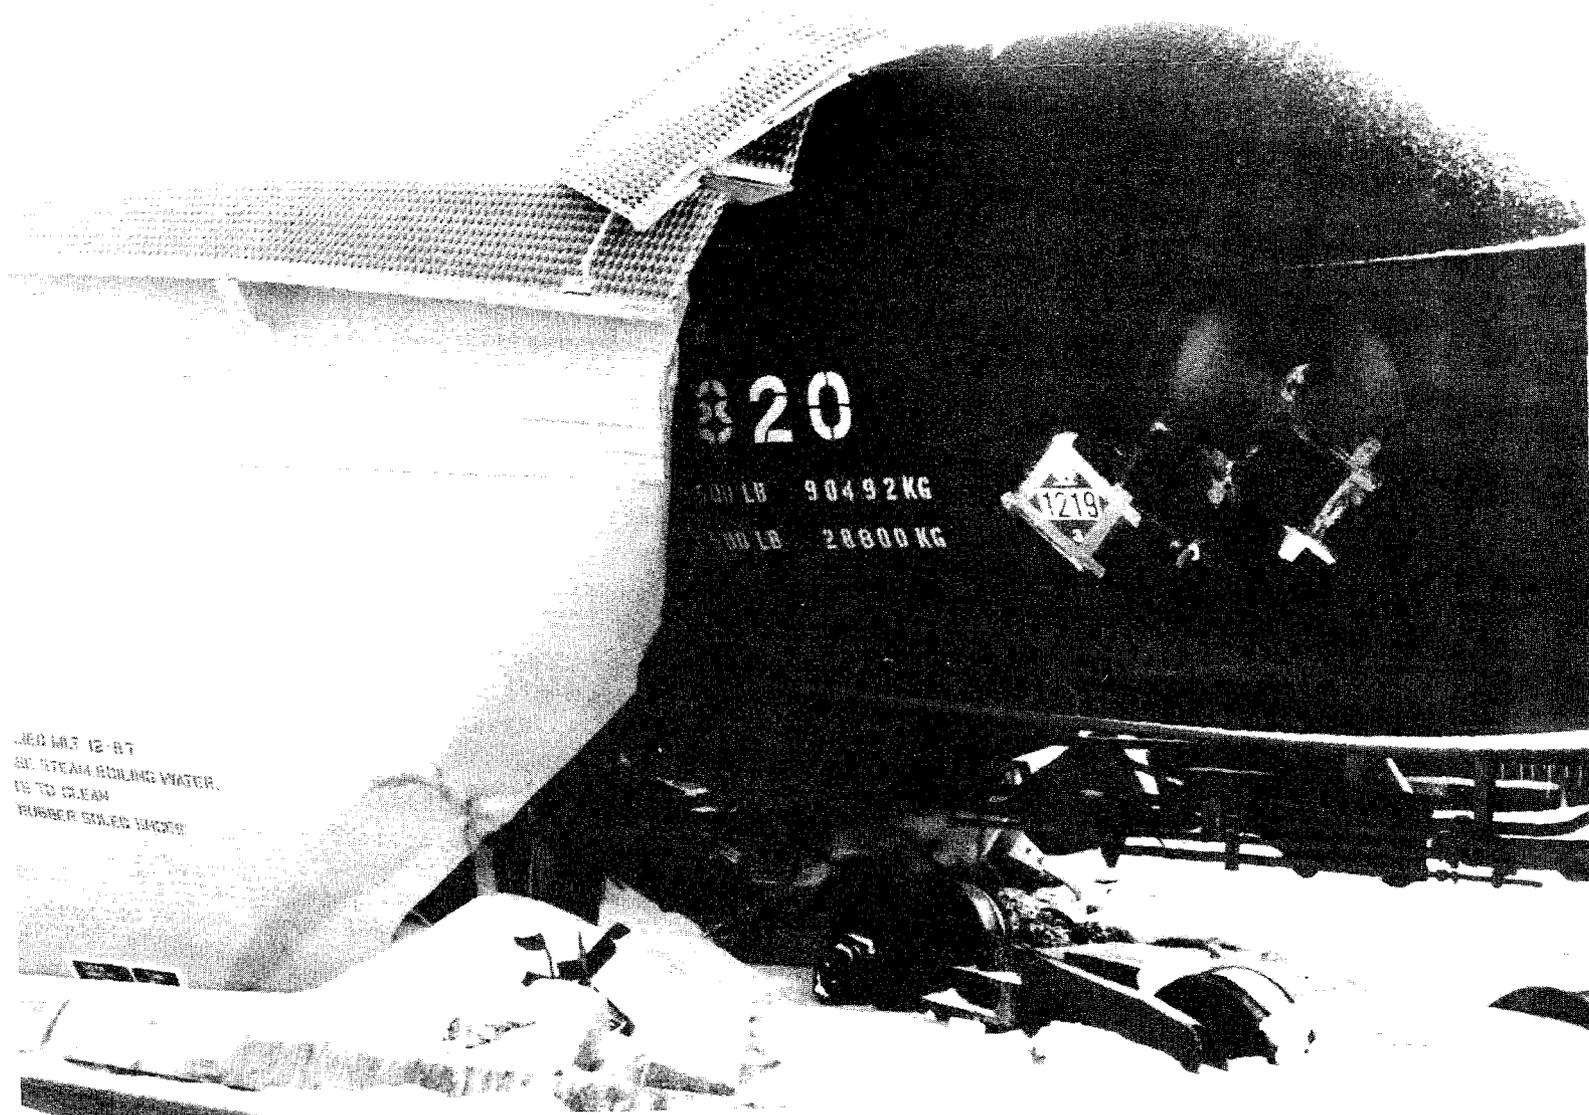
The 49 cars of train 121 collided with the standing Helper 1; however, only 21 cars, of which 15 derailed, were involved in the general area of the derailment. Fourteen of the 21 cars received extensive damage and were considered not repairable. Damages to the tank cars were as follows: (1) GATX 14247 disintegrated in the explosion with tank car fragments and debris scattered to the north and south; (2) GATX 73782 had overturned with the top of the tank car facing north, but remained in line with the track; (3) ACFX 57358 burned in the wreckage and about 1/3 of the car was missing; (4) ELTX 1425 was penetrated at the A-end by UTLX 820 and about 1/4 of the B-end tank shell of UTLX 820 was enveloped by ELTX 1425 (see figure 5); (5) the tank head on the B-end of UTLX 820 was punctured and the entire lading of isopropyl alcohol was released.

Figure 5.--ELTX 1425 penetrated by UTLX 820.

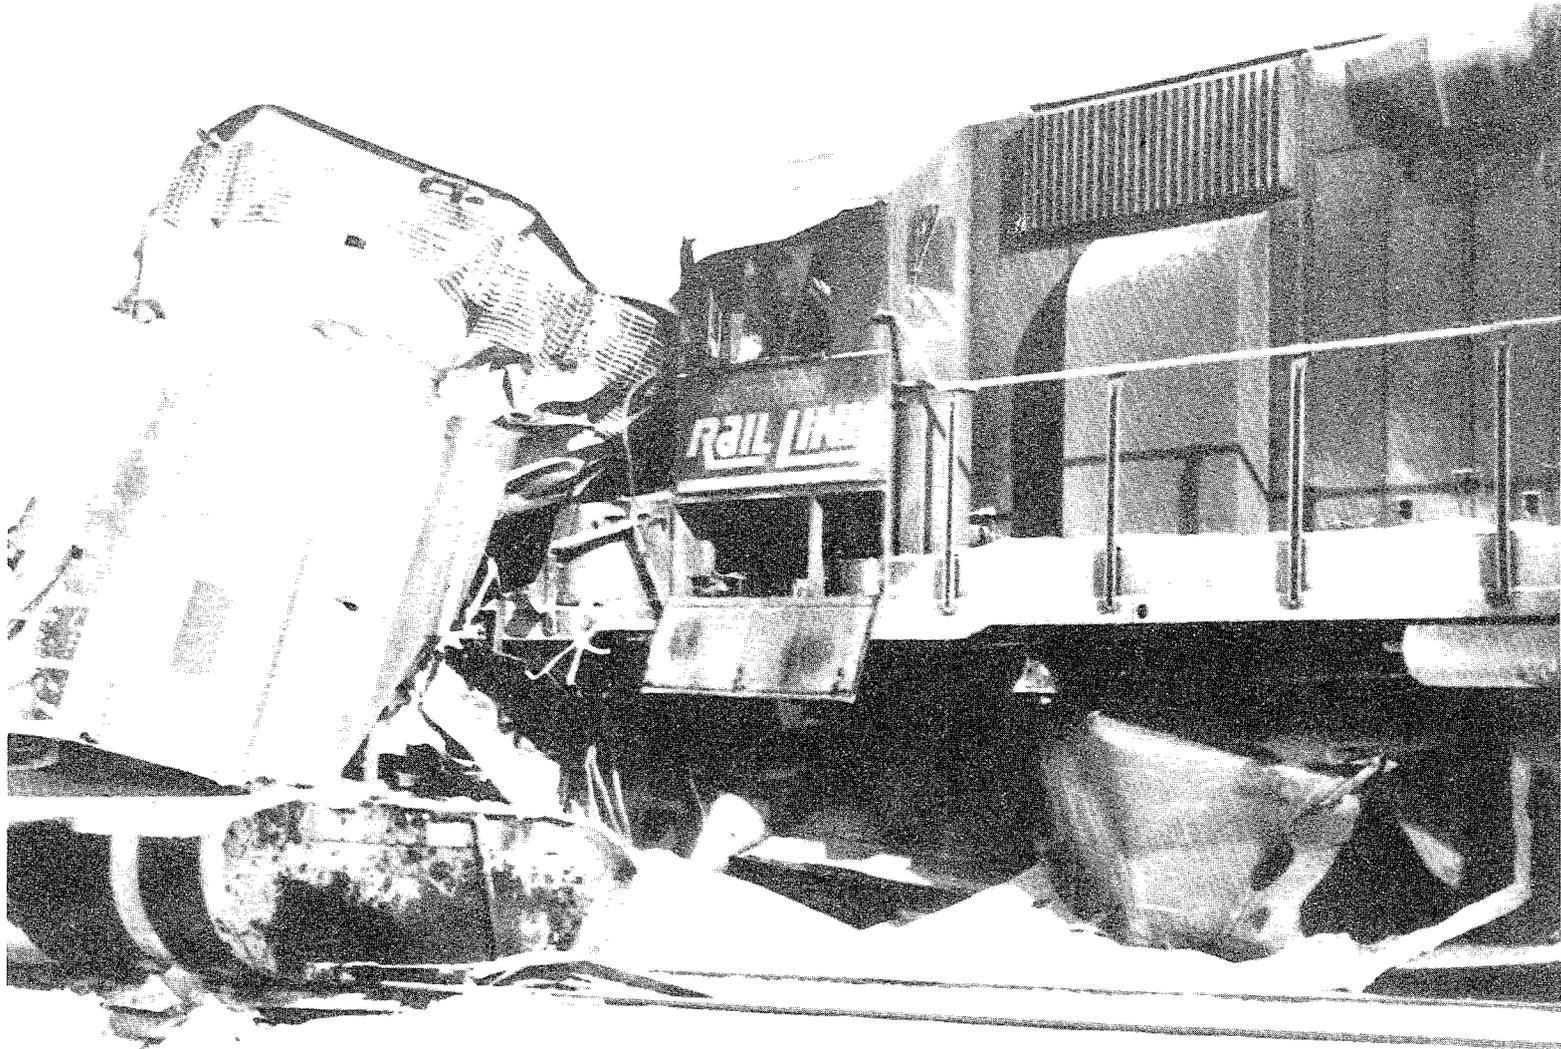
One locomotive unit of Helper 1, MRL 205, was damaged in the collision. MRL officials reported extensive damage to the cab compartment, pilot and electrical controls and freeze damage to coolant piping to the engine (see figure 6). The MRL superintendent stated that based on his observations of other collisions where the speed was from 15 to 20 mph, "...this [impact speed] was in excess of that...."

Figure 6A.--MRL 205 locomotive damage--helper 1.

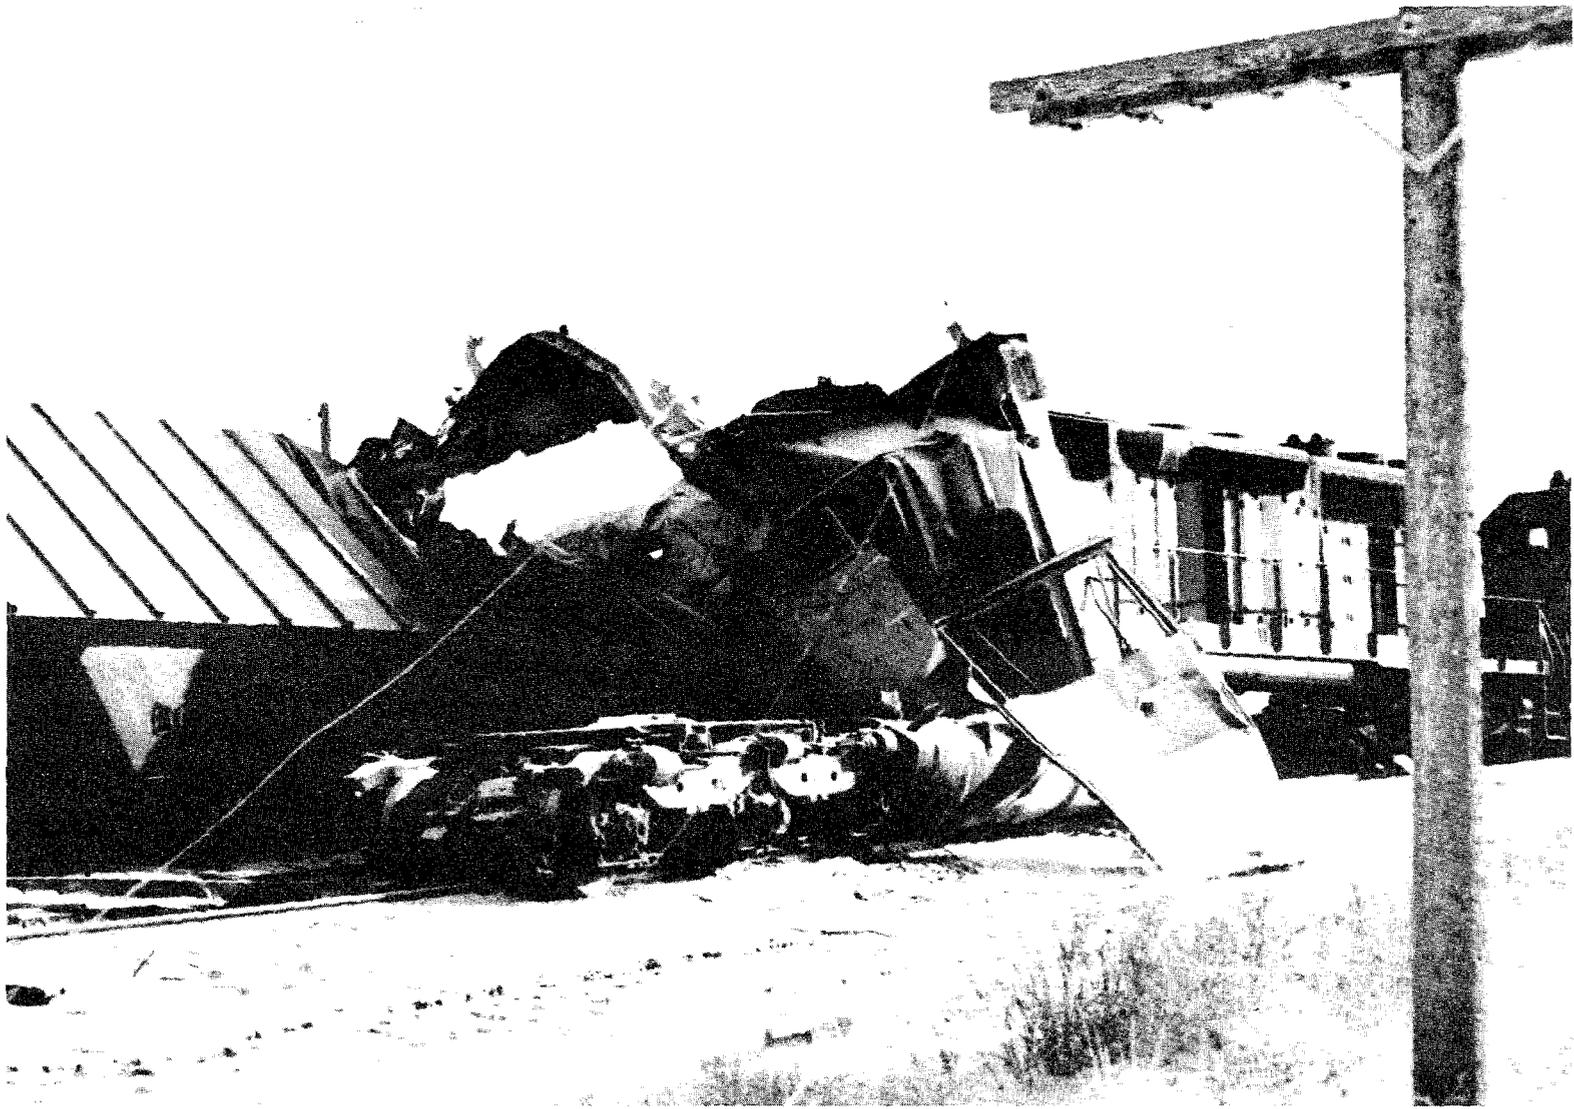
Figure 6B.--MRL 205 locomotive damage--helper 1.

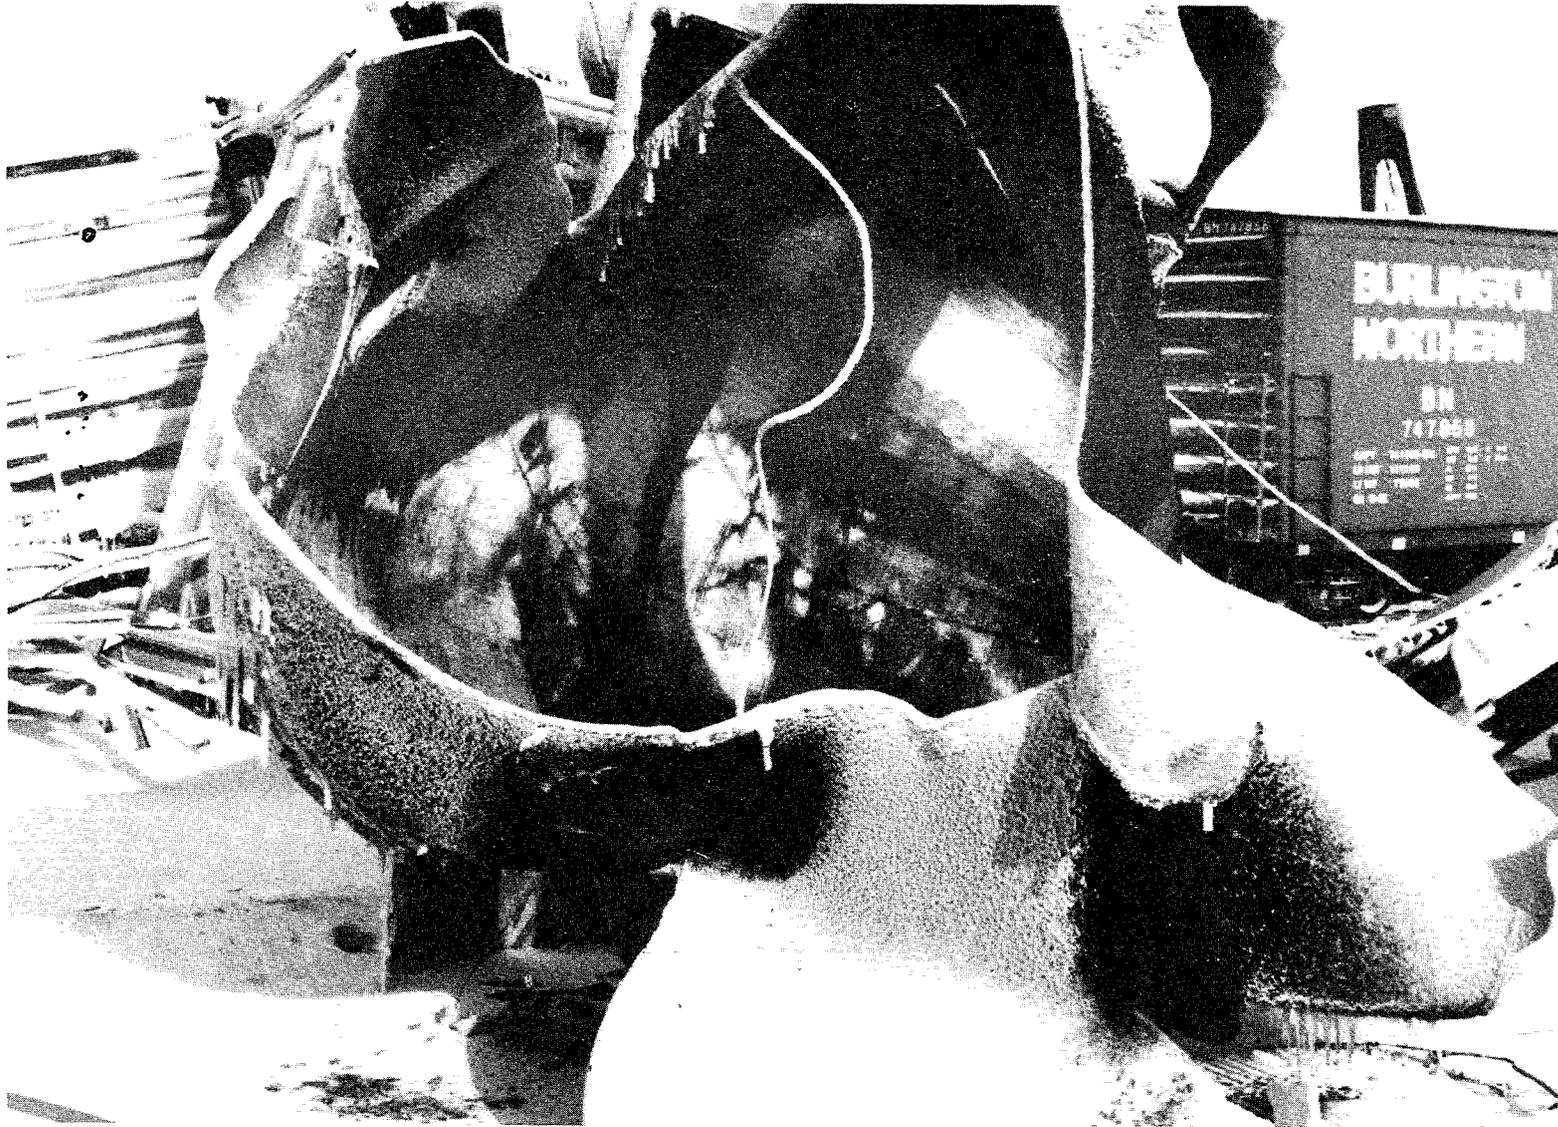
Figure 7A.-- Tank car GATX 14247.

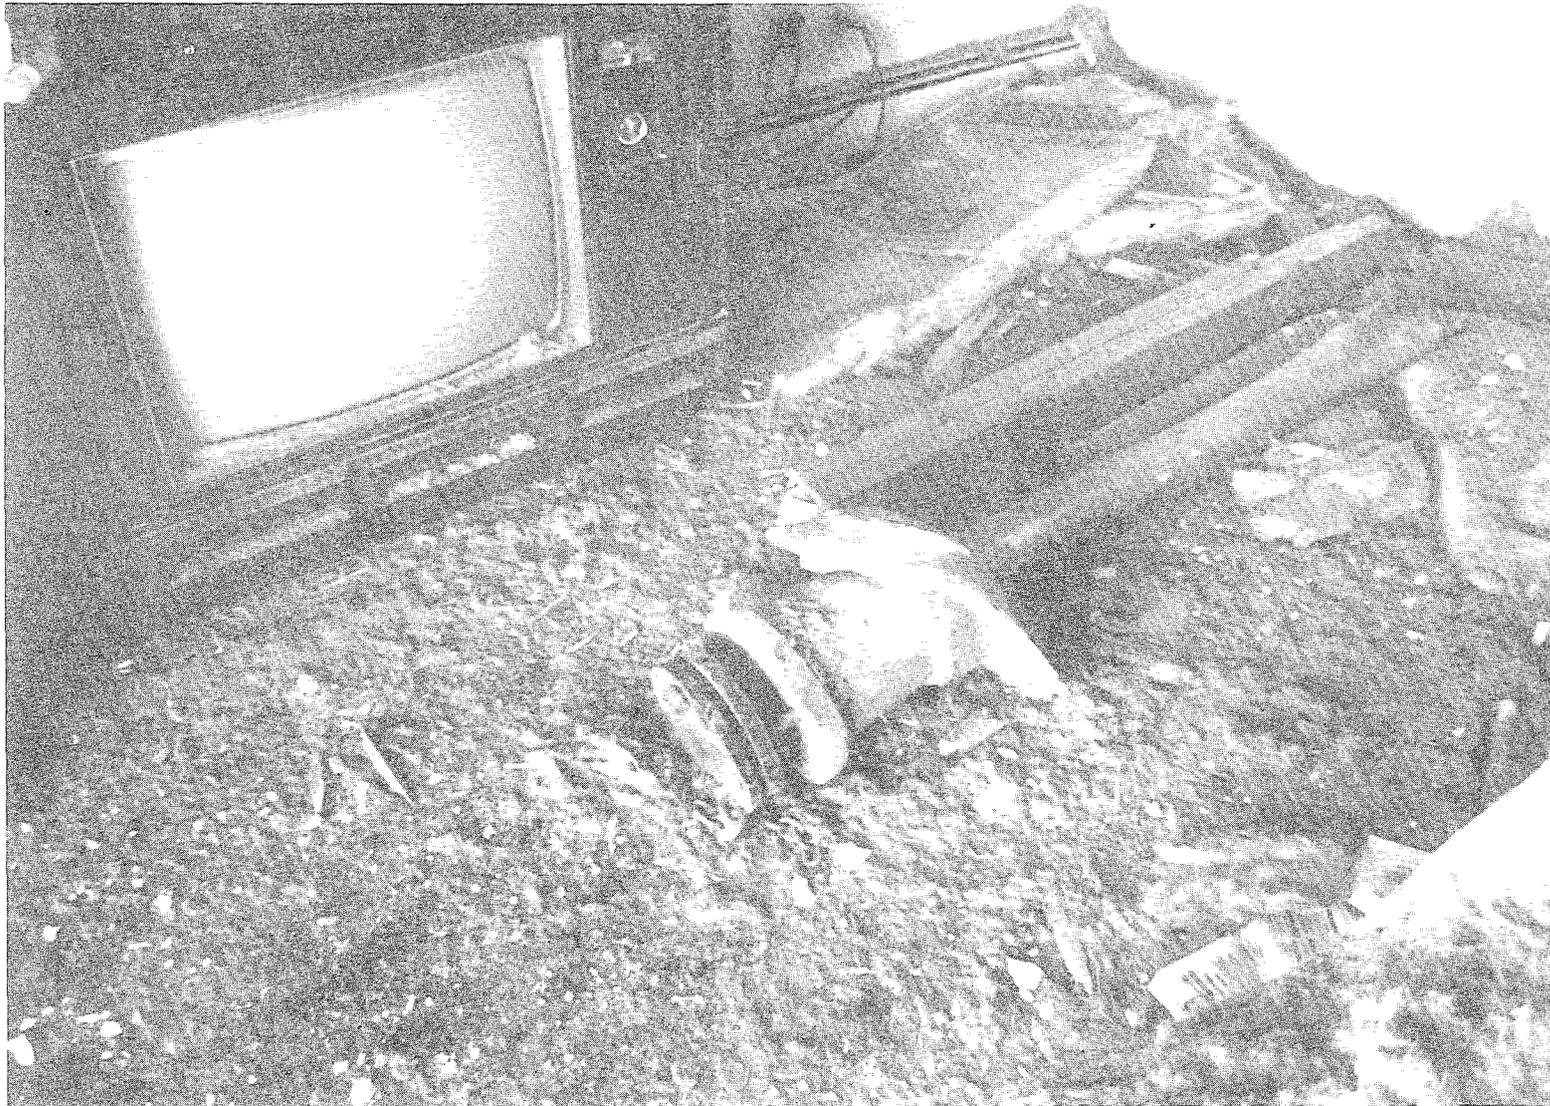
weighing about several hundred pounds (see appendix P). One home, located about 1/2 mile from the accident site, was penetrated by a section of the liquid eduction tube²⁹ from GATX 14247. (See figure 7.) The Elk River Concrete Products Company plant, located adjacent to the MRL tracks at Benton Avenue, sustained major structural damage along with multiple fragment penetration holes in walls and piping. Carroll College reported major damage to all of its buildings (10 buildings), with the greatest damage at the Physical Education facility; damage consisted of broken windows, roof penetrations, cracked walls and ceilings, and water damage due to the sub-zero temperatures and the power outage.

Figure 7B.--Liquid education tube from tank car GATX 14247.
