-----  
REPORT NO. 1969

REPORT OF THE DIRECTOR OF THE BUREAU OF SAFETY CONCERNING AN  
ACCIDENT ON THE NASHVILLE, CHATTANOOGA & ST. LOUIS  
RAILWAY AT LEXINGTON, TENN., ON FEBRUARY 23, 1935.

Inv. No. 1969  
 Nashville, Chattanooga & St. Louis Ry.  
 Lexington, Tenn.  
 Feb. 23, 1935.

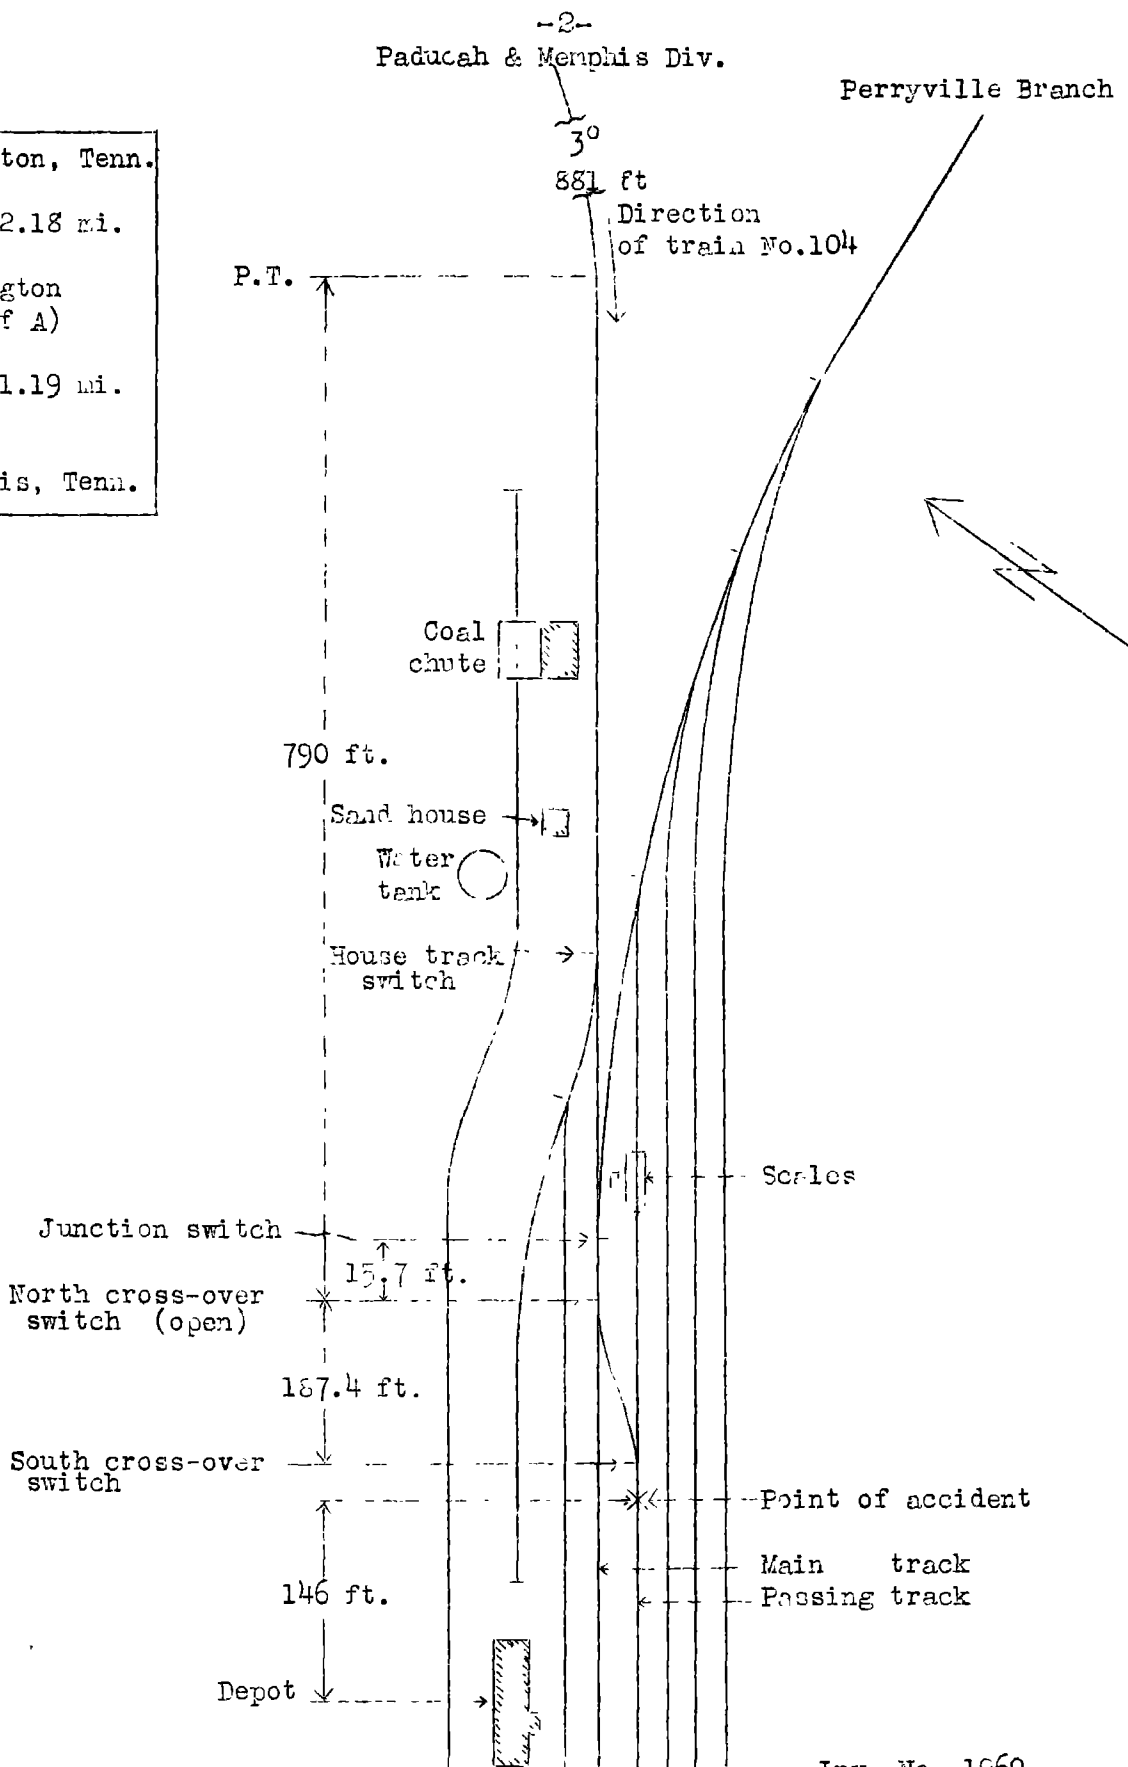
With the sun shining brightly, as was the case at the time of the accident, the indication displayed by the switch lamp of the north cross-over switch can not be seen and under such conditions the members of the engine crew of a south-bound train can determine the position of the switch only by seeing the switch points.

and locked, and it was not damaged, indicating that it had been opened after the passage of Train No. 105 at 10:30 a.m. Employees were in the vicinity practically continuously up to the time of the accident, but so far as could be determined no one touched the switch except Brakeman Garvey and he said he did not think that he became confused at any time as to the position of the switch and inadvertently changed it from the main track to the cross-over and locked it in that position; however, the investigation did not reveal any other possible explanation for the switch being open.

This accident was caused by an open switch.

It is recommended that the carrier make such changes as may be necessary in order to permit of the installation of a switch stand which will be adequate to afford a proper indication of the position of the switch to a train approaching from either direction.
