RAILROAD ACCIDENT REPORT

NATIONAL RAILROAD PASSENGER CORPORATION (AMTRAK)
HEAD-END COLLISION OF TRAIN NO. 111
AND PLASSER TRACK MACHINE EQUIPMENT
EDISON, NEW JERSEY
APRIL 20, 1979

NTSB-RAR-79-10

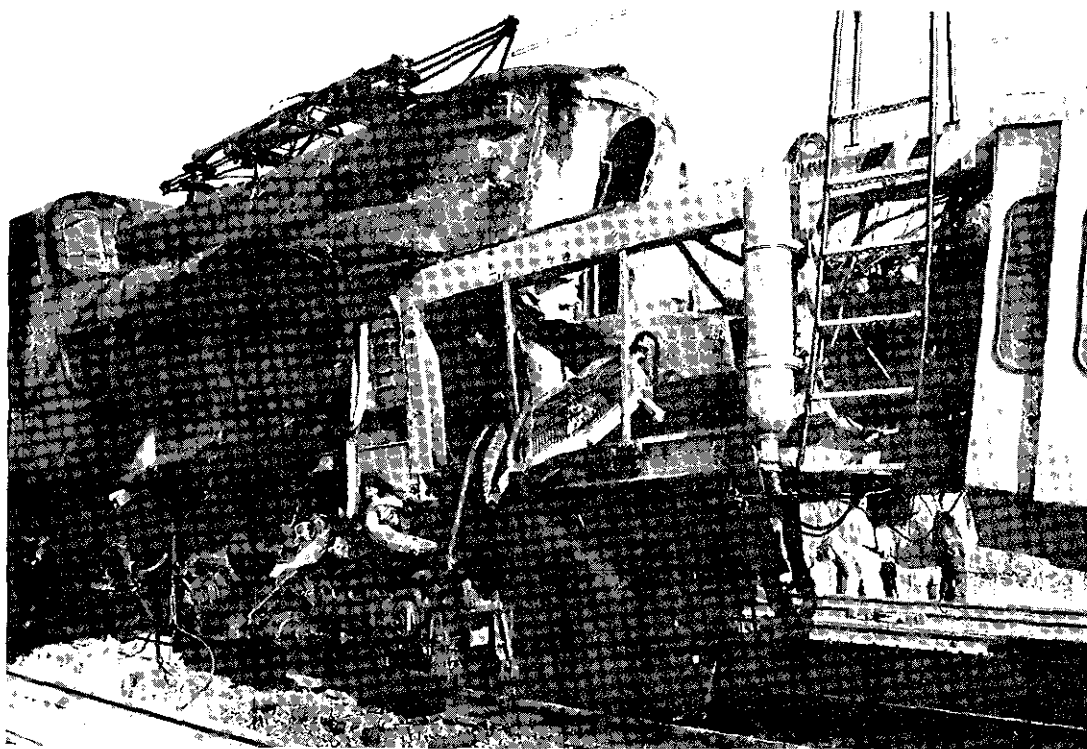
Figure 2. Track machine and locomotive after impact.

The track machine was embedded 12 feet into the front of the locomotive. (See figure 2.) As a result of the collision, fuel from the track machine sprayed over the train and then ignited. The flash fire covered the locomotive and the first car. The equipment was moved westward about 2,652 feet after the impact before stopping. The track machine and the lead truck of the first car derailed.

As the train and track machine collided, the track machine raised upward from the track and penetrated 12 feet into the superstructure of the locomotive, but did not enter the operating compartment. The engineer and fireman were injured slightly from exposure to smoke and fire following the collision.

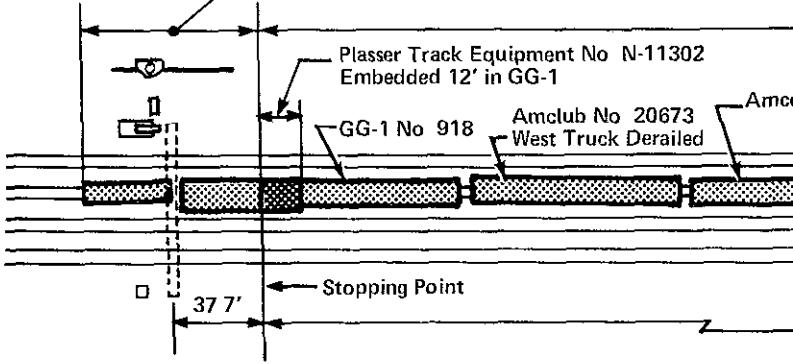
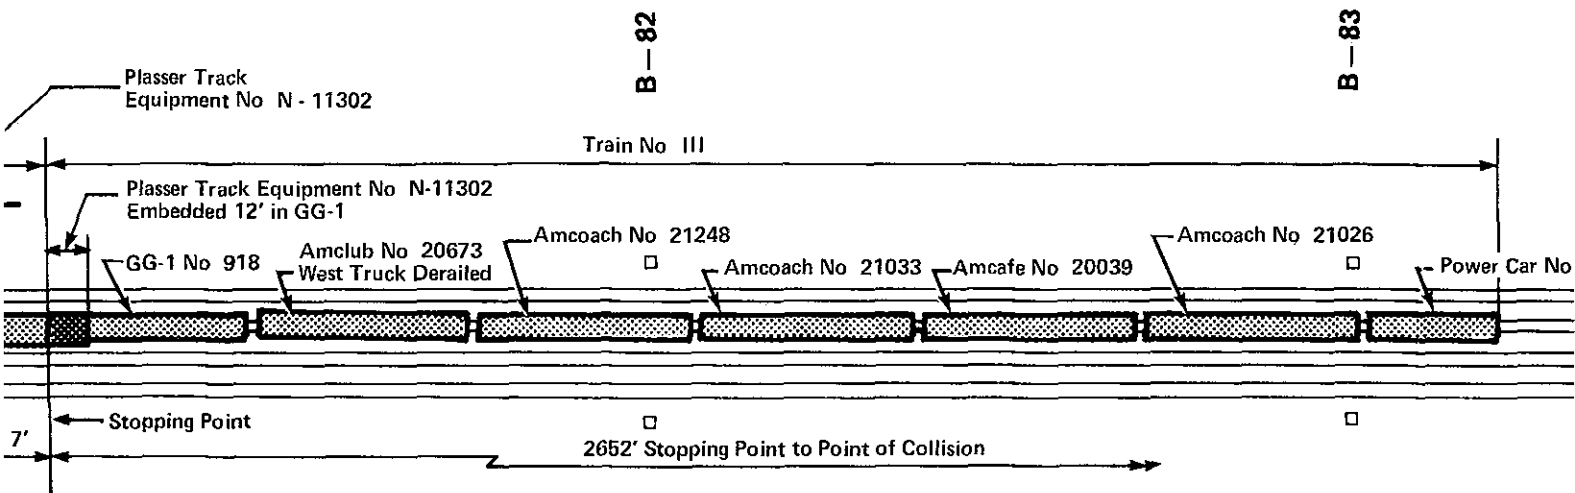
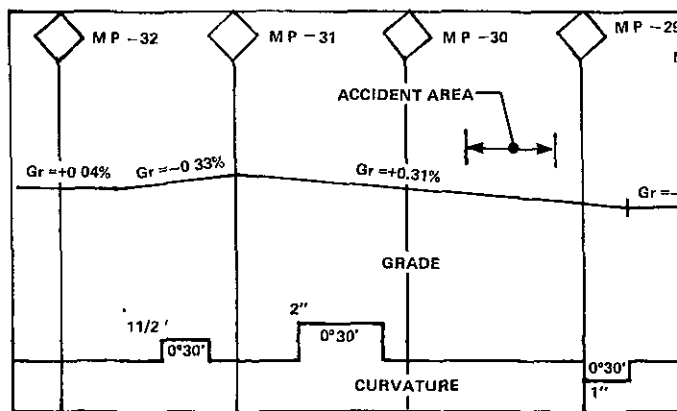
FIGURE 3
ACCIDENT SITE
EDISON, N.J.
TRAIN NO. III & PLASSER TRACK EQUIPI

The tracks of the four-track system in the vicinity of the accident, were numbered 1 to 4 from south to north. Tracks No. 2 and No. 3 were maintained for operation of Metroliner trains at speeds of 110 mph. Approaching Edison station, the train moved westward on straight track to a 0°30' right-hand curve 1,584 feet in length past the Edison station platforms and then onto straight track for 1,384 feet to the collision point. The grade for westbound trains is about 0.10 percent ascending. (See figure 3.)

Plasser Track Equipment No N-11302
Embedded 12' in GG-1

Amclub No 20673
West Truck Derailed
