Railroad Accident Investigation Report

Report No. 80-4

**National Railroad Passenger Corporation
Seaboard Coast Line Railroad Company
Lane, South Carolina**

May 10, 1978

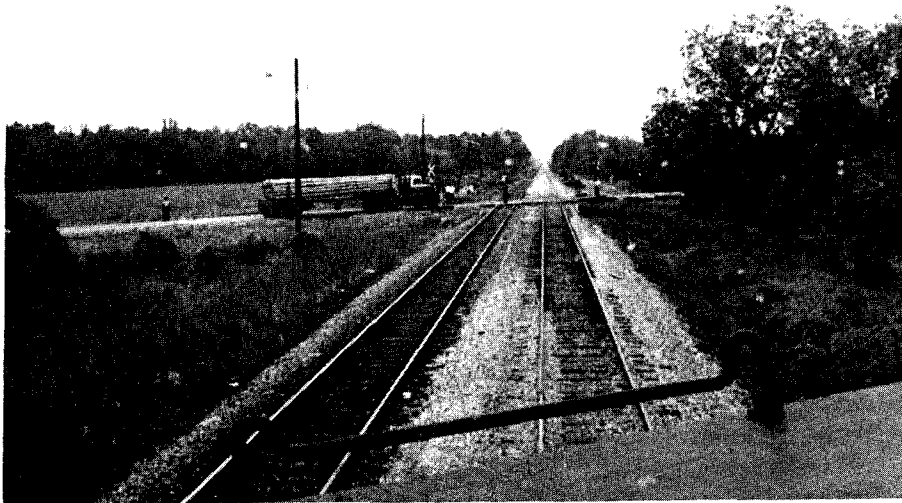
As an eastbound vehicle on State Road S-45-385 approaches the main track from the west, the angle of intersection of the railroad and highway is 47° 39' in the southwest quadrant. Foliage in this quadrant reduces the sight distance for both an eastbound truck driver and the train crew of a northbound train. Clear sight vision is possible after an eastbound vehicle is within 163 feet of the crossing, or a northbound train is within 236 feet of the crossing.

View of the grade crossing from an approaching locomotive. Truck in photograph is similar to the one involved in the collision.

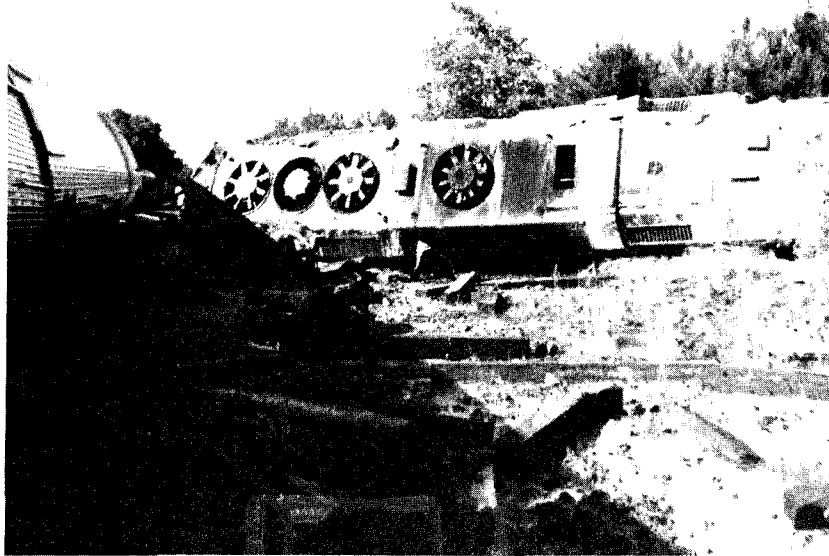
The locomotive uncoupled and veered to the right, leaving the track in a clockwise movement. As it continued northward perpendicular to the track, the locomotive overturned several times before coming to rest about 454 feet north of the grade crossing.

Diesel fuel from the overturned locomotive was ignited and caused a ground fire. A carrier employee and a train passenger used fire extinguishers from the train to put out the fire.

Locomotive No. 274, 454 feet north of impact. Note evidence of ground fire.
