# Railroad accident investigation report

**Report No. 80-3**

**National Railroad Passenger Corporation  
Seaboard Coast Line Railroad Company  
McIntosh, Georgia**

**February 11, 1979**

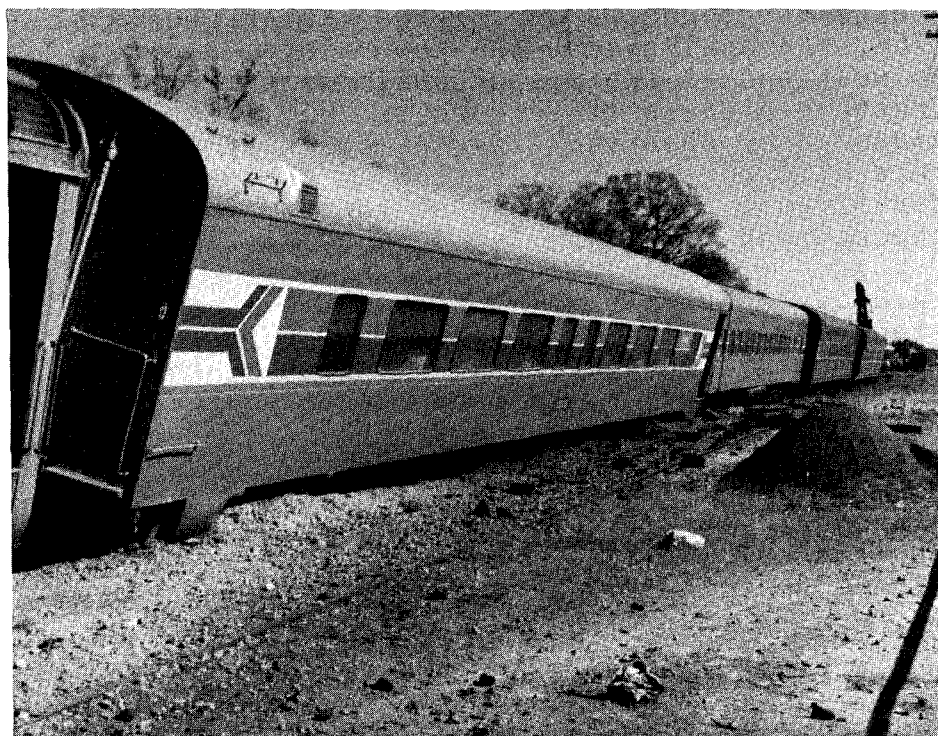
The two locomotive units and the first two cars did not derail. The rear truck on the third car, a sleeping car, and the following 12 cars derailed. The 10th and 11th cars were separated by a distance of 871 feet. All other cars remained coupled. The 13th derailed car remained nearly upright and in line with the track structure. Only two of the 13 derailed cars were substantially damaged.

View of the derailed cars

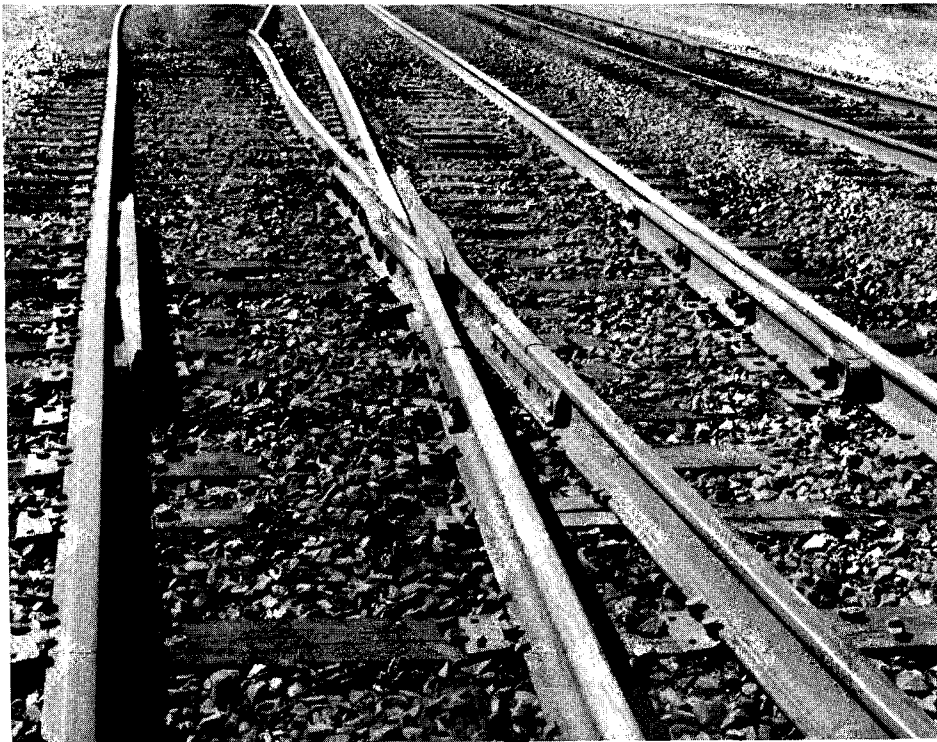
The main track was constructed of 132-pound continuous welded rail laid new in 1968. An examination of the track in the accident area revealed that the base of the east rail was marked on the gage side. From this point south, for approximately two miles, there were numerous wheel marks on the crossties. Rail anchors were displaced and spike heads on the gage side were damaged by the wheel. The facing point switch to a spur track also showed indications of damage. The toe of the frog was damaged as the wheel was temporarily rerailed at this point. Wheel flange marks were next found on the crossties on the field side of the east rail and on the gage side of the west rail. These marks continued to the frog at the north end of the house track which is located 1,217 feet south of the spur track switch, where a section of the west wheel was found after the accident. From this point south, the main and house tracks were damaged for a distance of 2,400 feet.

View of wheel markings on the rail adjacent to the frog at the north end of the house track
