REPORT NO. 79-6
NATIONAL RAILROAD PASSENGER CORPORATION
(AMTRAK)
ATCHISON, TOPEKA AND SANTA FE
RAILWAY COMPANY
PICO RIVERA, CALIFORNIA
APRIL 6, 1978

RAILROAD ACCIDENT INVESTIGATION
ACCIDENT REPORT NO. 79-6

NATIONAL RAILROAD PASSENGER CORPORATION (AMTRAK)
ATCHISON, TOPEKA AND SANTA FE RAILWAY COMPANY
PICO RIVERA, CALIFORNIA
APRIL 6, 1978

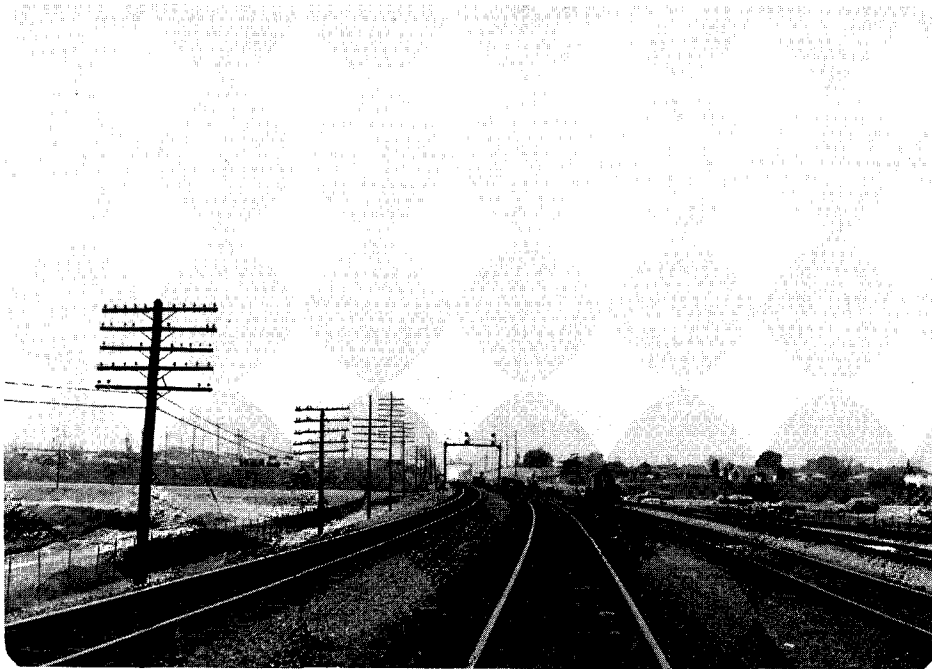
Because of track curvature, darkness and rain, the view between a flat car standing at the collision point and an approaching westbound train is restricted to approximately 500 feet.

Westward view taken 500 feet from point of collision.

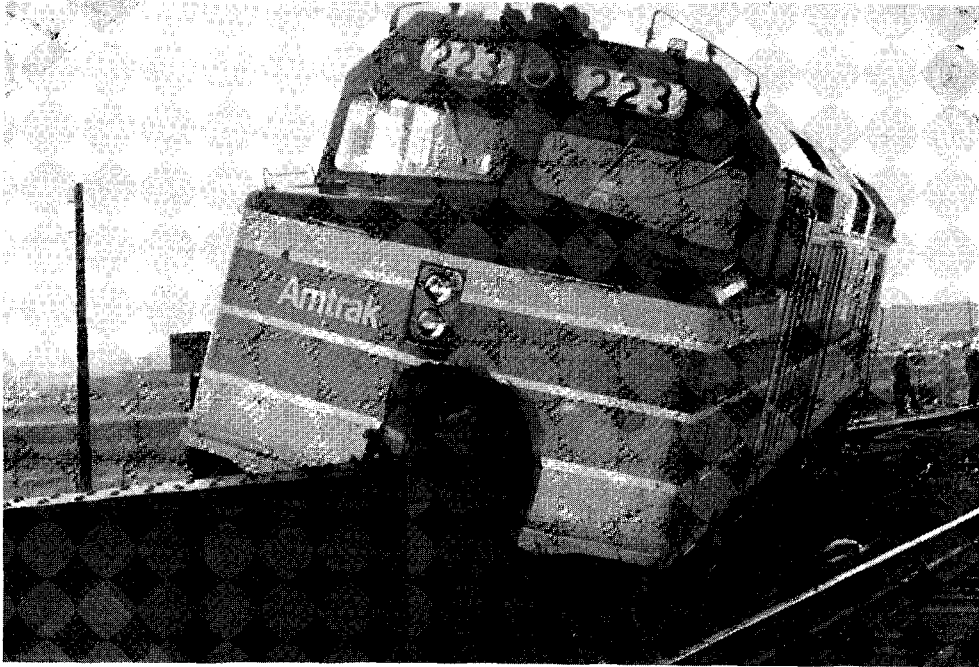
The collision forced the flat car to the north and the locomotive to the south. The locomotive struck the bridge and pushed the bridge 27 inches off of it's end bearings. The locomotive and the coaches were substantially damaged but remained upright. One end of the flat car was derailed and damaged slightly. The estimated cost of damage was as follows: railroad equipment \$200,000, track \$2,500 and bridge \$75,000.

Front of locomotive No. 223 struck the east end of the Rio Hondo River bridge.

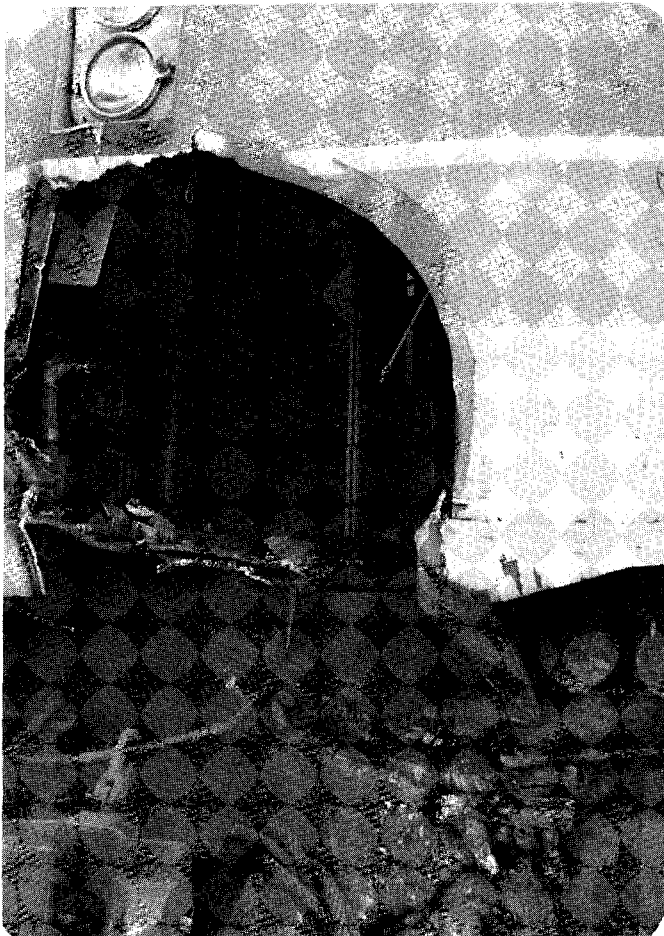
Close up view of damage to front of locomotive caused by striking the Rio Hondo Bridge.
