NATIONAL TRANSPORTATION SAFETY BOARD

HEAD-ON COLLISION OF NATIONAL RAILROAD
PASSENGER CORPORATION (AMTRAK)
PASSENGER TRAINS NOS. 151 AND 168
ASTORIA, QUEENS, NEW YORK, NEW YORK
JULY 23, 1984

✓
NTSB/RAR-85/09.

RAILROAD ACCIDENT REPORT

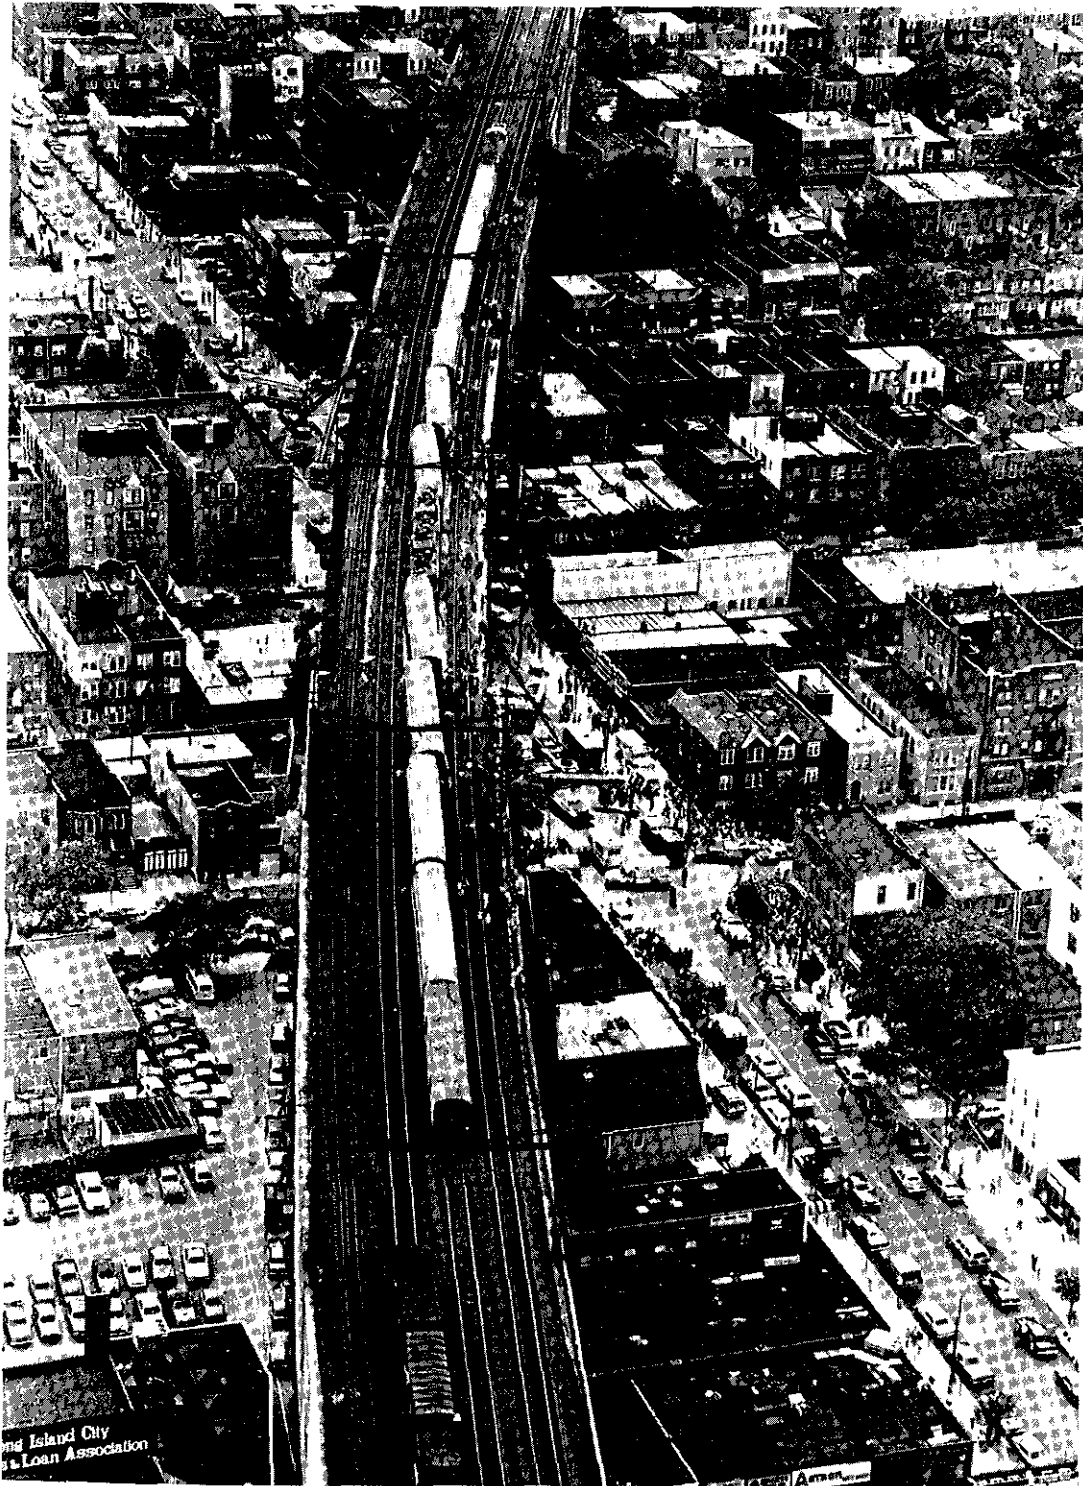
About 10:45 a.m., train No. 168 collided with train No. 151. Both trains were moving about 30 mph on an elevated section of track about 6,300 feet west of the 2E home signal. (See figure 2.) The locomotives and first four cars of each train derailed. The engineer of train No. 151 was knocked down in the engineroom of his locomotive, but he was able to recover and depart the locomotive through the rear operating compartment. The engineer of train No. 168 was found lying on the ground on the left side of his train adjacent to the locomotive of train No. 151.

Figure 2.--Aerial view looking west of accident site.
Train No. 168 is at top of of photograph, and train No. 168 is at bottom.

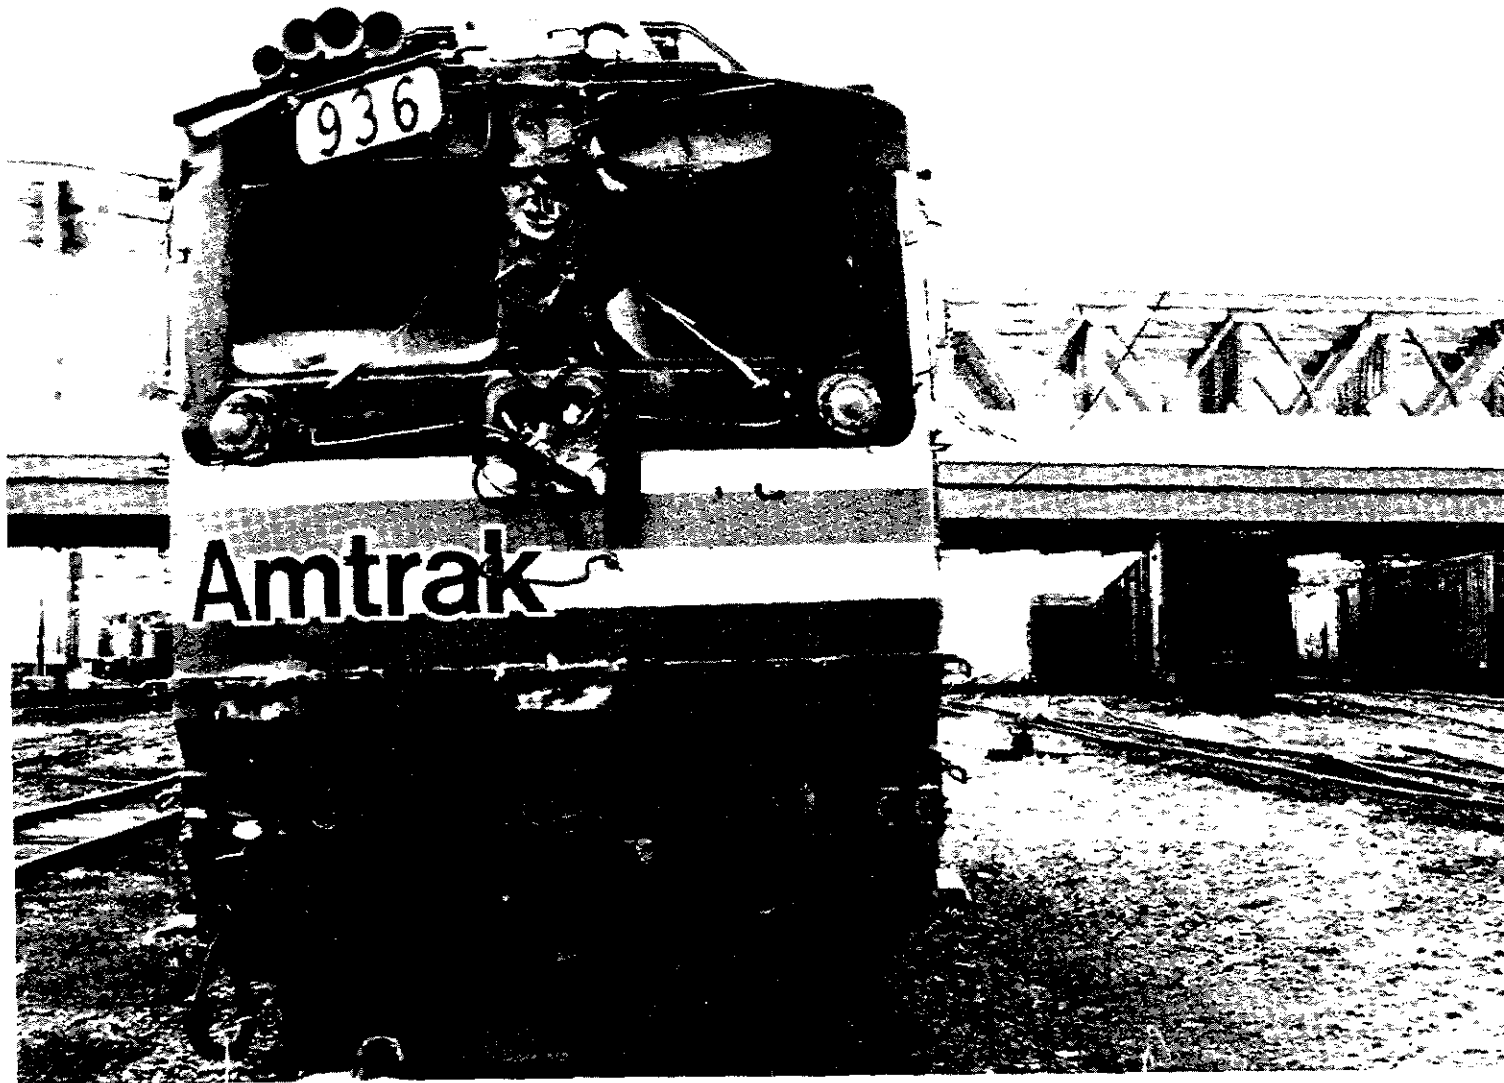
The predominant type of damage to the locomotives and coaches of both trains was end crush damage. The operating compartment of locomotive No. 936 on train No. 151 was displaced rearward about 2 feet at the floor and about 6 inches at the roof. The floor was buckled upward. The engineer's and fireman's seats were broken loose from the floor attachments and were leaning forward onto the operating desk. All components within the operating compartment were displaced and distorted. The side door on the engineer's side was ripped loose from its hinges, and the front of the door frame was moved backward about 18 inches. The door on the fireman's side was displaced backward, but it was not unhinged. Both halves of the two-part windshield were intact and the side window frames were buckled, but the glass was not broken. (See figure 3.)

Figure 3.--Damage to locomotive No. 936 train (No. 151).

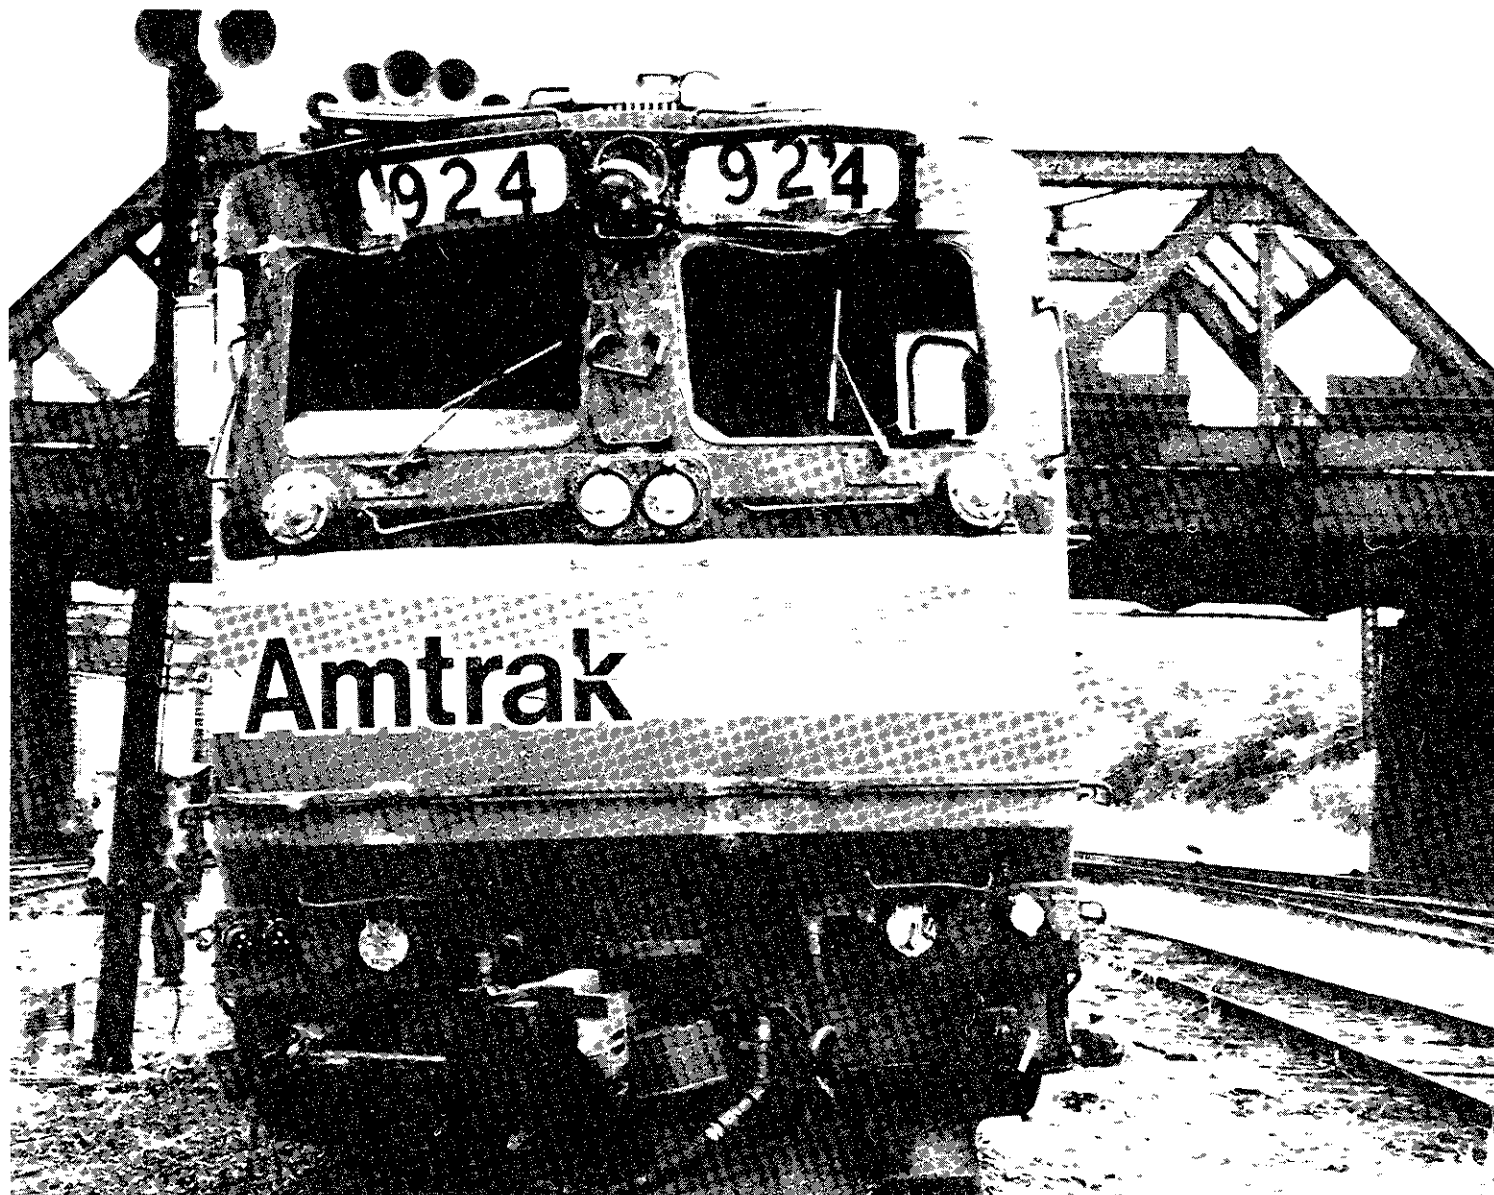
The same general crush damage was evident on locomotive No. 924 of train No. 168. However, the fireman's and engineer's seats were not broken loose from their attachments and the interior crush damage to the operating compartment was not as severe as it was to locomotive No. 936. (See figure 4.)

Figure 4.--Damage to locomotive No. 924 train (No. 168).

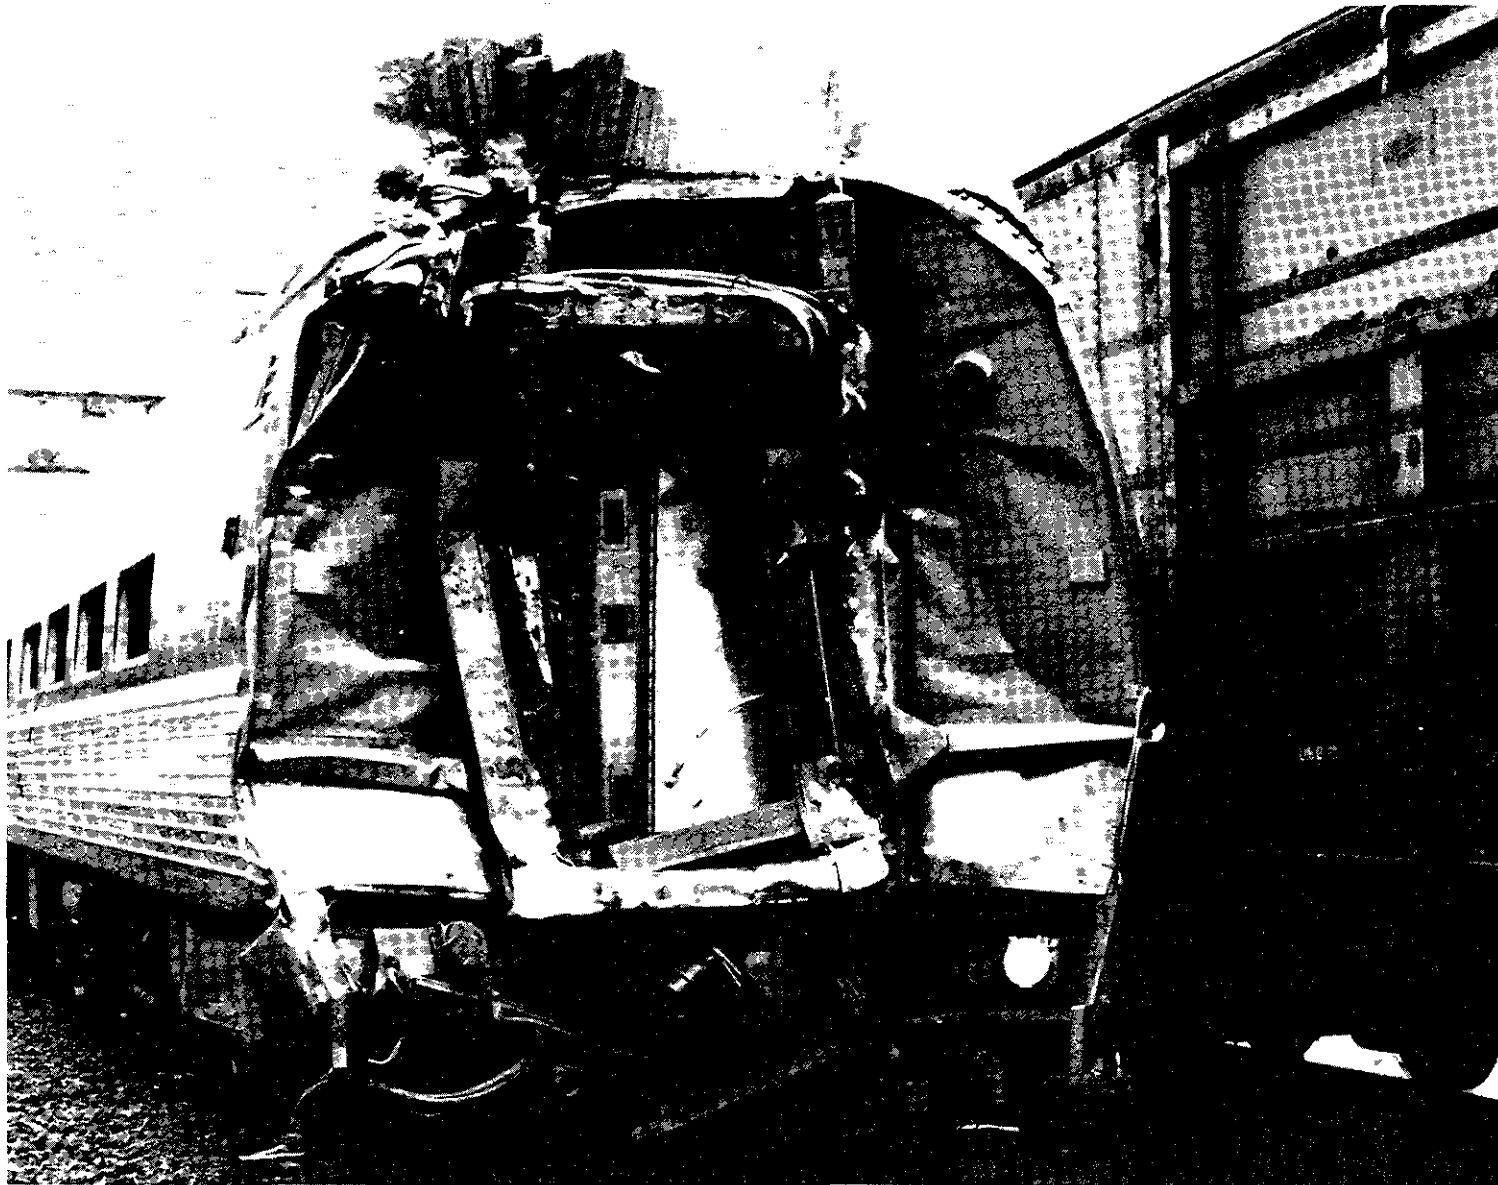
The vestibules of the first coach behind the locomotive of each train were crushed inward to the passenger compartment bulkhead. The side doors were either crushed or inoperative because of frame deformation. The end doors leading from the vestibules into the passenger compartments were in various positions and conditions. Some operating mechanisms were inoperable because of damage, and some operating mechanisms were operable but the doors would not function because of frame deformation which caused some doors to be jammed in either an open or closed position. Other coaches in the trains had similar damage, but the severity of the damage decreased as their location in the trains placed them farther from the locomotive. (See figure 5.)

Figure 5.--Damage to coaches typical for each train.

Major crash damage occurred to the cars in the area of the vestibules. The same type of damage also was evident on both ends of both AEM-7 locomotives.

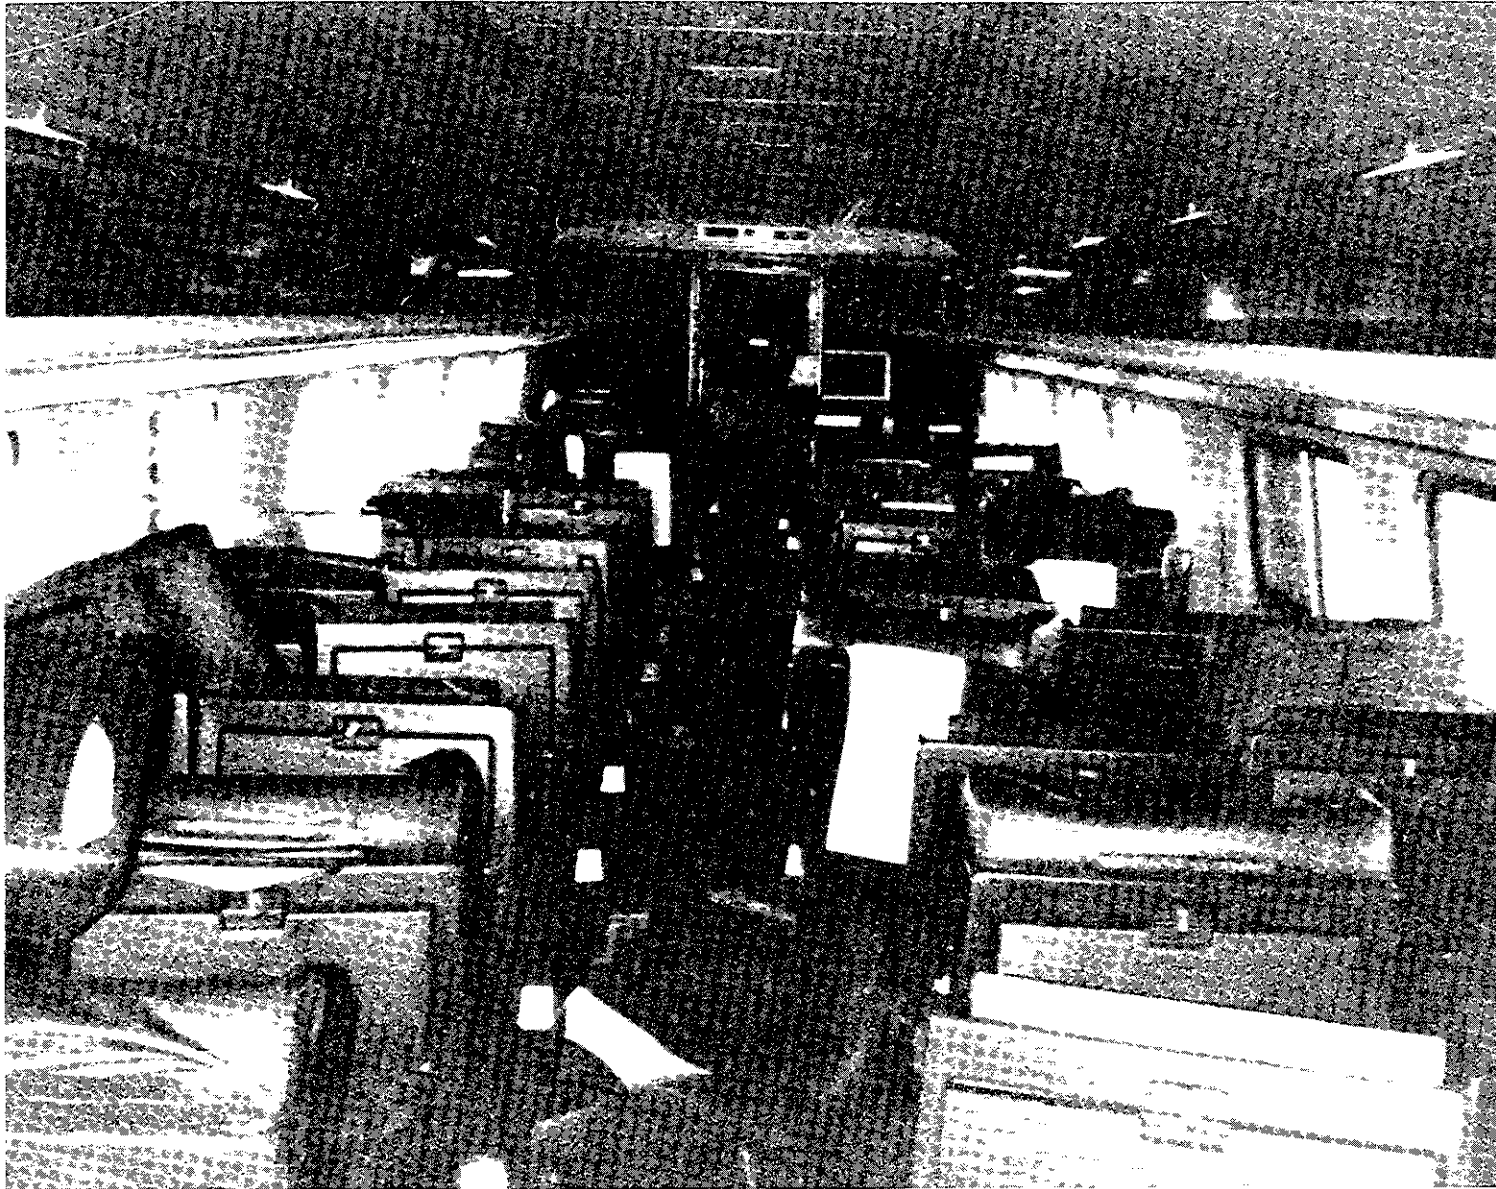
A large number of seat locking devices, which prevent seat rotation, were broken in the first and second head cars of train No. 151 and the first, second, third, and fourth head cars of train No. 168. The majority of the two-person seats had rotated. There were reports of some windows being knocked loose from their casings because of the impact forces. (See figure 6.)

Figure 6.--Interior view of typical coach disarrayment and condition.

The seat tracks were designed for a 5 G longitudinal force, which is more than the force which will pitch an unrestrained passenger from a seat. None of the seat tracks came loose even on the first two cars behind the locomotive where the greatest forces occurred. There was movement of the seats due to rotation, however.

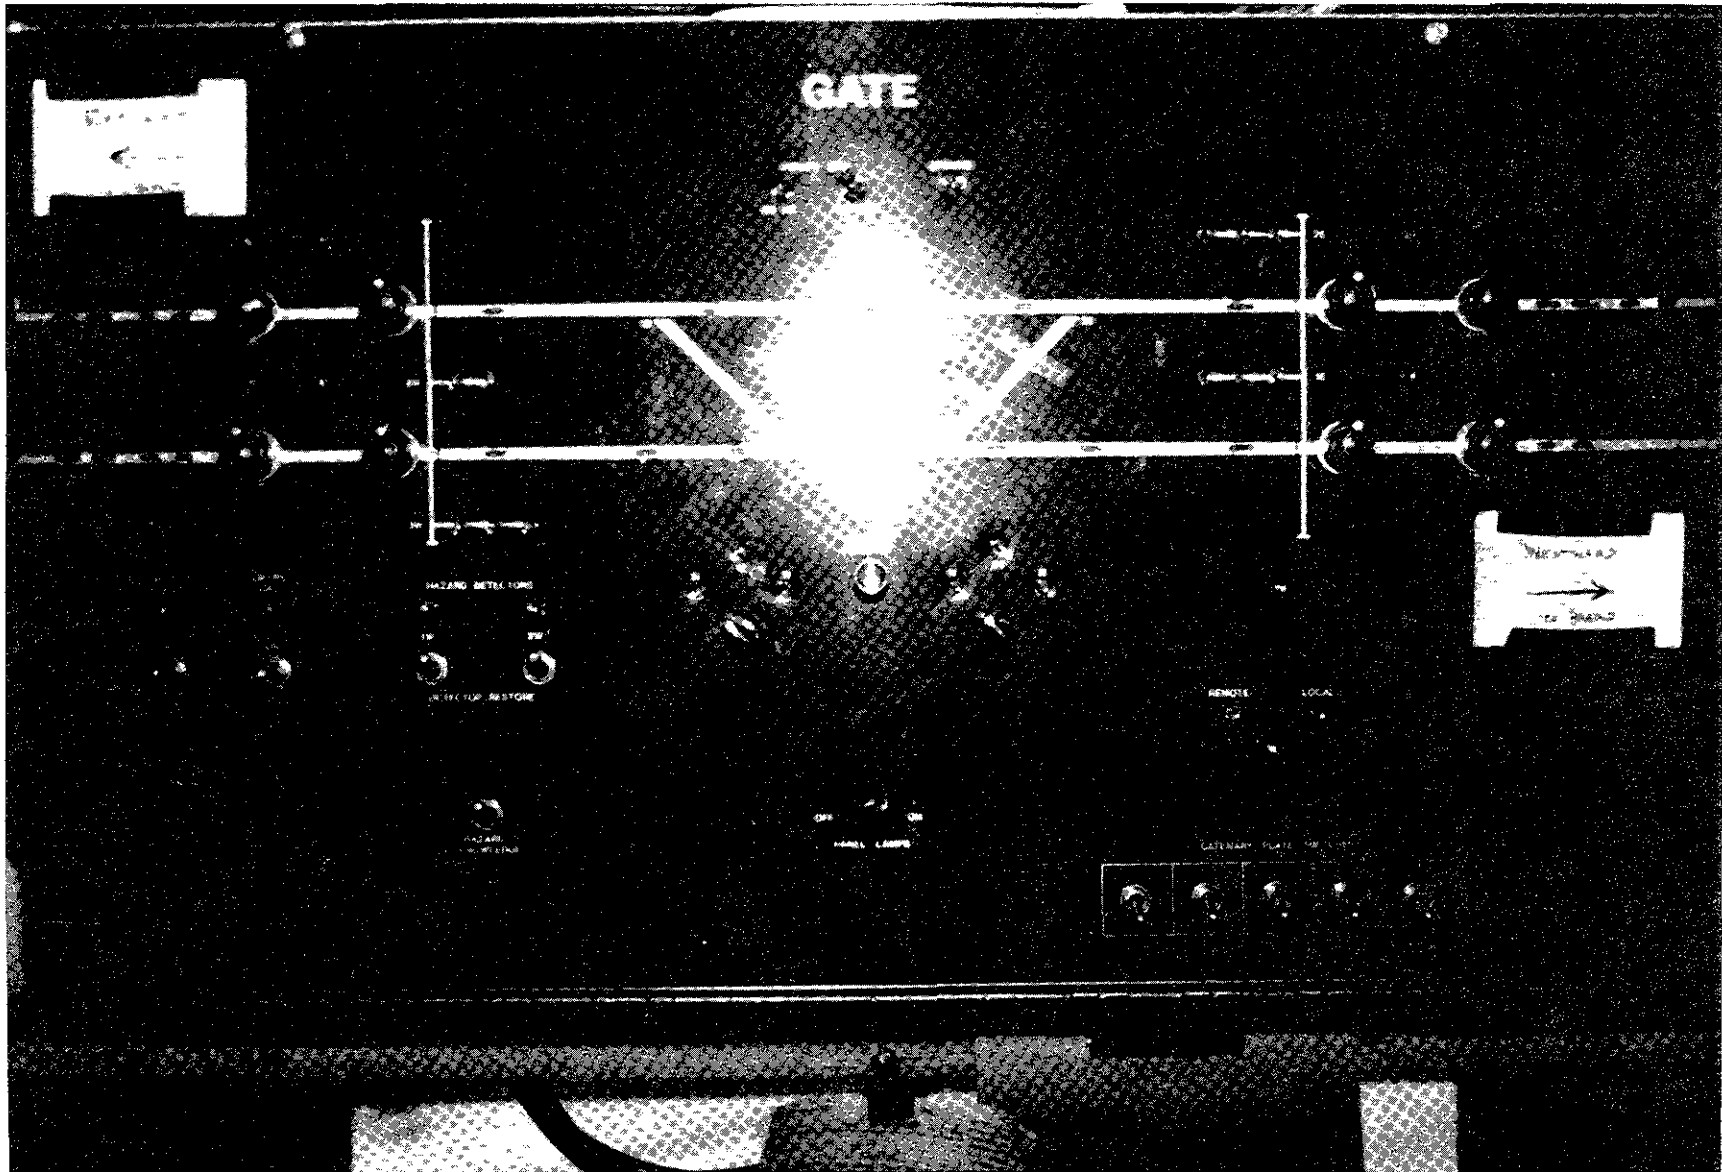
Figure 8.--Gate control panel. (Hand written labels not applied by the Safety Board.)

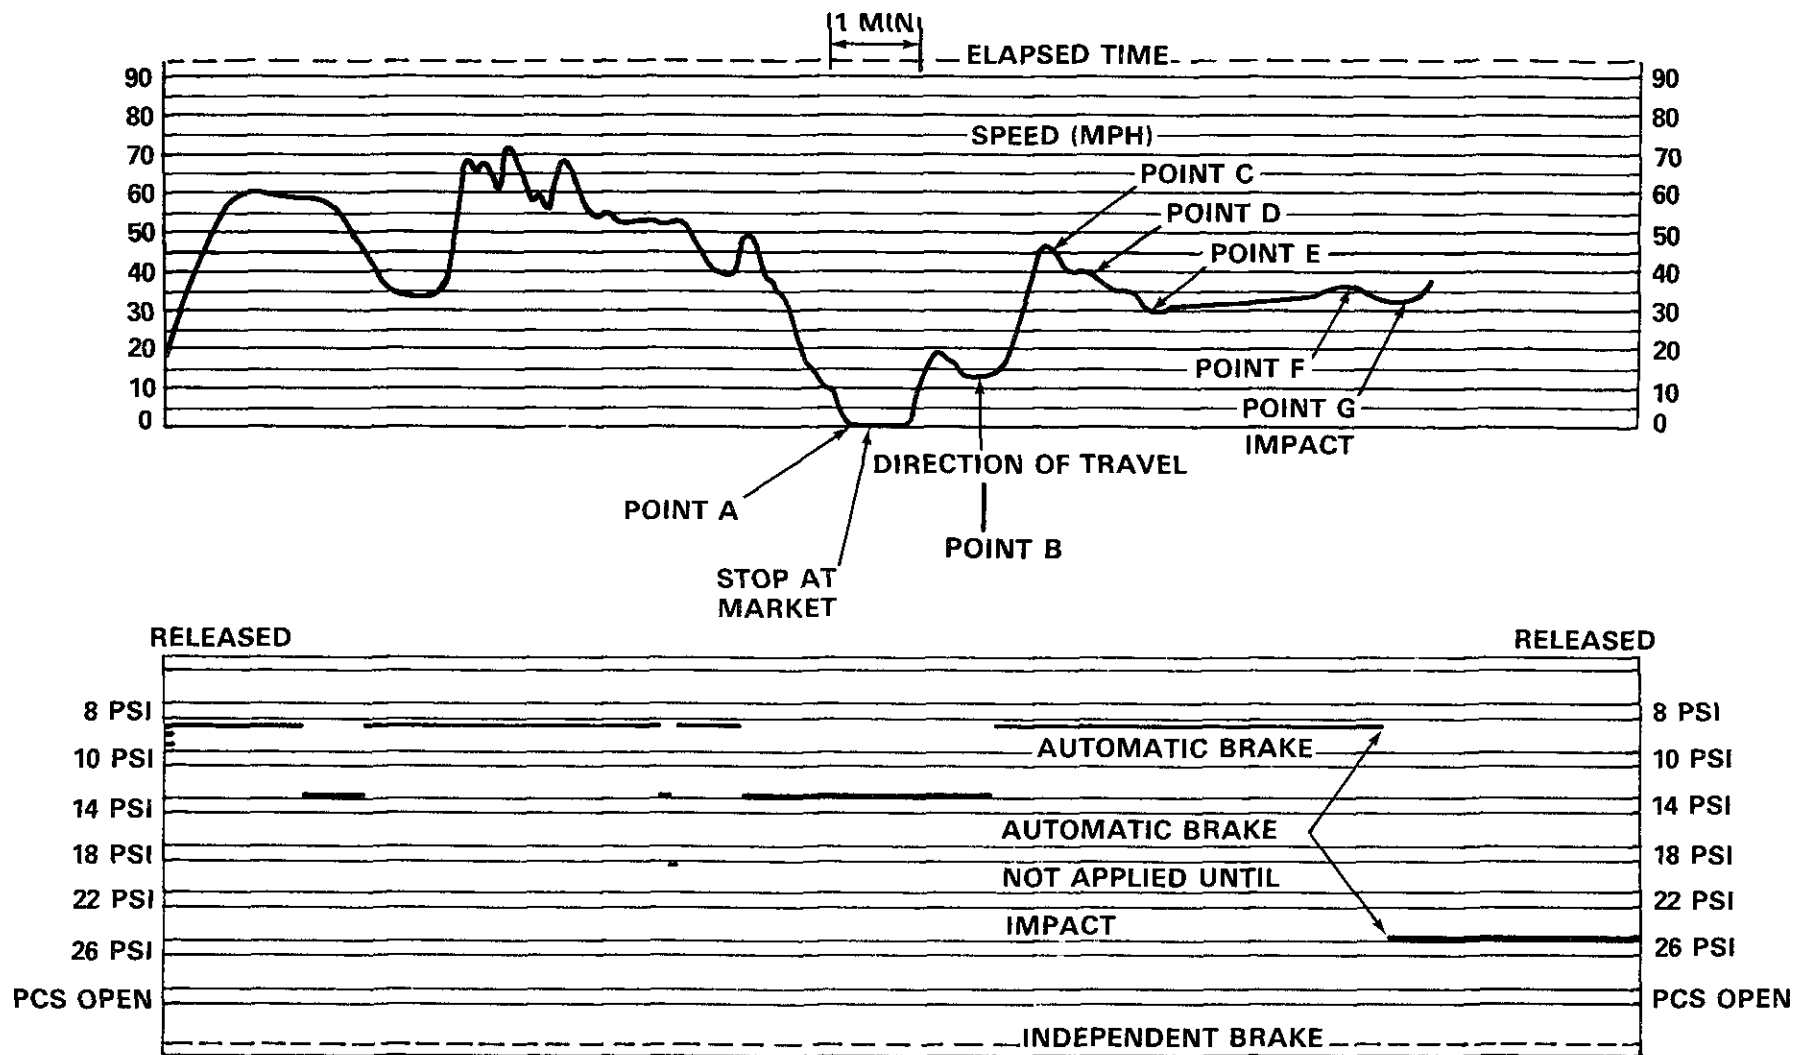
Speed Tapes from Train No. 151.--The speed tape from locomotive No. 936 train No. 151 was produced from a Pulse Electronics, Inc. cassette event recorder. (See figure 9.) The tape indicates that train No. 151 stopped at MARKET for the stop signal, point A, and that it slowed to receive the train order, point B. The speed recorder indicates that after the train left MARKET, the engineer accelerated the train to about 45 mph, point C. At MP 9.09, there is a 1° right curve westbound with a 30-mph

Figure 9.--Speed tape for train No. 151.

permanent speed restriction. The acknowledgement of the 30-mph speed restriction is not shown. The speed was reduced to about 40 mph, point D, which continued to decrease to about 30 mph, at point E. From point E, the speed gradually increased to about 36 mph, at point F. The speed then decreased to about 30 mph, point G, the point of the collision. The elapsed time for train No. 151 between MARKET and the collision point was about 5 1/2 to 6 minutes.

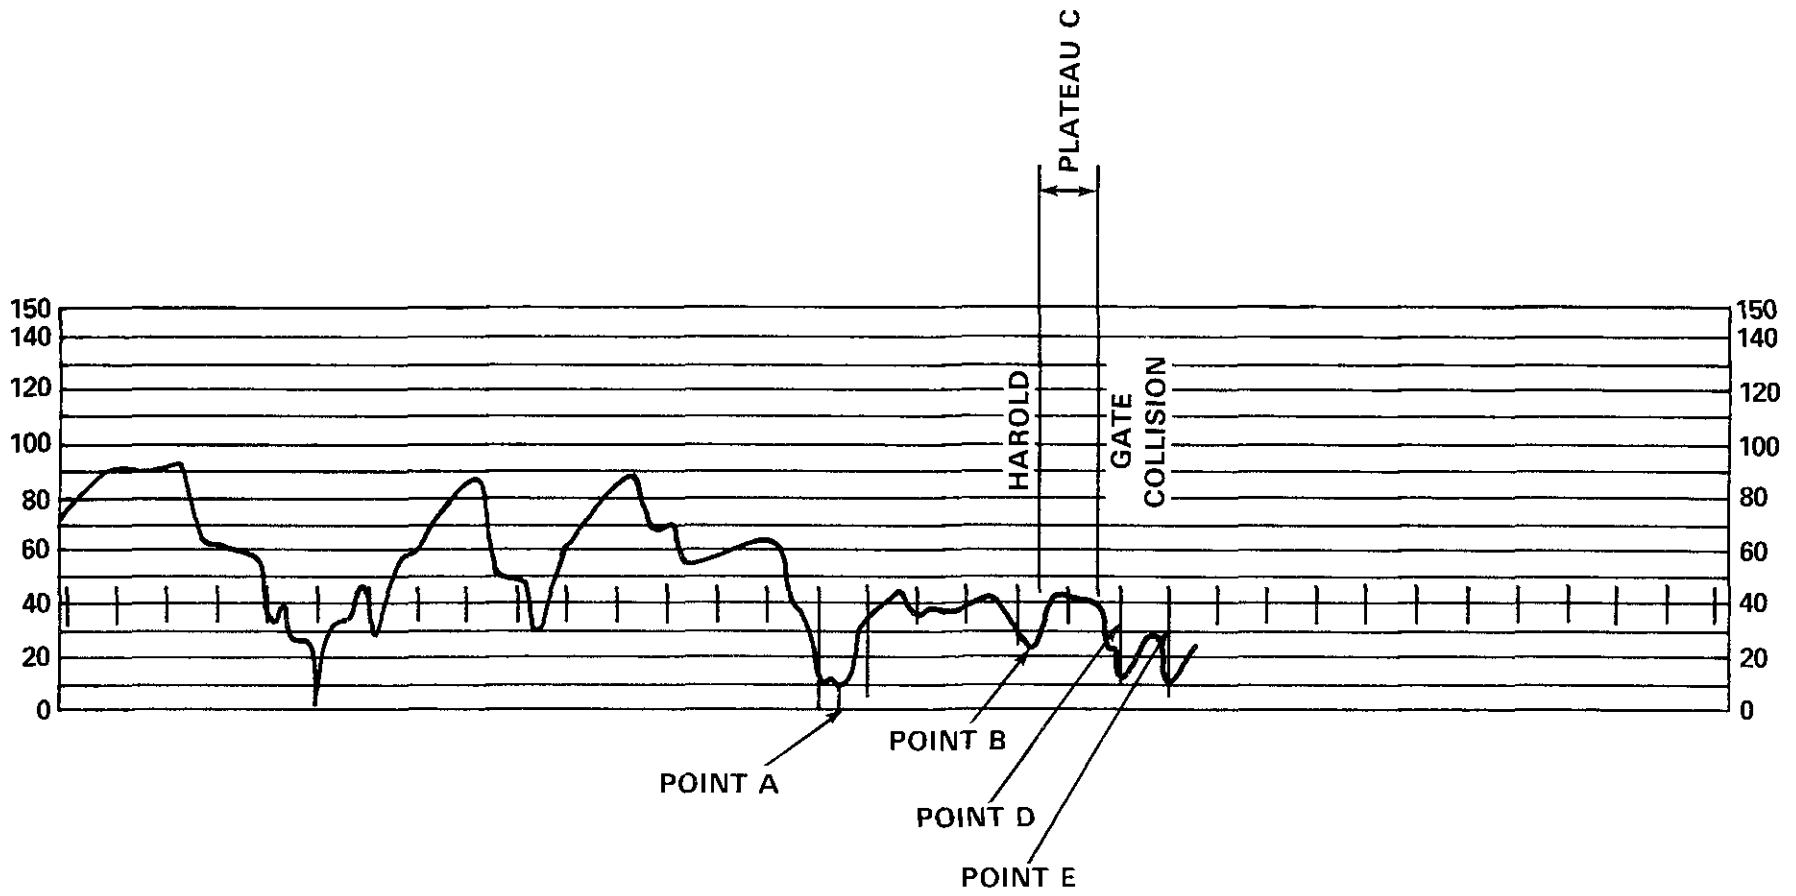
Figure 10.--Speed tape from train No. 168, July 23, 1984.

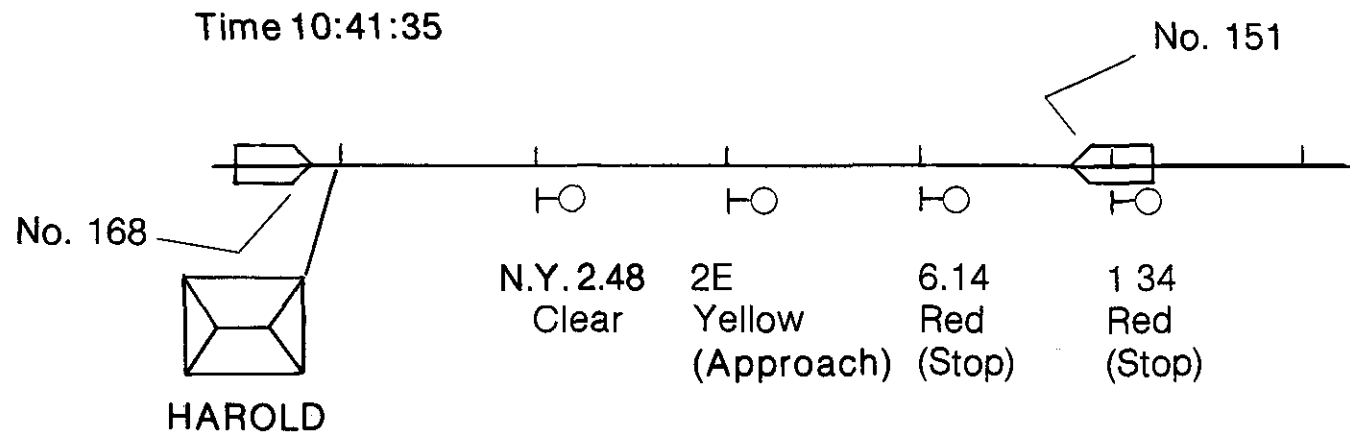
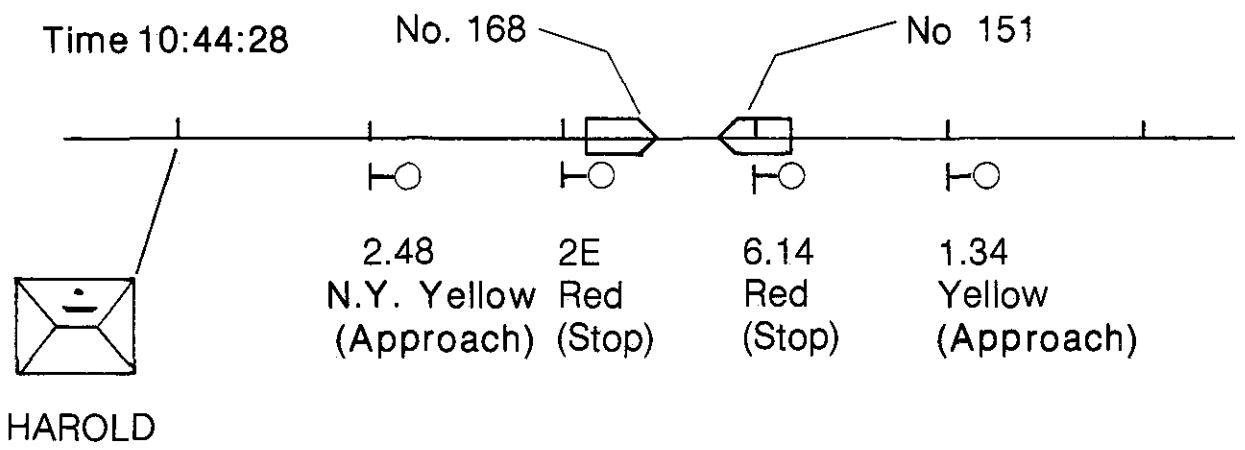
Figure 13.—Reconstruction of collision sequence.
