RAILROAD ACCIDENT INVESTIGATION

REPORT NO. 79-2

NATIONAL RAILROAD PASSENGER CORPORATION

FEBRUARY 15, 1978

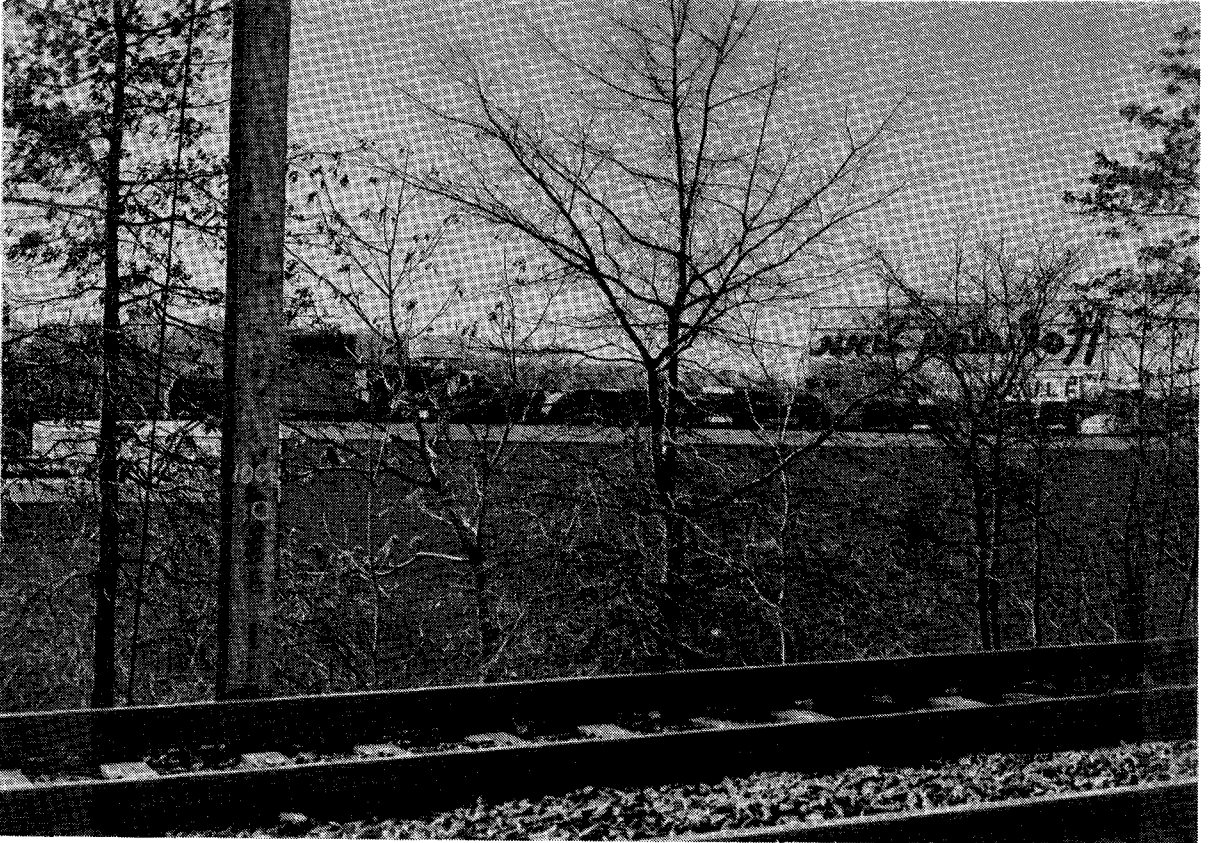
The subsidence of the ballast and embankment underneath the track caused the derailment.

The initial derailment occurred directly behind the Holiday Inn (not the Diplomat) which was built in 1965 (Fig. 1). During construction of the Holiday Inn the railroad embankment subsided for a distance of about 100 feet under tracks 2 and 3. Estimates of the movement of both tracks were four inches horizontally and eight inches vertically. The track repair that followed required extensive reballasting.

Fig. 1
The point of initial derailment. The Holiday Inn is in the background.

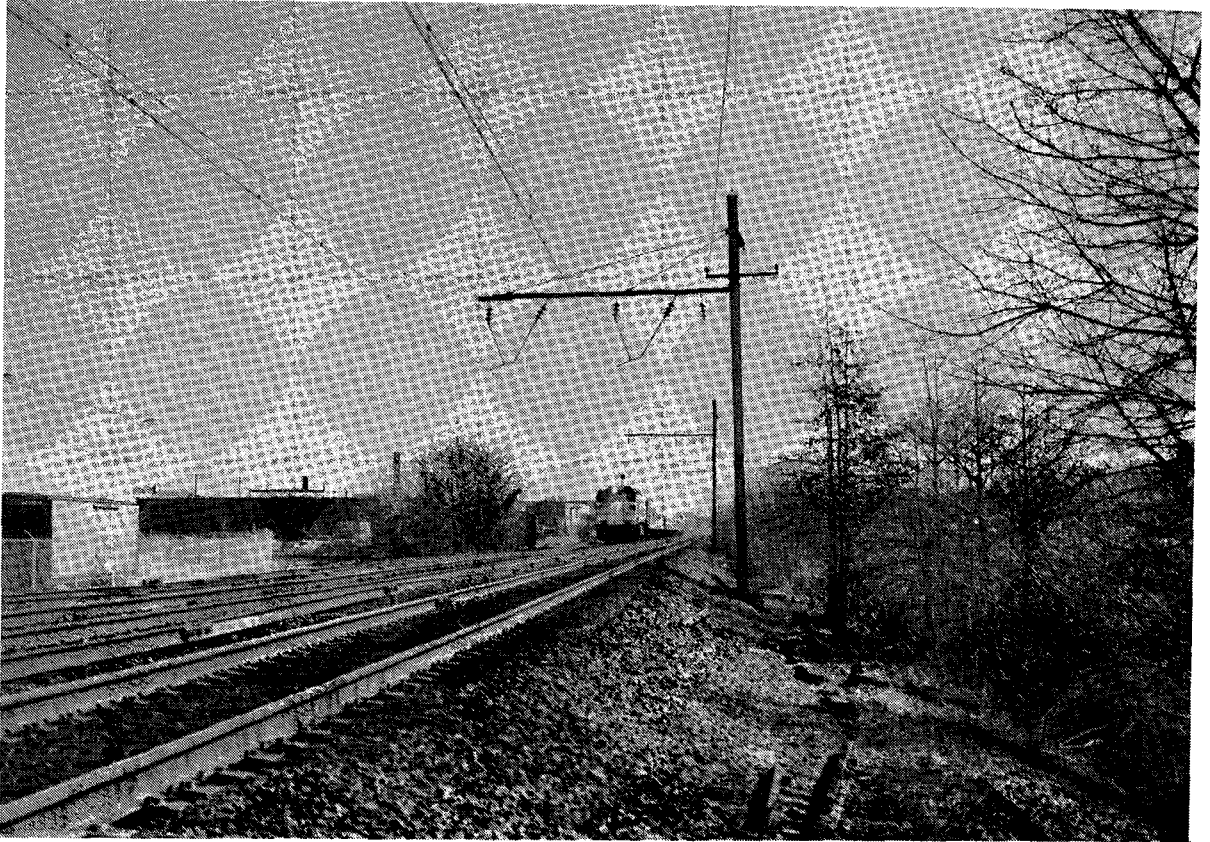
Catenary Pole No. 3326 (E 705), which is directly opposite the derailment site on the east side, is about two feet outside the alignment of adjacent catenary poles, and the arm supporting the catenary lines has been extended. This is due to the slide/slippage of the upper part of the embankment toward the east (Fig. 2).

Fig. 2
The right-of-way looking north. The initial derailment occurred opposite the catenary pole which is out of line with the others on the tangent track.
