RAILROAD ACCIDENT REPORT

DERAILMENT OF
NATIONAL RAILROAD PASSENGER CORPORATION
TRAIN 7
ON BURLINGTON NORTHERN RAILROAD
NEAR SACO, MONTANA
AUGUST 5, 1988

NTSB/RAR-89/03

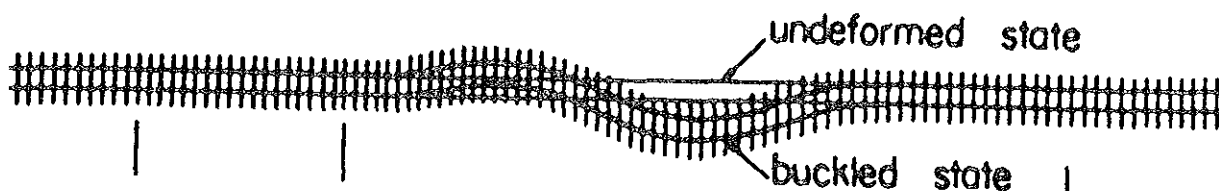
³Lateral displacement of the track structure normally associated with high ambient temperature.

Figure 2.--Sketch of sun kink

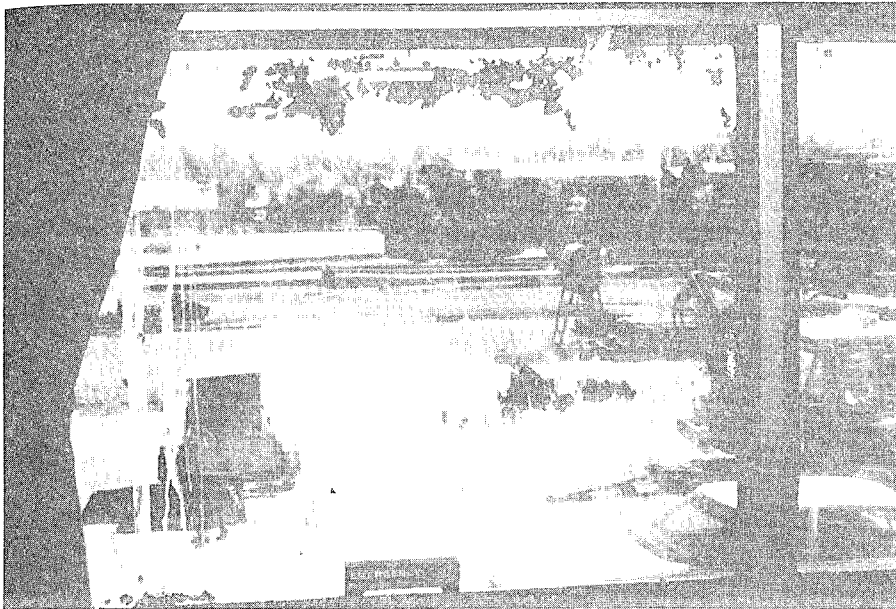
The graphic illustrates the metal handle located behind the red plastic handle. The postaccident inspection of the train equipment revealed that the placards were missing on some windows, that the metal handles were not located behind the red plastic handles on some windows (see figure 7), that the red plastic handles were missing on some windows, and that the metal handles were missing on some windows (see figure 8).

. . . it's a misapplication of the window, number one. The rubber was misapplied on the window. And if you were to pull on the handle, the red handle on this car, it would remove the rubber strip, and then you could pull on the handle and remove this window. The window would come out; it in no way hampers the operation of the window. It is not applied properly, and this is something that should be picked up in the normal inspection on a train.

Figure 7.--Misapplied emergency window, with missing placard

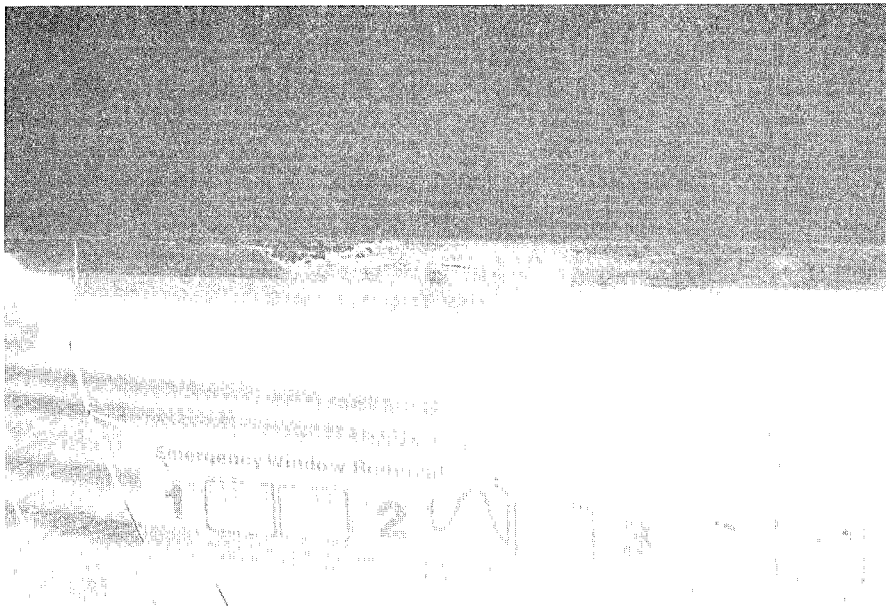
Figure 8.--Emergency window without metal handle

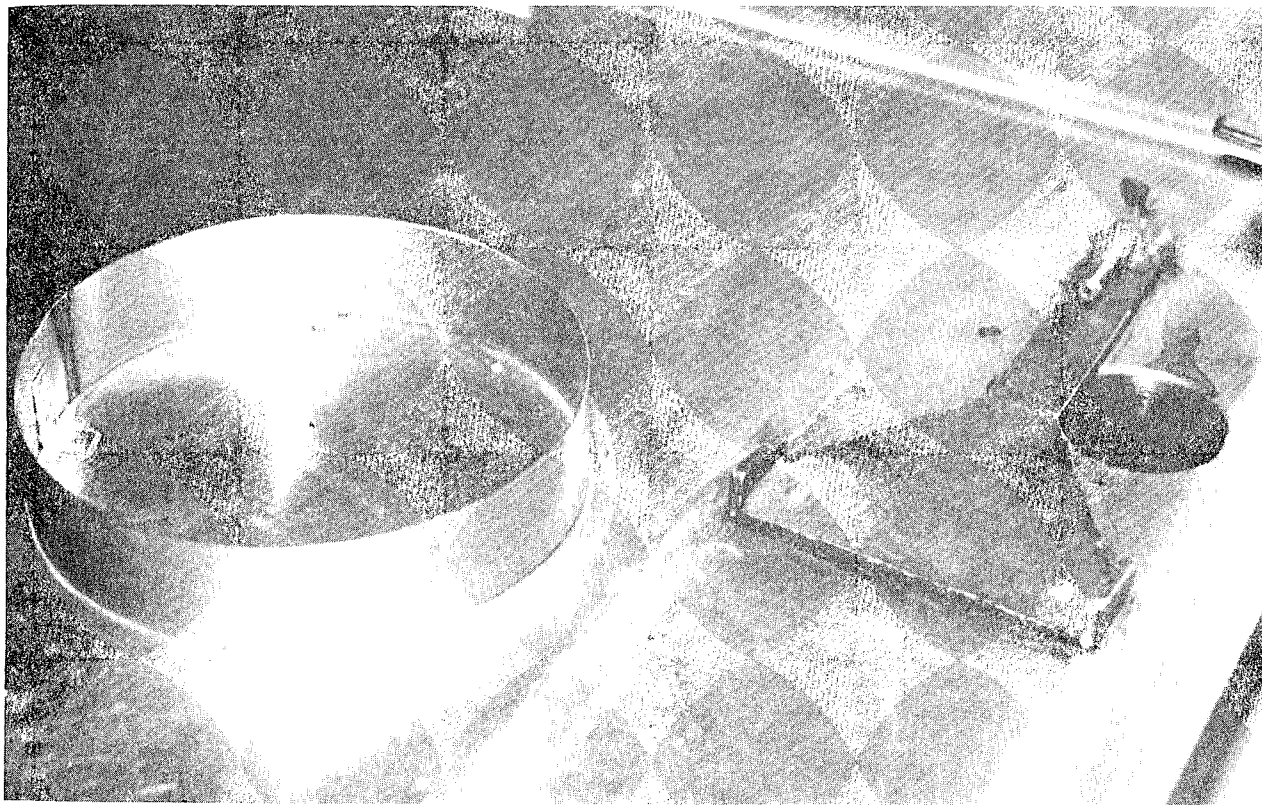
The coffeemaker retention device on train 7 consisted of an open metal ring attached to the countertop (see figure 12), and the coffeemaker was placed unsecured inside the metal ring. In this accident, the coffeemaker came out of the retention device and hot coffee injured the passenger, demonstrating that the retention device is ineffective. The Safety Board believes the lack of effective restraints and restraints devices not being in place (see figure 13) continues to allow food service items to be ejected, becoming potential sources of injury. The Board is holding Safety Recommendation R-88-48 in an "Open--Unacceptable Action" status until further response is received from Amtrak.

Figure 12.--Metal ring to restrain coffee pot

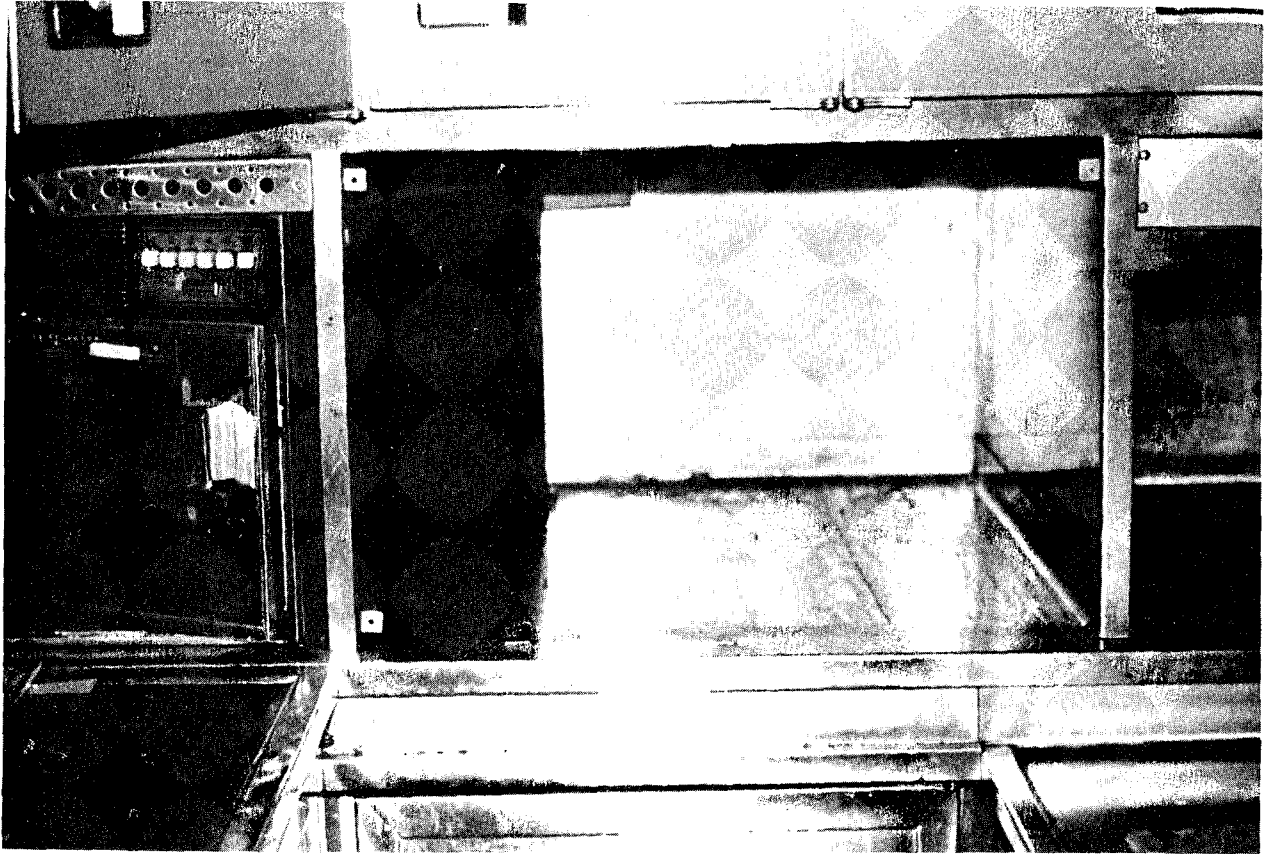
Figure 13.--Properly restrained oven on left remained in place during the accident. Restraints were not in place (although the restraint brackets were) and the oven on the right fell out during the accident.
