RAILROAD ACCIDENT INVESTIGATION

REPORT NO. 414

NEW YORK CENTRAL RAILROAD COMPANY

JANUARY 8, 1968

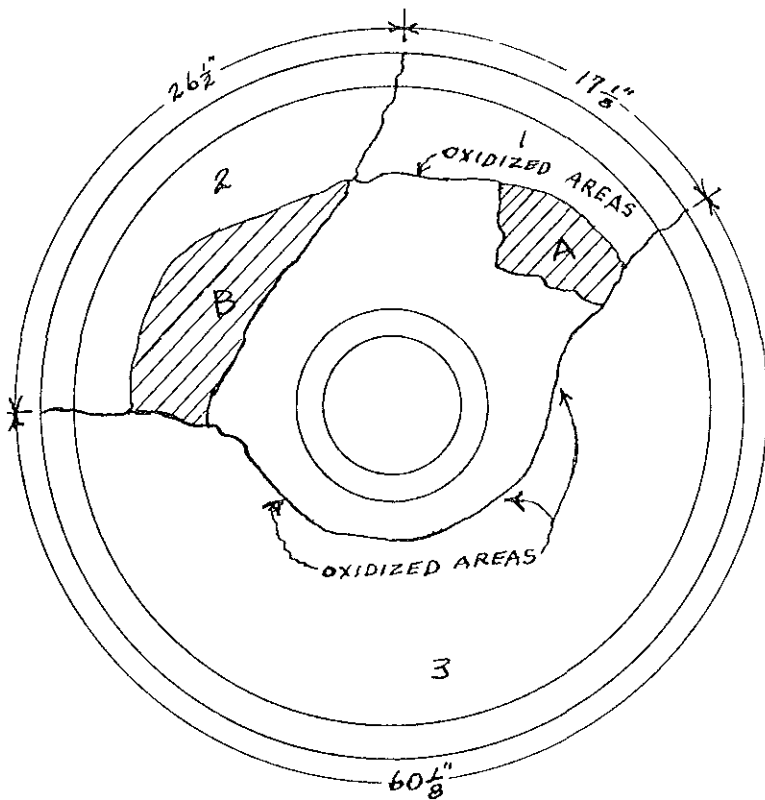
Broken Wheel of 60th Car

Examination of the derailed equipment disclosed that the front wheel on the south side of the rear truck of the 60th car (NYC 43704) had broken into five or more pieces, as shown in the wheel print appended to this report. Three of the broken off pieces (designated as 1, 2 and 3 in the wheel print) were recovered, at points 87, 201 and 249 feet west of the initial derailment point. The other portions (designated as "A" and "B" in the wheel print) were not recovered.

The three broken off pieces of the wheel recovered after the accident included all the flange of the wheel as well as the tread, rim and portions of the plate. No unusual condition of the flange tread or rim was disclosed. The rim thickness, and the flange height and width were well within limits of wear prescribed by the carrier and the Association of American Railroads.

Laboratory analysis of the wheel after the accident disclosed that the steel met the chemical requirements of AAR specification M-107 for wrought carbon steel wheels. It further disclosed that a number of small oxidized areas appeared in the fractured surfaces of the wheel plate at locations indicated in the wheel print of this report, and that tooling discontinuities or flaws, including a lap-like discontinuity, residual to wheel rolling operations during manufacture, appeared in these areas. The exact location where the wheel began to fracture could not be determined. However, it is apparent that the original fracture started on the inner plate surface, at one of the small oxidized areas, and progressed rather slowly around the hub. This eventually weakened the plate structure to the extent that the

fracture then progressed rapidly around the hub, causing three radial fractures through the plate and rim, and resulting in complete failure of the wheel

The wheel failed as a result of tooling discontinuities or flaws residual to wheel rolling operations during manufacture by the Armco Steel Company in August 1961. These irregularities may not have been visible to ordinary visual inspections conducted by Armco Steel Company employees after manufacture, or by New York Central Railroad Company employees prior to mounting the wheel on the axle. On the other hand, they might have been visible and detected had the wheel been

1. At the time of the initial derailment, the train was proceeding westward in accordance with applicable rules and regulations of the carrier.
2. The derailment was caused by a broken wheel on the 60th car.
3. The wheel broke in the plate due to tooling discontinuities or flaws residual from wheel rolling operations in manufacture.

In any event, it is evident that the wheel involved was manufactured with several tooling discontinuities in the plate, and that the inspections made after manufacture were not thorough enough to disclose these irregularities. Tooling discontinuities can act as stress risers which may eventually lead to wheel failures such as occurred in this case. Consequently, it is imperative in the interest of railroad safety that the Armco Steel Company and other wheel manufacturers review their quality control measures at appropriate intervals, to ensure that proper wheel rolling practices are being followed and that wheels supplied railroad carriers are free of defects which might ultimately result in wheel failures. It is further imperative that a wheel be thoroughly and carefully inspected by a responsible employee of the carrier's shop or car department before it is mounted on an axle, to determine whether it has any defective condition which might lead to ultimate failure.
