RAILROAD ACCIDENT INVESTIGATION

Report No. 4115

THE NEW YORK CENTRAL RAILROAD COMPANY

HARBOR CREEK (CP 79), PA.

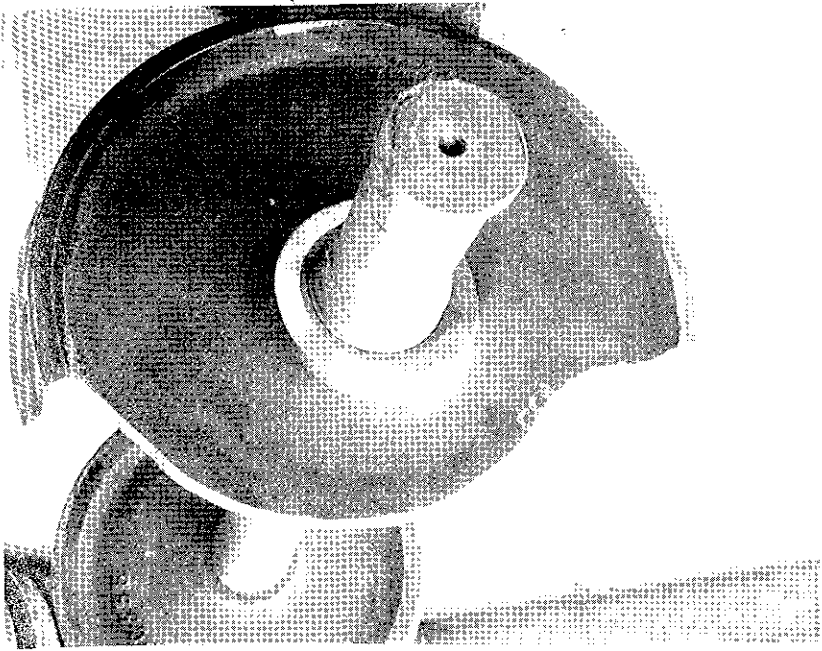
Examination of the equipment of No 23 after the accident disclosed that a large section of the front wheel on the north side of the front truck of the 31st car, a baggage-express car, was broken (see photos). Two large pieces of the broken off section of the wheel were found on the north side of track No. 1, 1.2 miles east of the initial derailment point. One of the pieces was $34\frac{1}{2}$ inches in length along the flange and $6\text{-}\frac{3}{8}$ inches deep through the flange and rim, and into the plate. The other piece was about 8 inches in length along the flange and $4\text{-}\frac{3}{8}$ inches deep. That part of the broken wheel remaining on the axle disclosed no evidence of the wheel having been loose or having turned on the axle wheel seat. Flange and tread wear were within limits of wear prescribed by standards of the Association of American Railroads. There was no evidence of slid flat wheels.

Laboratory analysis of the broken wheel disclosed that the steel met the chemical requirements of AAR Specification M-208-66 for cast carbon steel wheels. It also disclosed that the rim of the wheel had been overheated due to braking action and that there were numerous thermal cracks in the tread. At one end of a broken off piece, a progressive fracture, $\frac{7}{8}$ inch wide and $1\text{-}\frac{3}{4}$ inches long, appeared in the plate and rim. It originated at a thermal crack in the outer tread. Adjacent to the progressive fracture, a secondary fracture consisting of both old and new break, 1 inch wide and 3 inches long, also appeared in the rim and plate. It also originated at a crack in the outer tread and progressed into the rim and plate.

Front wheel on north side of
front truck of 31st car
