INTERSTATE COMMERCE COMMISSION

ACCIDENT ON THE

NEW YORK CENTRAL RAILROAD

INVESTIGATION NO. 2031

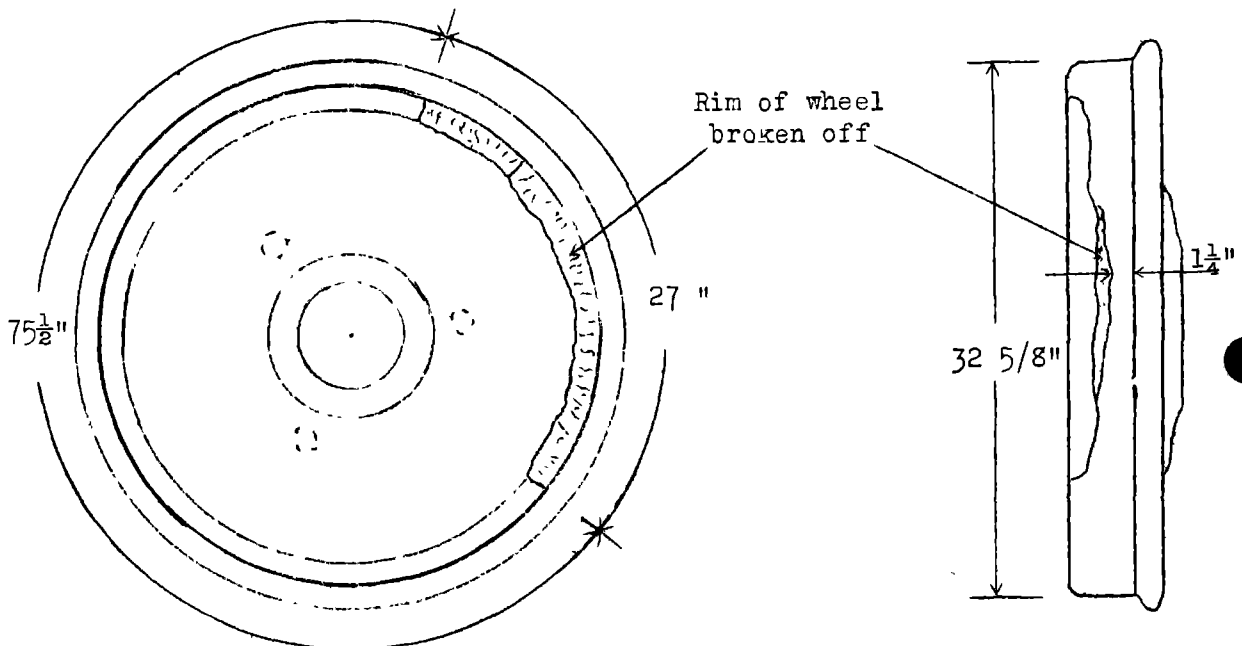
General Car Foreman Ruxton stated that the accident was caused by a broken wheel tread on the fifth car in the train, B&O 124105. This wheel was the L-4, lead wheel of the lead truck, A end; the circumferential length of this broken rim fracture was 27 inches and the fracture extended to within $1\frac{1}{4}$ inches of the throat of the flange. Detailed inspection revealed some interwoven circumferential cracks in the remaining portion of the tread, indicating a defective wheel which could not be discovered in ordinary inspection. It was a 33-inch cast iron wheel, #5 tape, mounted on a steel axle, $5\frac{1}{2}$ by 10 inch journals; double plate wheel #9960, cast 2-23-28, manufactured by the Maryland Car Wheel Company, Baltimore, Md., under ARA 1920 specifications; weight, 750 pounds. The right No. 4 wheel, the mate to the defective wheel was of the same manufacture, kind and weight, being cast on 2-24-28, and bearing number 10247. A portion of flange $21\frac{1}{2}$ inches in circumferential length was broken from this wheel, the fracture being 100 percent new, and it is evident that when the left wheel dropped inside the left rail, a severe thrust was placed between the flange of the right wheel and the gauge side of the right rail, causing a portion of the flange to break off. The flange of this wheel was noticeably worn, the wear being quite uniform throughout the circumference, but careful measurements and check with an A.A.R. standard wheel gauge indicated

Examination by the Commission's inspectors of the wheel involved showed the part of the broken tread remaining in the wheel to be cut and ground to a marked degree along its outer edge, in a manner which showed conclusively that this remaining narrow section of tread, adjacent to the flange, had wedged or slipped down on the inside of the rail. The metal in the tread of the wheel at the ends of the fracture showed evidence of violent blows and an additional irregular piece of the tread at the end of the fracture, weighing about 4 pounds, was found to be cracked and almost broken off and was readily knocked off by a hammer blow. Neither the wheel tread nor the flange were found to have excessive wear, and both were well within the limits of the standard A.A.R. wheel gauge. Careful examination

of the tread, when well cleaned, showed several longitudinal and interwoven lines.

From the chemical analysis and examination of the wheel, the conclusion of the engineer of tests was that the wheel failed because of insufficient chill in the tread; that in lieu of $\frac{1}{2}$ inch minimum depth chill at tread required by A.A.R. specifications, the broken wheel was found to have no chill; that all the evidence indicated the breaking down of the tread which led to the actual fracture occurred very rapidly after it originated and there was probably no indication of the condition detectable by inspection when the car was last inspected; that the low combined carbon disclosed by the analysis indicates a lack of chill in the wheel when manufactured; that in a properly chilled wheel the combined carbon would be between .50 and .70 percent in the back plate and approximately 3.00 percent at a point $\frac{3}{16}$ inch below the tread surface, whereas the broken wheel contained but .25 percent combined carbon in the back plate and 1.71 percent at a point $\frac{3}{16}$ inch below the surface of the tread, with correspondingly increased amounts of graphite carbon.

The evidence indicates that a piece broke from the tread of the left front wheel, lead truck of B&O car 124105, the fifth car in the train. From the marks on the left rail it is evident that after the fracture occurred other pieces were chipped or broken off by the violent pounding effect as the wheel continued to revolve and the tread was soon destroyed or reduced to such an extent that sufficient bearing surface was no longer left to support the load; it then dropped inside of the rail, causing a side thrust which broke the flange of the opposite wheel and allowed it to drop off on the right side of the right rail. A heavy snow covered the ground at the time of the accident and continued to fall after the accident occurred; no pieces of the broken tread or flange could be found. The crew at no time noticed anything wrong prior to the derailment, and the heavy snow no doubt extinguished any sparks or flying fire which may have been caused by the broken wheel coming in contact with the rail.

It is evident from the laboratory analysis of the wheel that the conditions or weaknesses which led to its failure were inherent within the wheel from the time of its manufacture because of a deficiency of combined carbon and an excess of graphite in the tread, and a lack of sufficient chill to meet the A.A.R. specifications; this condition is specifically referred to in a treatise by the Association of Manufacturers of chilled car wheels as a weakness of vital importance against which caution must be taken. Although the wheel rendered considerable service, it was far from the condemning limits of wear for such wheels, which fact makes wheels of this character an extraordinary element of hazard, because when once accepted from the manufacturer and placed in service, there is little if any possibility of detecting such inherent weakness and, as in this case, the wheel may suddenly collapse in fair usage long before it becomes worn to an extent justifying removal. The remedy for prevention of such hazards must, therefore, necessarily lie at the source, that is in the manufacturing processes and in the inspection and tests made by the purchaser before accepting and putting wheels in service.
