INTERSTATE COMMERCE COMMISSION

Ex Parte 186

ACCIDENT IN PENNSYLVANIA NEAR CONNEAUT, OHIO

Accident in Pennsylvania near Conneaut, Ohio, on March 27, 1953, caused by damaged track as a result of improperly secured lading falling from a car.

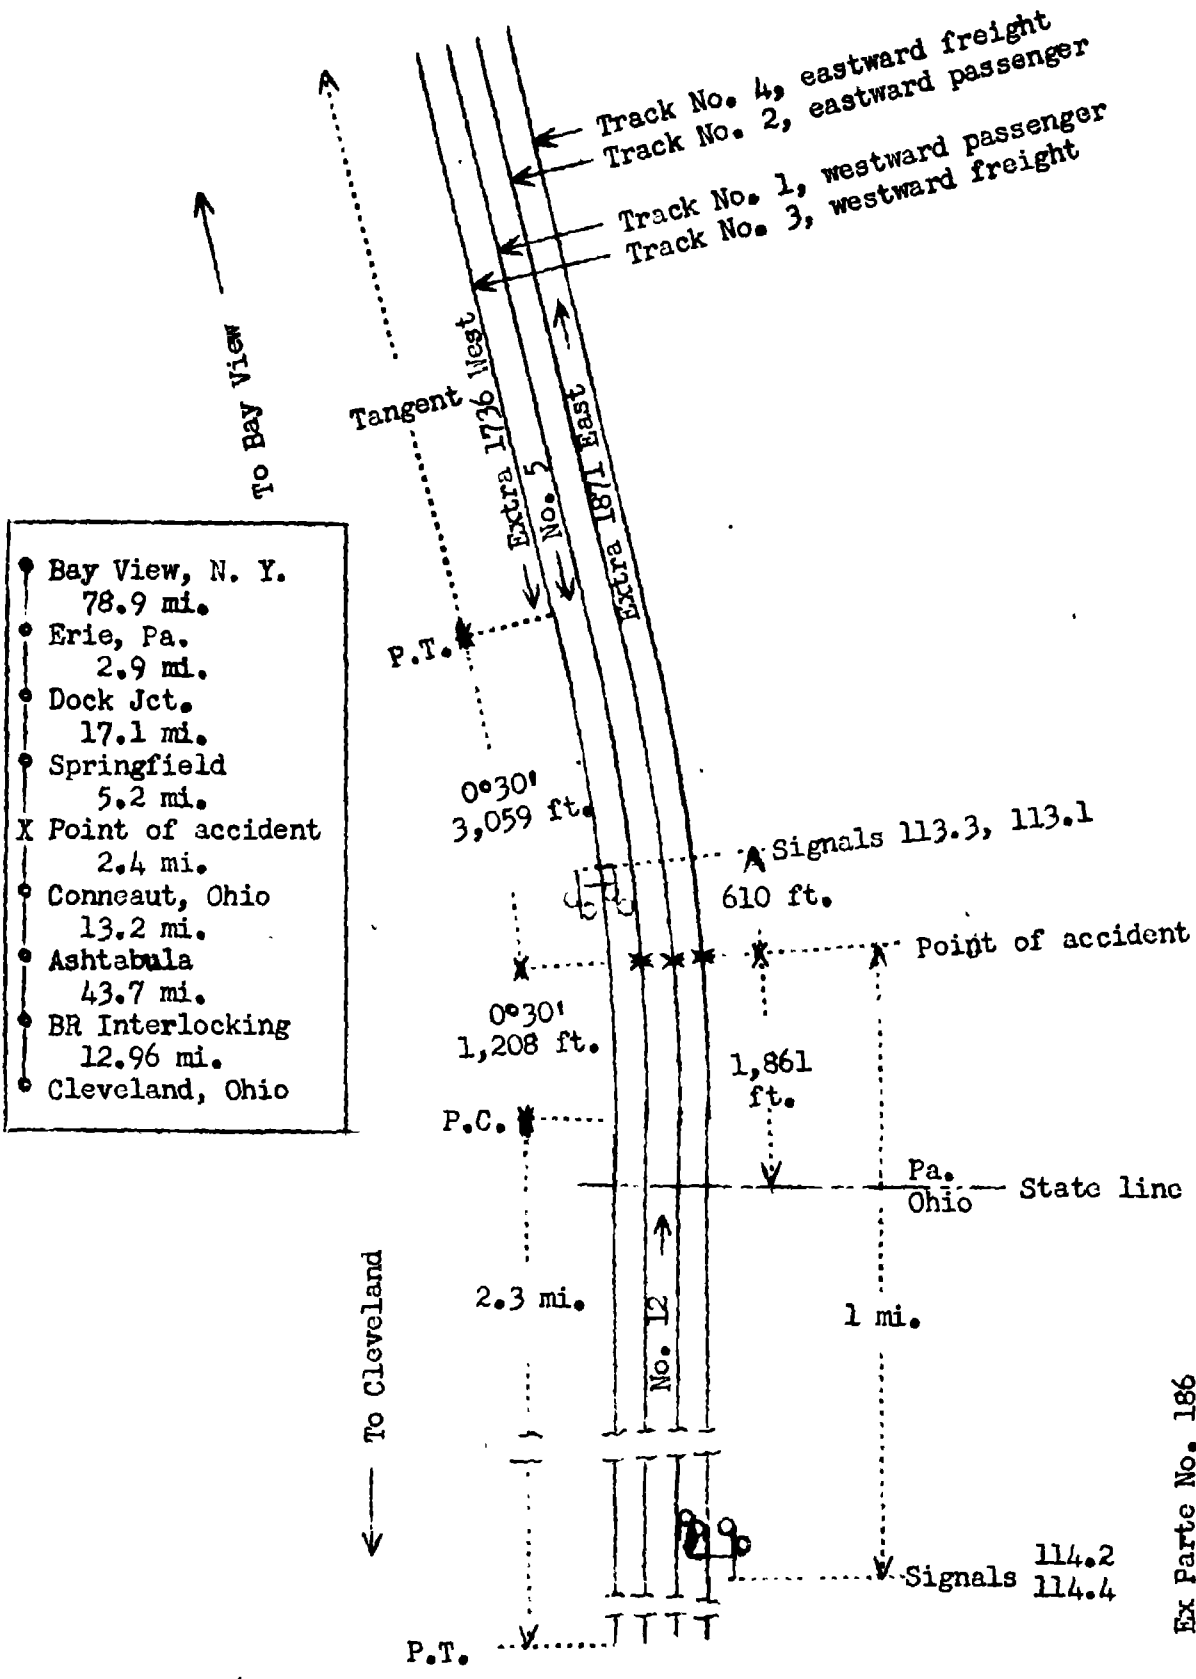
Ex Parte No. 186
 New York Central Railroad
 Near Conneaut, Ohio
 March 27, 1953

The four tracks were destroyed throughout a distance of approximately 200 feet. Six pieces of pipe which had fallen from Extra 1871 East were found in the wreckage at the point of accident and three pieces of pipe were found on the track structure at a point approximately 2 miles east of the point of accident. Examination of Baltimore and Ohio 254645

disclosed that three pieces of pipe were missing from both the seventh and eighth layers, two pieces from the sixth layer, and one piece from the fifth layer on the north side of the car. The side stakes on the north side of the car were broken off flush with the top of the car side. The top portion of the stake nearest the front end of the car was suspended from the high tension band to which it was fastened but the tops of the other stakes on the north side of the car were missing. All stakes on the south side of the car, except the stake nearest the front end, were broken at the top, apparently, as a result of inward pressure on the high tension bands as the lading shifted and fell from the opposite side of the car. The top high tension band was missing at each stake location except on the pair of stakes at the front end of the car. The intermediate high tension bands had slipped and separated and only the high tension bands which extended through the load immediately above the top of the car sides held. All high tension bands which encircled the load had slipped and separated. All seals except one were missing from the encircling bands and the seal which remained was not properly crimped. Three seals, none of which had been crimped properly, were found on the high tension bands. All other seals were missing or covered by the load. Four of the high tension bands bore indications of slight crimping where a seal had been applied and had slipped but the other bands showed no indications of crimping. Loading inspectors from the Association of American Railroads examined the car and found that it had been loaded in conformity with the loading specifications in all respects except that the high tension bands securing the load had not been properly sealed. They examined the seals which remained on the car and were accessible for inspection and found that none had been crimped properly to provide 25 percent of the load strength of the band, as required by the loading rules. It was their opinion that because of the faulty application of the seals, the high tension bands had loosened during the movement of the car and the load had shifted sufficiently to exert excessive pressure on the side stakes which then broke on the north side of the load and permitted part of the lading to fall from the car. A fresh batter mark, evidently caused by contact with a heavy metallic object, was found at the corner of the end sill on the north side of the car at the west end. No other defective condition of the car or load was found.

When the pipe fell from the car one piece became wedged between the track structure of track No. 1 and Canadian National 487579, the next car. As the train was proceeding at a speed of 36 miles per hour the resultant thrust transmitted by the pipe to track No. 1 moved track No. 1 northward a distance of about 18 inches before the pipe fell clear of the cars. The damaged condition of the track was not observed before No. 5 arrived at the point of accident. Canadian National 487579 is an all-steel box car with corrugated ends. It was loaded with wire nails and destined to Albany, N. Y. This car was inspected at Albany on March 31, 1953 by members of the mechanical force of the carrier. The inspection disclosed that the front end of this car bore marks which indicated that it had been in contact with a piece of the pipe which had fallen to the track structure at the scene of the accident from the preceding car. A triangular shaped indentation in the corrugated metal extended horizontally inward from a point 1 foot 6-1/2 inches from the north side of the car at the front end. The depression was 1 foot 10 inches long, and 3 inches and 7-1/4 inches high at the outer and inner ends, respectively. The bottom of the indentation was 6-3/4 inches above the bottom of the end sheet of the car. The depression had a maximum depth of 5 inches from a plane over the corrugations and evidently was caused by contact with the periphery of a metallic object of approximately the diameter of the steel pipe. There were two smaller marks above and

1. The lading of Baltimore and Ohio 254645 was not properly secured for movement when loaded because the high tension bands were not properly sealed.

3. Because the lading was not properly secured, a portion fell from the car while in transit, damaged the westward passenger track sufficiently to cause the derailment of No. 5 which in turn caused the derailment of Extra 1736 West.
