REPORT NO. 3441
THE NEW YORK CENTRAL RAILROAD COMPANY
IN RE ACCIDENT
AT GRAND CENTRAL TERMINAL,
NEW YORK, N. Y., ON
NOVEMBER 22, 1951

Location: Grand Central Terminal,
New York, N. Y.

Kind of accident: Side collision

Accident at Grand Central Terminal, New York, N. Y., on
November 22, 1951, caused by failure to operate
Extra N.H. 4260 West in accordance with a signal
indication.

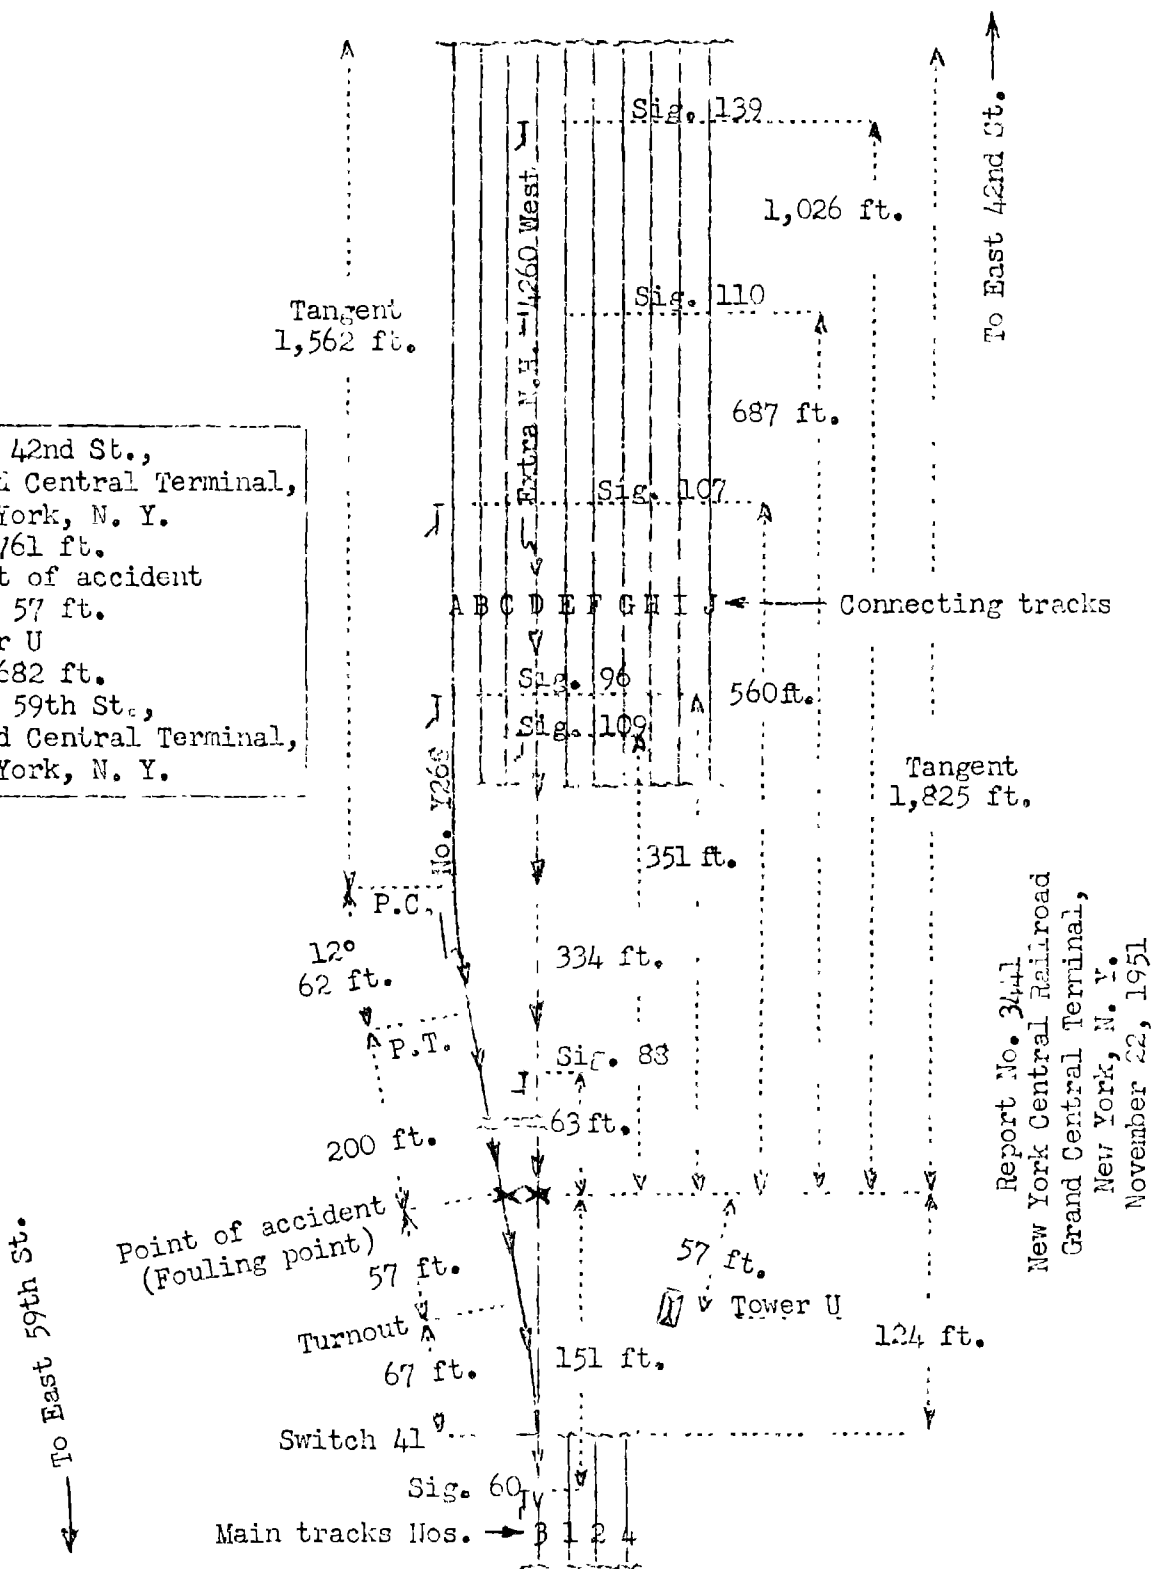
- o East 42nd St.,
Grand Central Terminal,
New York, N. Y.
3,761 ft.
- X Point of accident
57 ft.
- o Tower U
682 ft.
- o East 59th St.,
Grand Central Terminal,
New York, N. Y.

Interlocking signals 107 and 96, governing west-bound movements on track A, are located, respectively, 560 feet and 351 feet east of the point of accident. Interlocking signals 139, 110, 109 and 88, governing west-bound movements on track D, are located, respectively, 1,026 feet, 687 feet, 334 feet and 63 feet east of the point of accident. Interlocking signal 60, governing west-bound movements on track No. 3, is located 151 feet west of the point of accident. These signals are dwarf signals of the one-arm upper quadrant semaphore type. They are continuously lighted by two 20-watt lamps connected in parallel. Signals 107, 96, 139, 110, 109 and 88 displays two aspects and signal 60 displays three aspects. Because of the restricted view, a signal of the color-light type is located on the wall directly opposite signal 60 and repeats the indication of that signal. The aspects applicable to this investigation and their corresponding indications are as follows:

No. Y268 stopped with the front end of the second car about 35 feet west of signal 60 on track No. 3. The third car was derailed and stopped about 109 feet west of the point of collision. It leaned to the north at an angle of about 60 degrees and against the north wall of the terminal structure. The front truck of the fourth car was derailed to the north. The third car was badly damaged and the fourth car was slightly damaged. The front truck of the first car of Extra N.H. 4260 West was derailed and stopped with the front end of the car about 78 feet west of the point of collision and wedged between the third car of No. Y268 and the curtain wall on the south side of the track. The front end of the first car of Extra N.H. 4260 West was badly damaged. No other equipment of either train was derailed or damaged.
