## INTERSTATE COMMERCE COMMISSION

REPORT OF THE DIRECTOR OF THE BUREAU OF SAFETY IN RE  
INVESTIGATION OF AN ACCIDENT WHICH OCCURRED ON THE  
NEW YORK CENTRAL RAILROAD AT MAPES, PA., ON SEPTEMBER 29, 1931.

Inv. No. 1726  
New York Central R. R.  
Harpes, Pa.  
September 2, 1951

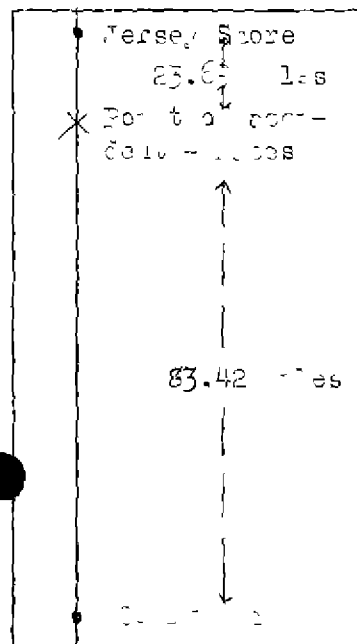
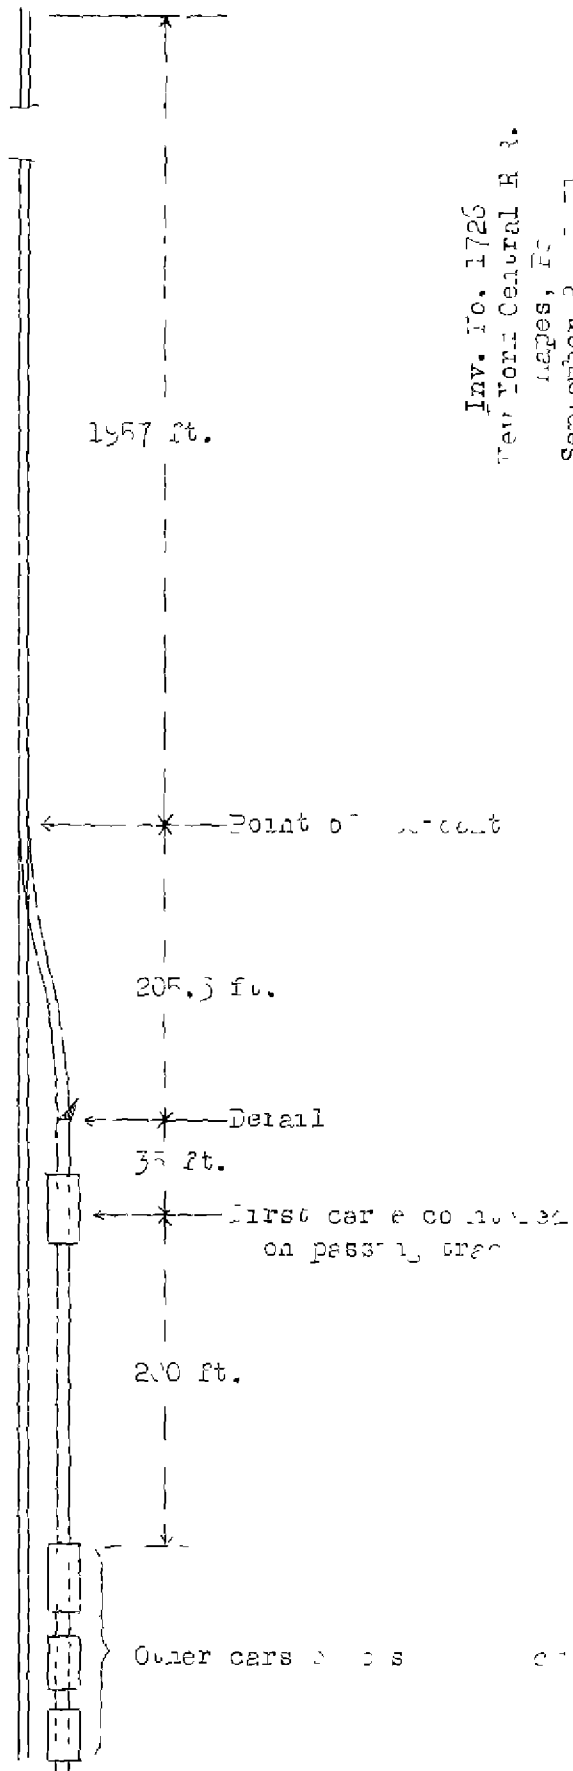
The switch at which this accident occurred is a facing-point switch for westbound trains and leads off the main track through a No. 10 turnout to the left or south. The switch stand is of the Ramapo No. 31 type and is located on the north side of the main track, it is equipped with a semaphore target, 7 feet 11 inches above the top of the rail, and a switch lamp, the center of the lens being 9 feet 6 inches above the top of the rail. The track is laid with 105-pound rails, 30 and 33 feet in length, with an average of from 16 to 18 hardwood ties to the rail-length, single-spiked, fully tie-plated, and ballasted with crushed rock to a depth of 2 feet. The track is well maintained. A split-point derail is located on the passing track at a point 205.5 feet west of the switch

Engine 5108 stopped on the passing track at a point 578 feet beyond the switch, with its pony-truck wheels and all wheels on the right side derailed. It had been partly derailed at the switch, and then, after colliding with a flat car loaded with rails standing on the passing track 35 feet west of the derail, it had continued until it encountered some stored cars about 200 feet farther west, resulting in four of these cars being derailed and demolished and engine 5108 badly damaged. The first car in extra 5108 remained coupled to the tender with the front wheels of the forward truck derailed. The employees killed were the fireman and a brakeman, and the employee injured was the engineman.

This accident was caused by a cocked switch, which had been mischievously tampered with by two young boys

Examination of the switch stand after the occurrence of the accident showed it lined for the passing track and the lock lying on the ground beside the switch block. The marks on the north or right switch point, rails, and ties, indicated that the right pony-truck wheel of engine 5108 caught the switch point, causing this pair of wheels to straddle the points, while the following wheels of the engine caught the switch points in such a manner as to set the switch for the turnout, throwing the switch points all the way over, and forcing the lever down into the socket of the switch stand. Two young boys, one 11 and the other 9 years of age, had been playing with the switch to find out how it worked. They found the lock in the staple not securely closed, took it out and raised the lever, but were unable to throw the switch over entirely; they then tried to replace the lever as they found it, but were unable to do so, and returned to their home nearby, the accident occurring very soon thereafter
