INTERSTATE COMMERCE COMMISSION

REPORT NO. 3416

THE NEW YORK CENTRAL RAILROAD COMPANY

Accident (derailment) near Muncie, Ind., on June 10, 1951,
caused by failure of a driving wheel on a Diesel-electric
locomotive unit.

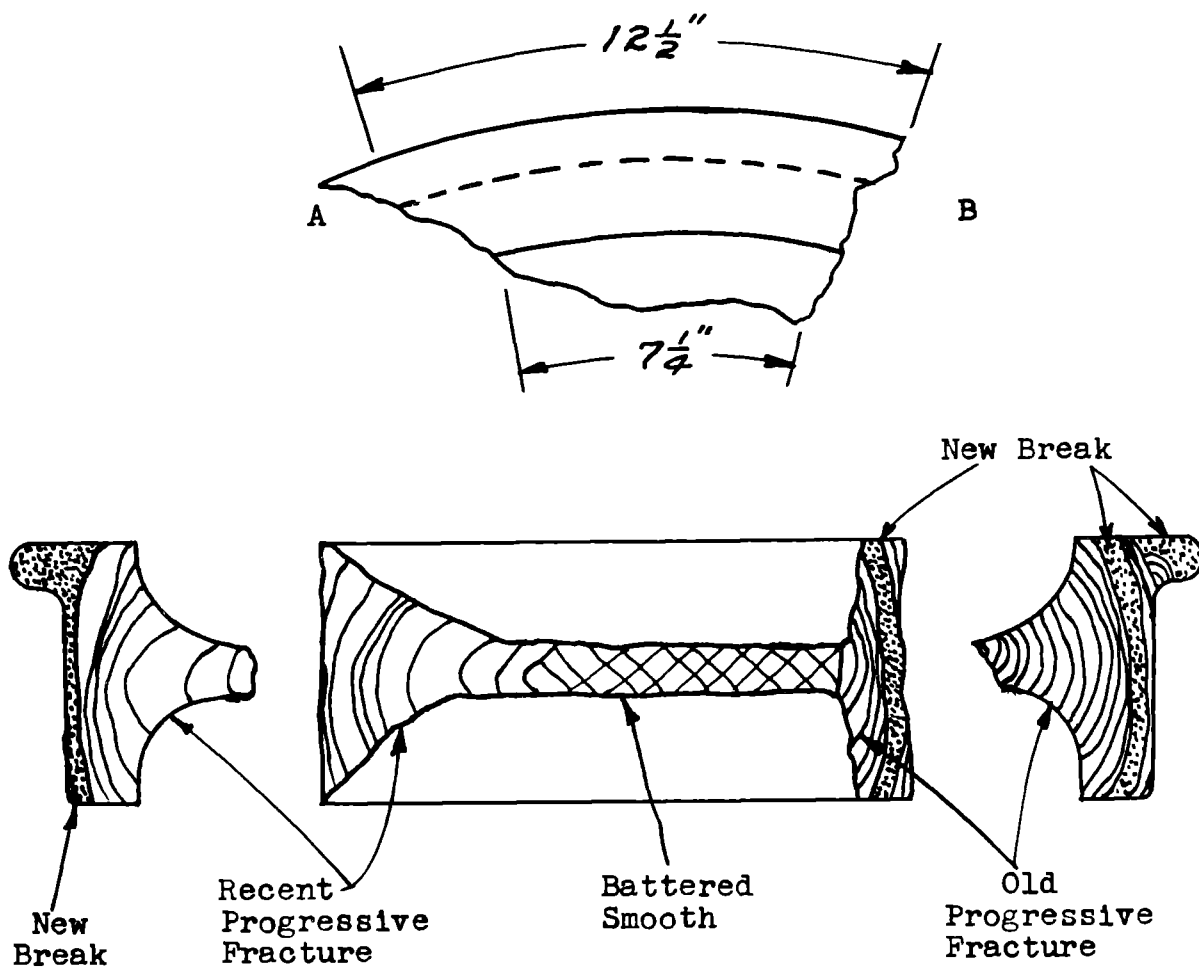
Sketch B shows outline of the piece of the wheel that was not recovered. Character of fracture was determined by adjoining parts that were available for examination. Fracture at the plate was irregular with surface showing old progressive fracture with lines of progression battered smooth. Fracture surface at one end showed very recent progressive fracture extending to within about 1/4 inch of surface of tread. Fracture surface at other end showed progressive fracture extending toward the tread to within 3/4 inch of the surface, a band of new break area about 1/2 inch wide, and progressive fracture about 1/4 inch wide to the tread of the wheel.

It is found that this accident was caused by failure of a driving wheel under a Diesel-electric locomotive unit, resulting from progressive fracture in the plate section.

Sketch B - Broken 36" MW Wrot Steel Wheel from Location B4,
DPB 4112, which Caused Derailment in Train 41 at Hart, Indiana,
June 10, 1951.

It is recommended that this carrier promptly arrange to have wheels on Diesel-electric locomotive units cleaned and carefully inspected at maintenance terminals at the end of each trip, and that locomotive units also receive inspection of running gear at all points where air brake tests are required to be made.

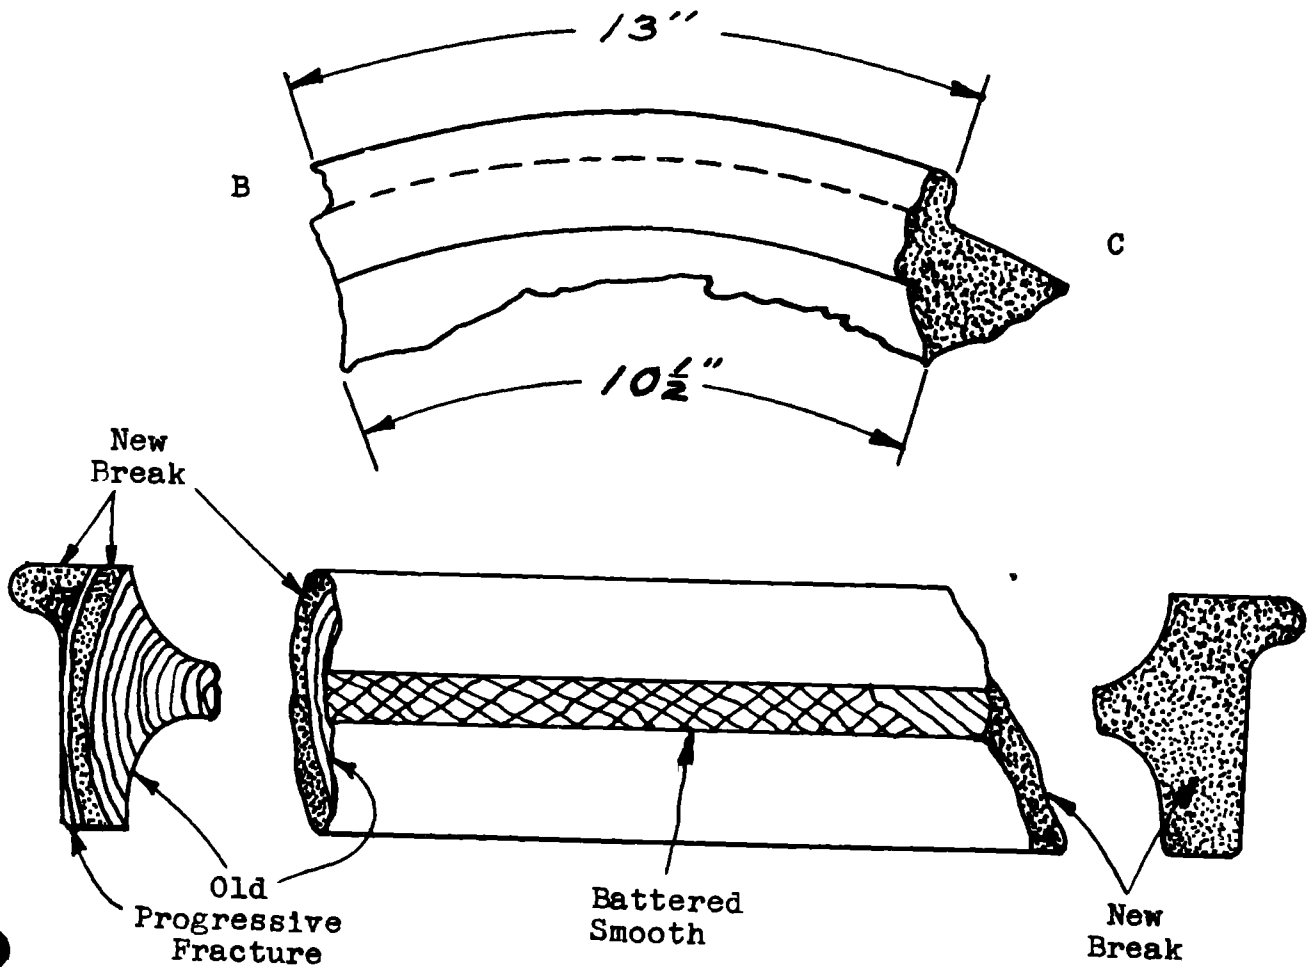
Sketch C shows details of portion of the wheel which measured 13 inches on tread and 10 1/2 inches at plate. Frac-

ture surface at plate was irregular and showed old progressive fracture with lines of progression battered smooth. Fracture surface at one end showed progressive fracture extending to within about $3/4$ inch of the tread, a band of new break about $1/2$ inch wide, and then progressive fracture area about $1/4$ inch wide extending to the tread of the wheel. Other end of this portion showed all new break with no indication of progressive fracture.

Sketch C - Broken 36" MW Wrot Steel Wheel from Location B4,
DPB 4112, which Caused Derailment in Train 41 at Hart, Indiana,
June 10, 1951.
Examined at Hart, Indiana, June 10, 1951.
Material - Heat Treated Wrot Steel

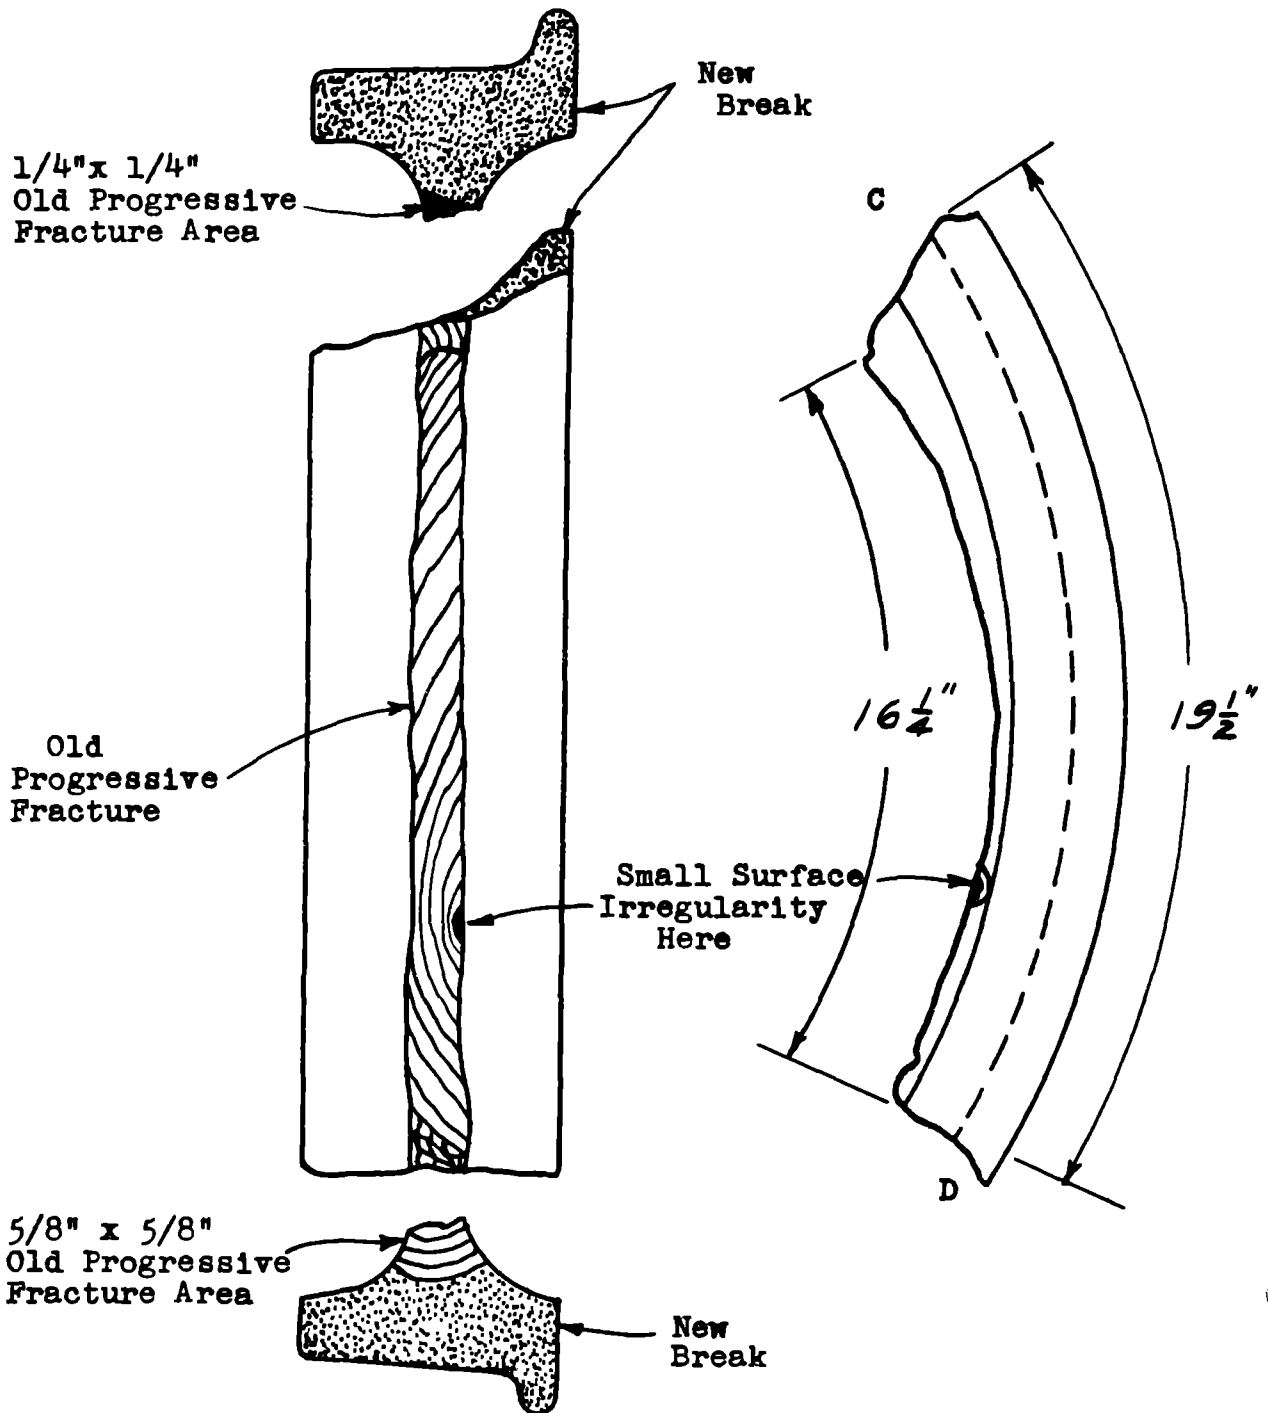
Sketch D shows portion of the wheel which measured $19\frac{1}{2}$ inches on tread and $16\frac{1}{4}$ inches at the plate. Fracture at the plate was relatively smooth and showed an old progressive fracture originating on the inside surface of the plate in a surface irregularity, the nature of which was not determined by visual examination. The regularity of fracture through the plate at this location indicated that this could have been the primary failure. Fracture surface at one end showed all new break except a small progressive fracture area about $1/4$ inch x $1/4$ inch extending upward from the plate at the outer edge. Fracture surface at other end showed about $5/8$ inch progressive fracture area extending toward the tread and remainder a new break.

Sketch D - Broken 36" MW Wrot Steel Wheel from Location B4,
DPB 4112, which Caused Derailment in Train 41 at Hart, Indiana,
June 10, 1951, Examined at Hart, Indiana, June 10, 1951.
Material - Heat Treated Wrot Steel

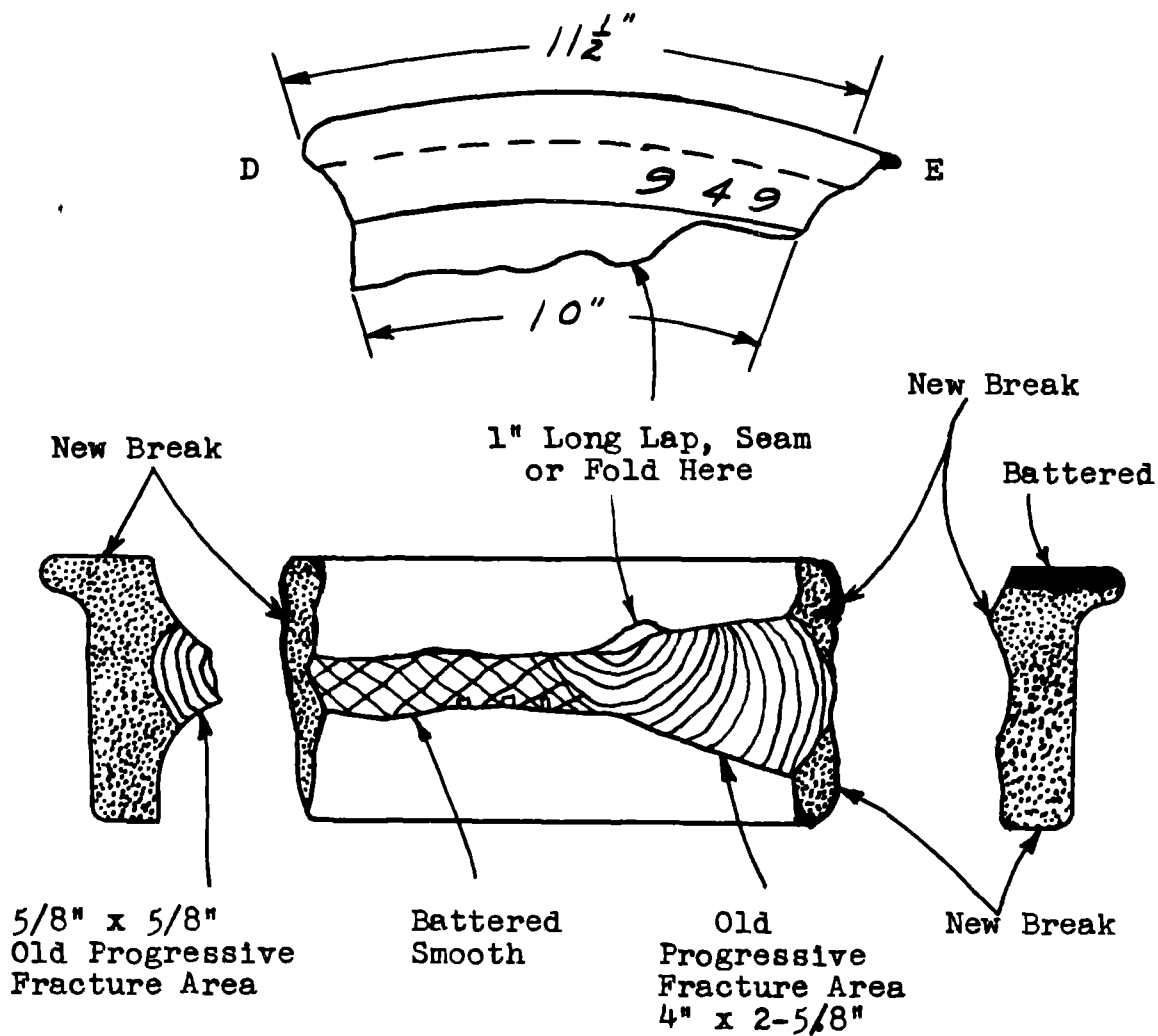
Sketch E shows portion of the wheel which measured $11\frac{1}{2}$ inches on tread and 10 inches at the plate. Fracture surface at the plate was irregular with an old progressive fracture area about 4 inches long and $2-5/8$ inches wide at one end which appeared to have originated at a 1 inch long lap, fold, or scar in the metal on the inside surface of the plate. Remainder of fracture in the plate showed old progressive fracture with lines of progression battered smooth. Fracture surface at one end showed progressive fracture area extending about $5/8$ inch toward the tread with remainder a new break. Other end of this portion showed all new break with inside area battered.

Sketch E - Broken 36" MW Wrot Steel Wheel from Location B4, DPB 4112, which Caused Derailment in Train 41 at Hart, Indiana, June 10, 1951. Examined at Hart, Indiana, June 10, 1951. Material - Heat Treated Wrot Steel
