INTERSTATE COMMERCE COMMISSION

REPORT OF THE DIRECTOR OF THE BUREAU OF SAFETY CONCERNING AN
ACCIDENT ON THE NEW YORK CENTRAL RAILROAD AT PLEASANTVILLE,
OHIO, ON DECEMBER 10, 1932.

January 19, 1933.

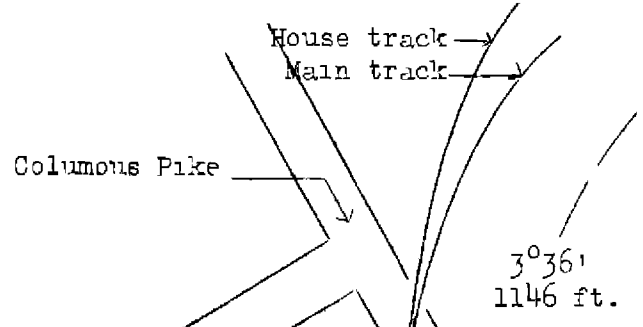
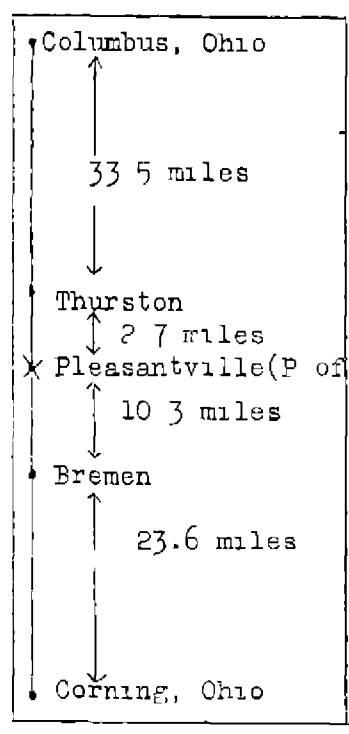
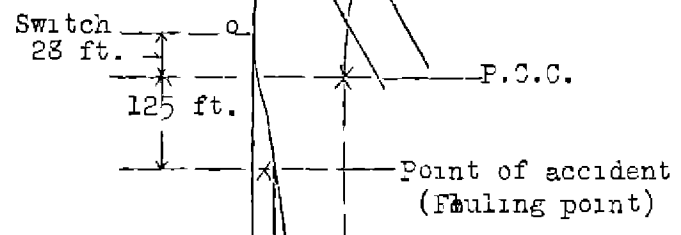
Inv No 1797
New York Central P R.
Pleasantville, Ohio
December 10, 1932

at Pleasantville. Extra 18 departed from Thurston at 11 16 p.m., according to the train sheet, and on arrival at Pleasantville it pulled in and stopped behind engine 7980, with the rear four cars and caboose extending out upon the main track, while standing in this position they were struck by train third No. 91.

Engine 87 was not derailed, but it derailed and overturned the fourth, third and second cars ahead of the caboose in extra 18, and then coupled into the first car ahead of the caboose and shoved that car and the caboose backward about six car-lengths. The employees injured were the engineman and fireman of train third No. 91, who jumped just before the accident.
