INTERSTATE COMMERCE COMMISSION

REPORT OF THE DIRECTOR OF THE BUREAU OF SAFETY IN RE INVESTIGATION OF AN ACCIDENT WHICH OCCURRED ON THE NEW YORK CENTRAL RAILROAD AT RICHARDS, OHIO, ON MAY 8, 1931

JULY 27, 1931

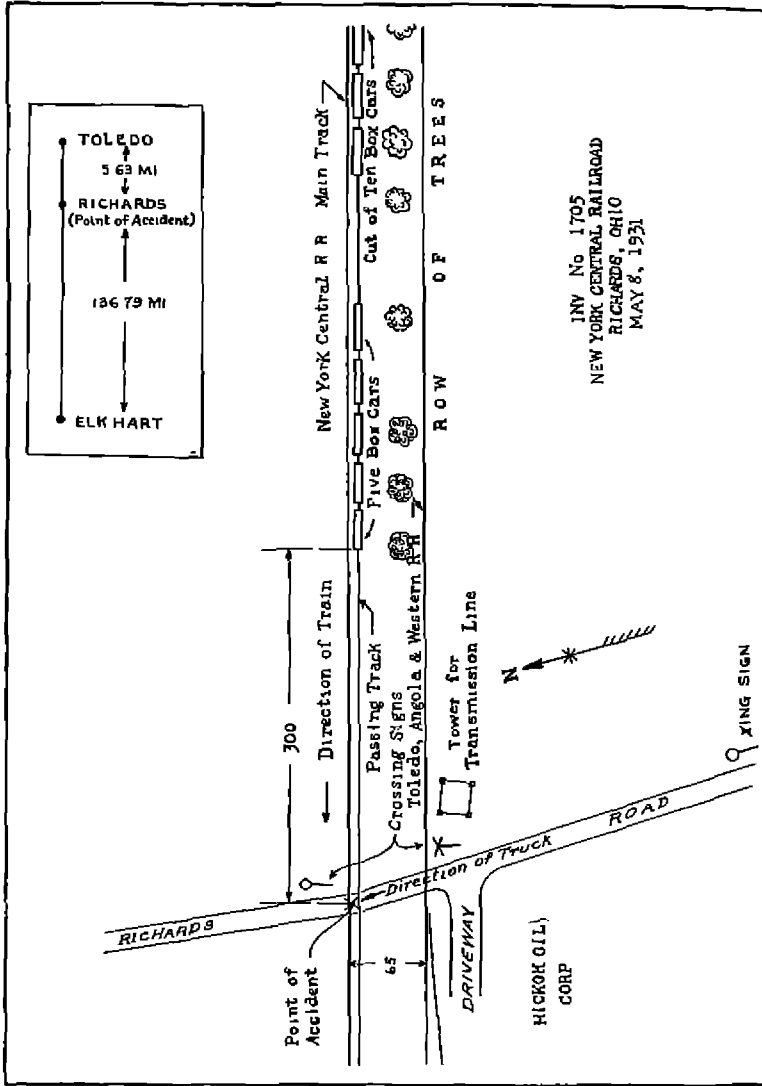
FIGURE 1—Track layout and other physical conditions as they existed at time of accident

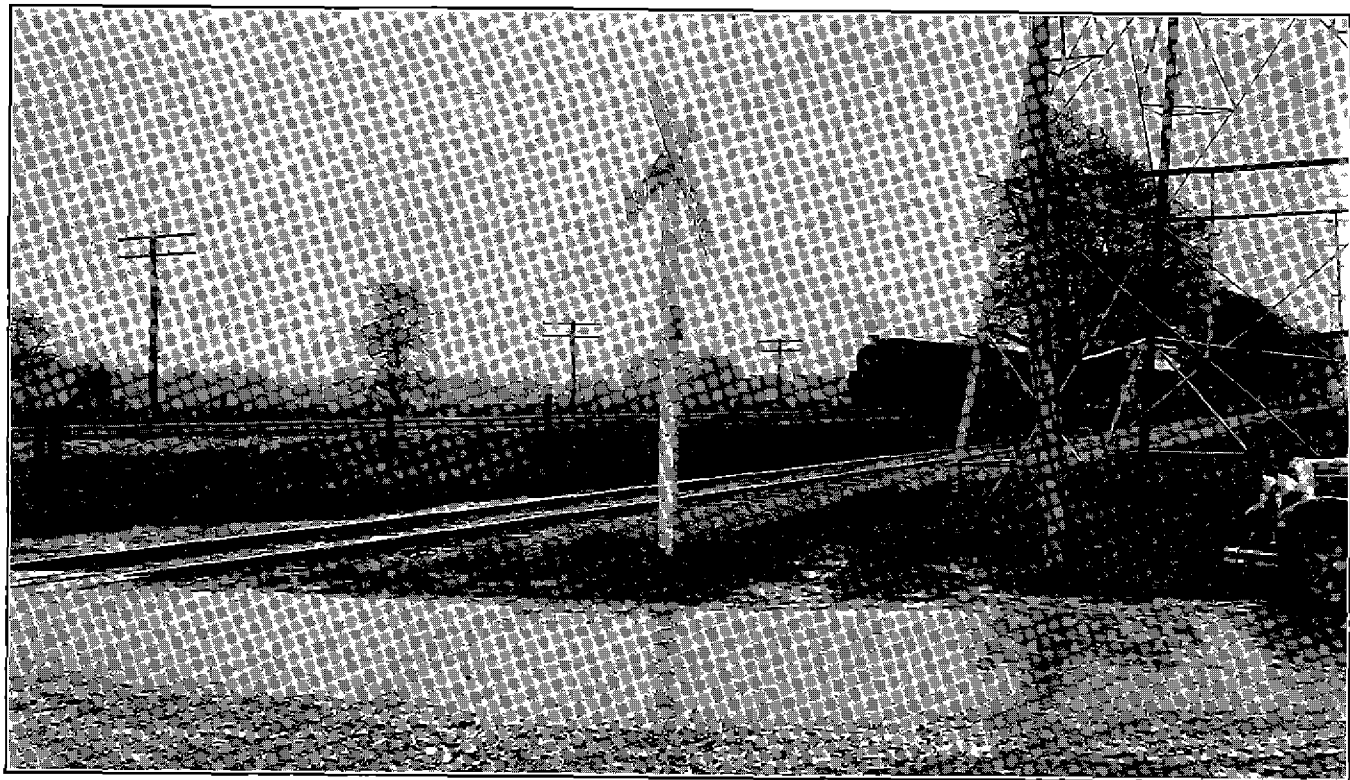
FIGURE 2—View from Hickok Oil Corporation plant driveway showing higaway and engine on New York Central track east of crossing, almost completely obscured by cars standing on passing track

On account of the box cars standing on the passing track and the row of trees, the view of the approaching westbound train on the track of the New York Central Railroad was almost entirely obscured from the driver of the northbound automobile tank truck on the highway, from a point about 75 feet south of the New York Central crossing until a point about 18 feet south of that crossing was reached, or until such train appeared from behind the west end of the cars.

According to the record, movements over this crossing average about 11 trains and 400 vehicles daily. While this amount of traffic is relatively light, a considerable number of tank trucks loaded with gasoline pass over this crossing and frequently the view is obstructed, as in this instance, by cars standing on the passing siding. At the time of this accident this crossing was not protected except by fixed signs, the installation of crossing signals to indicate the approach of trains would materially reduce the hazard at this crossing and both the railroad officials and local authorities having jurisdiction should give consideration to the need for such protective devices at this point. Cars left standing on this passing siding should, whenever practicable, be placed at a sufficient distance from the crossing to avoid obstructing the view from the highway of a closely approaching train.

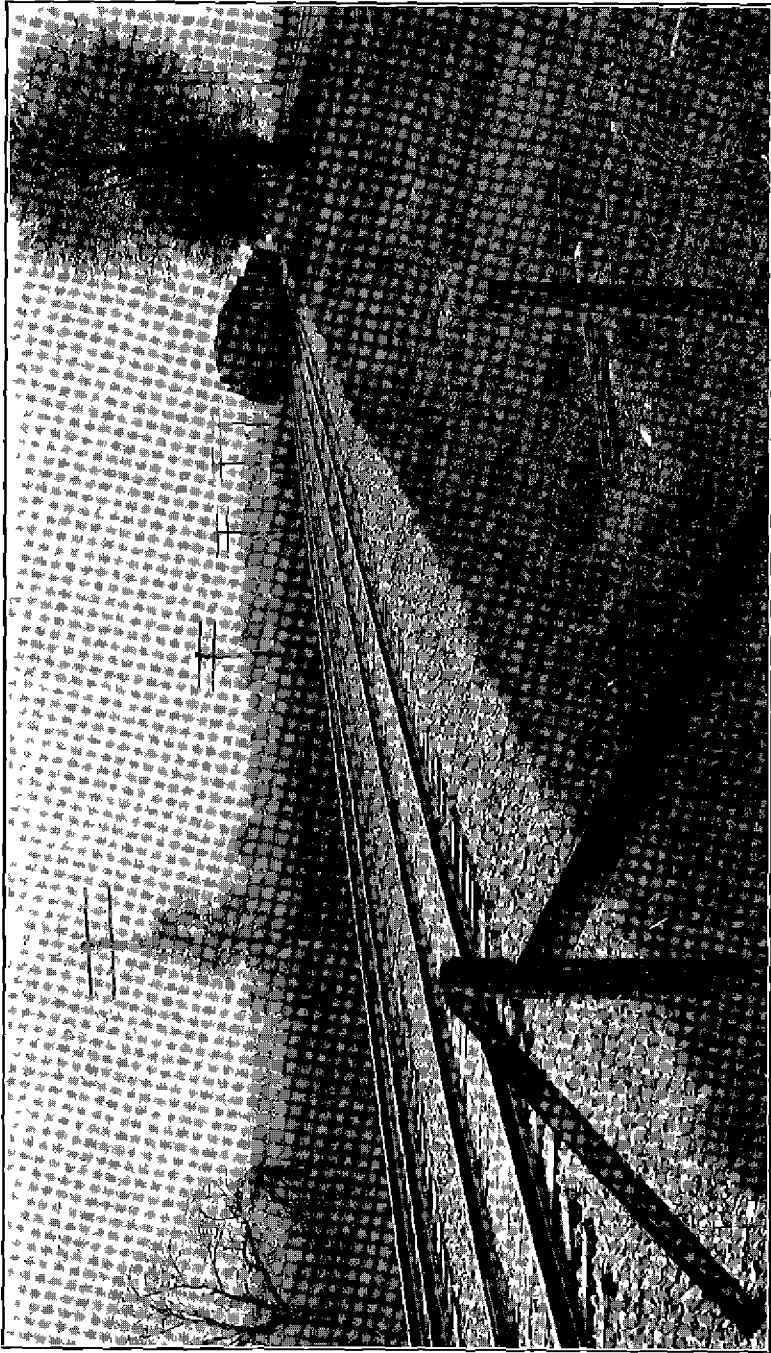
FIGURE 3 --View from center of highway 33 feet south of New York Central main track, looking east
