ACCIDENT ON THE
NEW YORK CENTRAL RAILROAD

SOUTH BEND, IND.

OCTOBER 18, 1940

INVESTIGATION NO. 2154

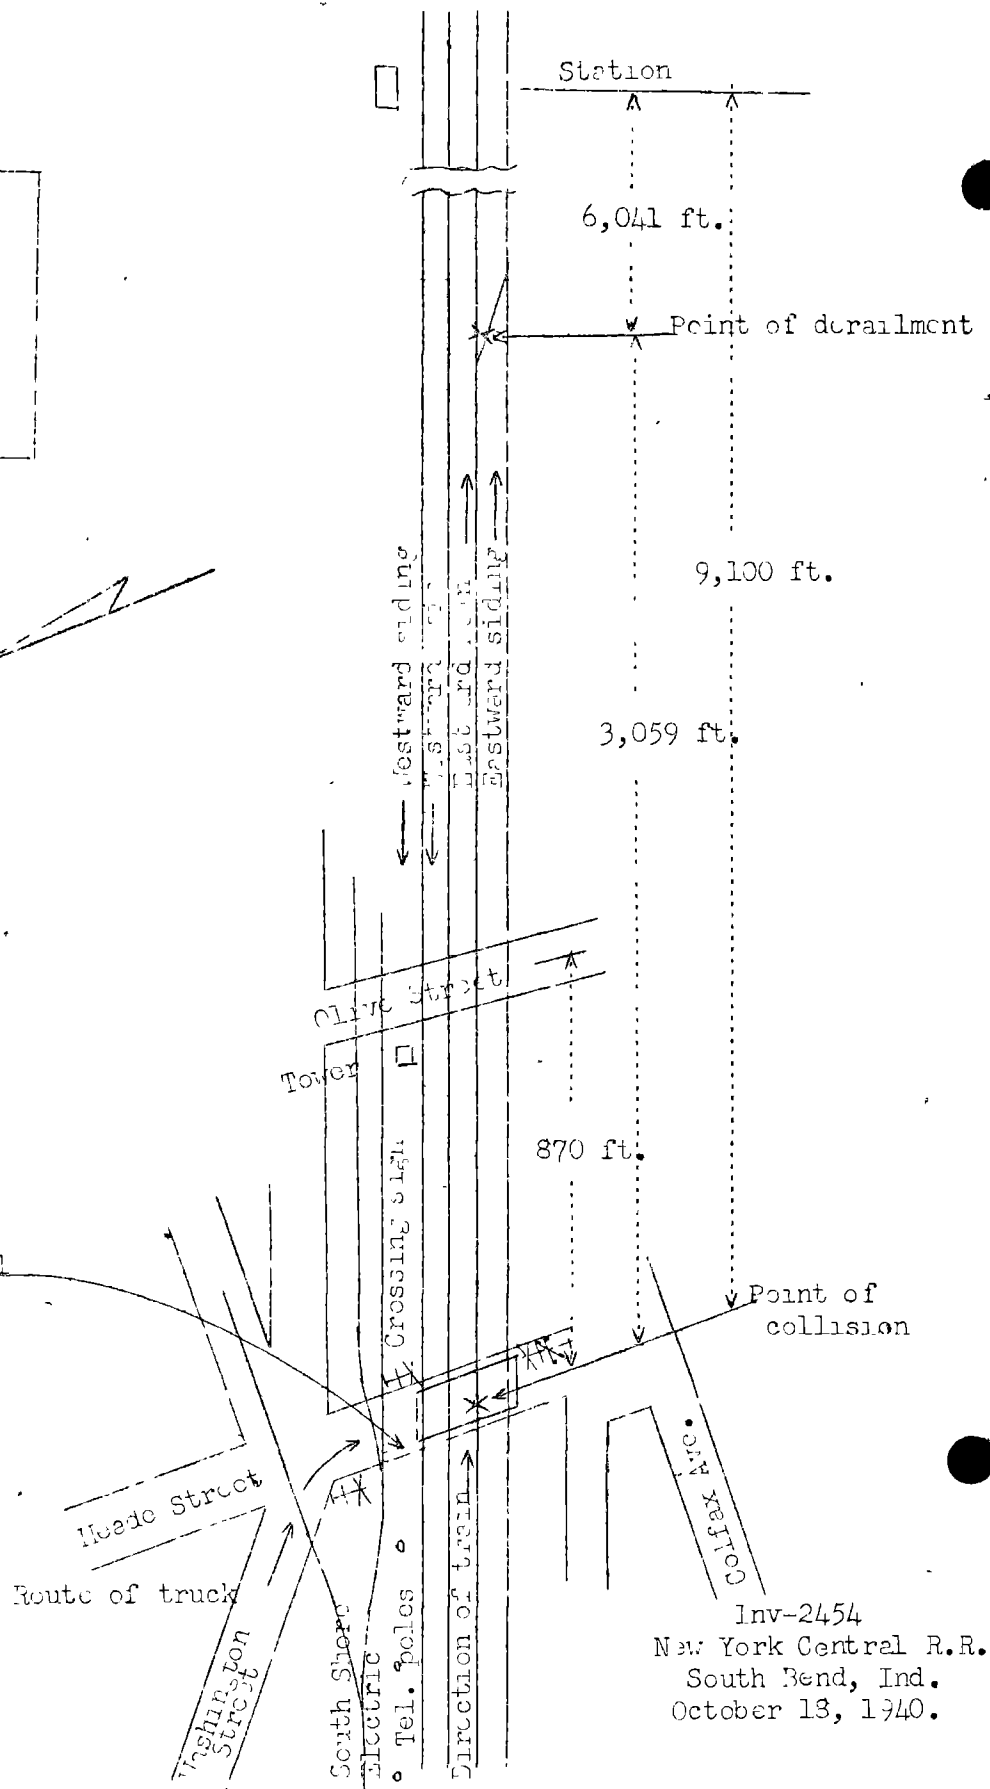
Inv-2454
 New York Central R.R.
 South Bend, Ind.
 October 13, 1940.

The collision with the motor-truck occurred at a point 9,100 feet west of the station, where Meade Street crosses a single-track line of the South Shore Electric Railroad and the two main tracks and the two sidings of the New York Central at an angle of 65 degrees. Washington Street practically parallels the railroad on the north and intersects Meade Street at a point about 150 feet north of the railroad. North of the crossing Meade Street is surfaced with crushed stone and cinders, and between the tracks with crushed stone and macadam. The crossing is 32.5 feet in width. At the crossing over the eastward and the westward sidings there are planks 4 inches by 8 inches by 16 feet on each side of each rail; between the planks inside the rails the surface is of crushed stone and macadam. Over the eastward and the westward main tracks the crossing consists entirely of planks. The minimum distance between track-centers is 13 feet. As the crossing is approached from the north on Meade Street the grade is 5.9 percent ascend-

The New York Central crossing is protected on the north and the south by flashing-light signals. The signal governing south-bound traffic on Meade Street is to the right of the direction of traffic and 13.2 feet north of the north rail of the westward siding. A cross-buck sign is mounted on a mast 11 feet 5 inches above the base, and bears the words "RAILROAD CROSSING;" a horizontal sign beneath the cross-buck bears the word "DANGER." A horizontal bar to which a red light is attached at each end is mounted on the mast 8 feet 1 inch above the base; the lenses are 7-1/4 inches in diameter. The flashing-light signals are controlled by a crossing watchman at Clive Street tower, located 870 feet east of Meade Street. A control circuit which extends 8,049 feet west of the tower actuates a buzzer to warn the watchman of the approach of an east-bound train; the watchman must throw an electric switch to operate the flashing-light signals. In the tower a light bulb is connected to the signal circuit and indicates when the signals are operating.

At Meade Street a row of telegraph poles located between the South Shore Electric and the New York Central tracks interferes to some extent with the view toward the west. As a south-bound vehicle turns into Meade Street from Washington Street the driver can see an east-bound train a distance of 3,000 feet. When the vehicle is 100 feet, 72 feet, and 48 feet, from the center of the eastward main track, an unobstructed view of the track to the west can be had at distances of 3,500 feet, 2,500 feet, and 3,300 feet, respectively.
