INVESTIGATION NO. 2836
THE NEW YORK CENTRAL RAILROAD COMPANY
REPORT IN RE ACCIDENT
NEAR TIADAGHTON, PA., ON
OCTOBER 19, 1944

Railroad: New York Central

Date: October 19, 1944

Kind of accident: Side collision

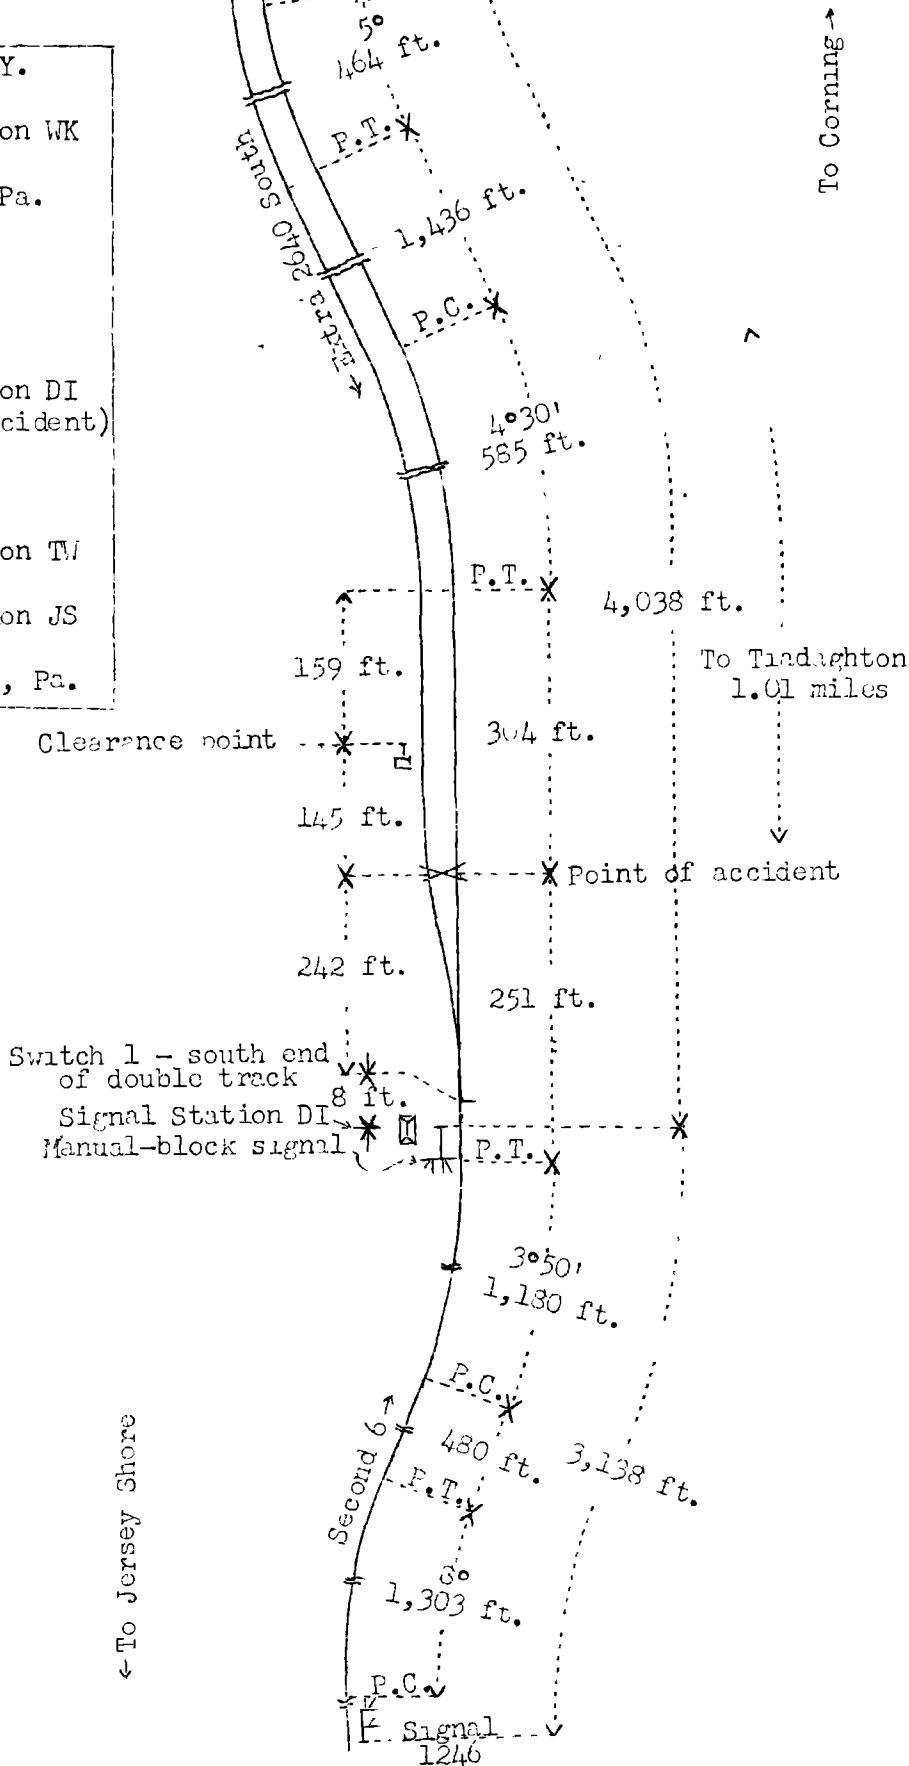
Inv-2836
 New York Central Railroad
 Tiadaghton, Pa.
 October 19, 1944

Signal 1221
 End-of-automatic-block sign 5,958 ft
 Northward main track
 Southward main track
 P.T.
 349 ft.
 P.C.
 5°
 1,464 ft.
 P.T.
 1,436 ft.
 P.C.
 4°30'
 585 ft.

- o Corning, N. Y.
 0.34 mi.
- o Signal Station WK
 30.31 mi.
- o Middlebury, Pa.
 11.84 mi.
- o Ansonia
 9.03 mi.
- o Tiadaghton
 1.01 mi.
- x Signal Station DI
 (Point of accident)
 7.09 mi.
- o Blackwell
 33.21 mi.
- o Signal Station TW
 2.35 mi.
- o Signal Station JS
 1.65 mi.
- o Jersey Shore, Pa.
