REPORT NO. 3393  
THE NEW YORK CENTRAL RAILROAD COMPANY  
IN RE ACCIDENT  
AT TRENTON, MICH., ON  
MARCH 15, 1951

Accident at Trenton, Mich., on March 15, 1951, caused  
by a broken rail.

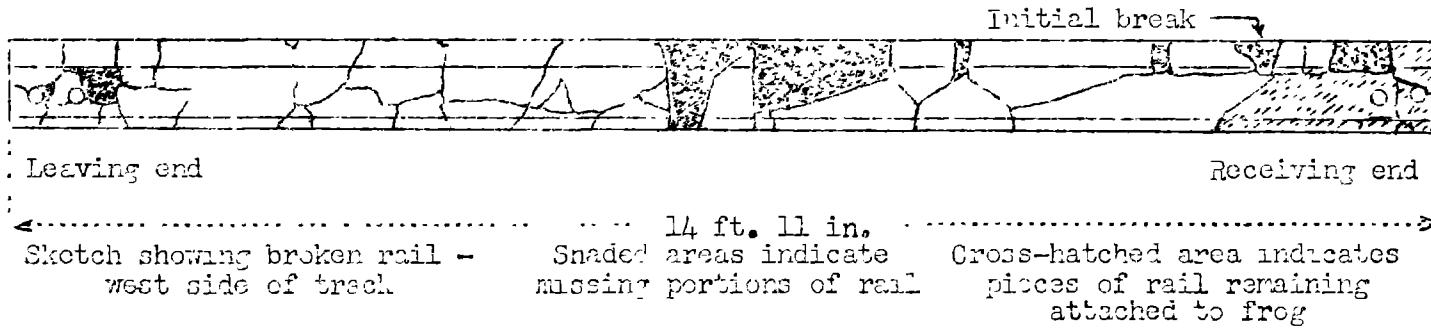
Sketch of end view showing vertical split-head fracture

The defective rail was rolled in March, 1925, by the Illinois Steel Company and bore heat number 2135, letter A. It was laid in the main track of the D. & T.S.L. in 1925 and was removed from the D. & T.S.L. track after 1939 to provide a stock of rail suitable for rail replacement in main tracks. It was installed as a closure rail in the N.Y.C. crossing at Trenton in April, 1947. Under an arrangement between the two carriers, the D. & T.S.L. maintains the crossing in question. The rail in the southward main track of the N.Y.C. in the vicinity of the point of accident was laid new in 1948, and a rail-defect detector car has not been operated over the southward main track since that time.
