REPORT OF THE DIRECTOR OF THE BUREAU OF SAFETY CONCERNING AN
ACCIDENT ON THE NEW YORK CENTRAL RAILROAD AT WEEHAWKEN,
N. J., ON FEBRUARY 21, 1934.

April 26, 1934.

Inv. No. 1893
New York Central R.R.,
Weehawken, N.J.
Feb. 21, 1934

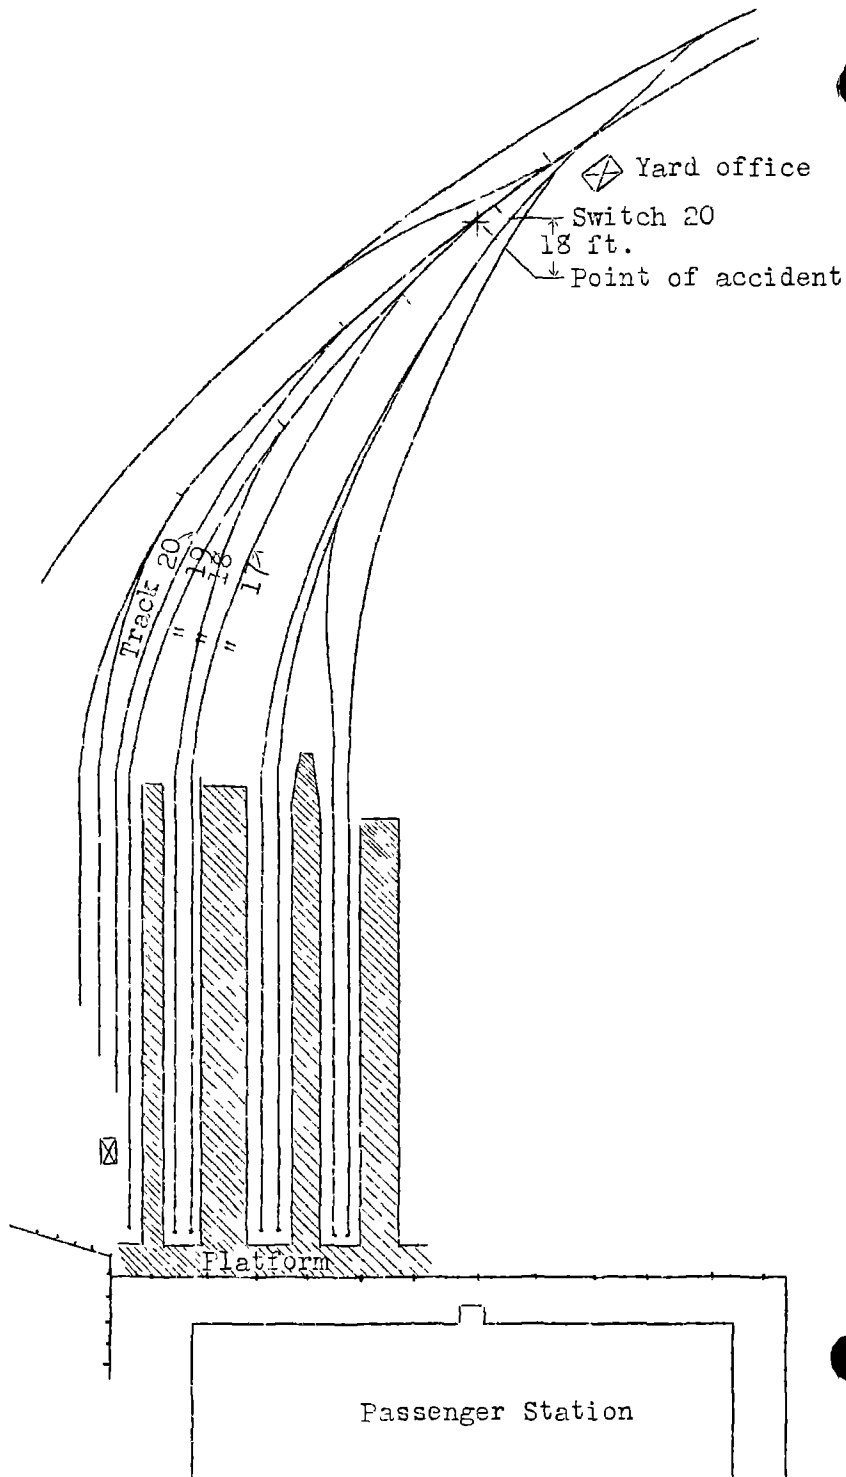
Only the forward truck of the lead car was derailed and it ran a distance of 148 feet after being derailed. The employee killed was a brakeman, who had been riding on the forward end of the lead car and who apparently was thrown or fell off and under the car.

This accident was caused by the damaged condition of a facing-point switch, which had been run through by a previous movement.
