ACCIDENT ON THE
NEW YORK CENTRAL RAILROAD

WICKLIFFE, OHIO

JANUARY 19, 1940

INVESTIGATION NO. 2409

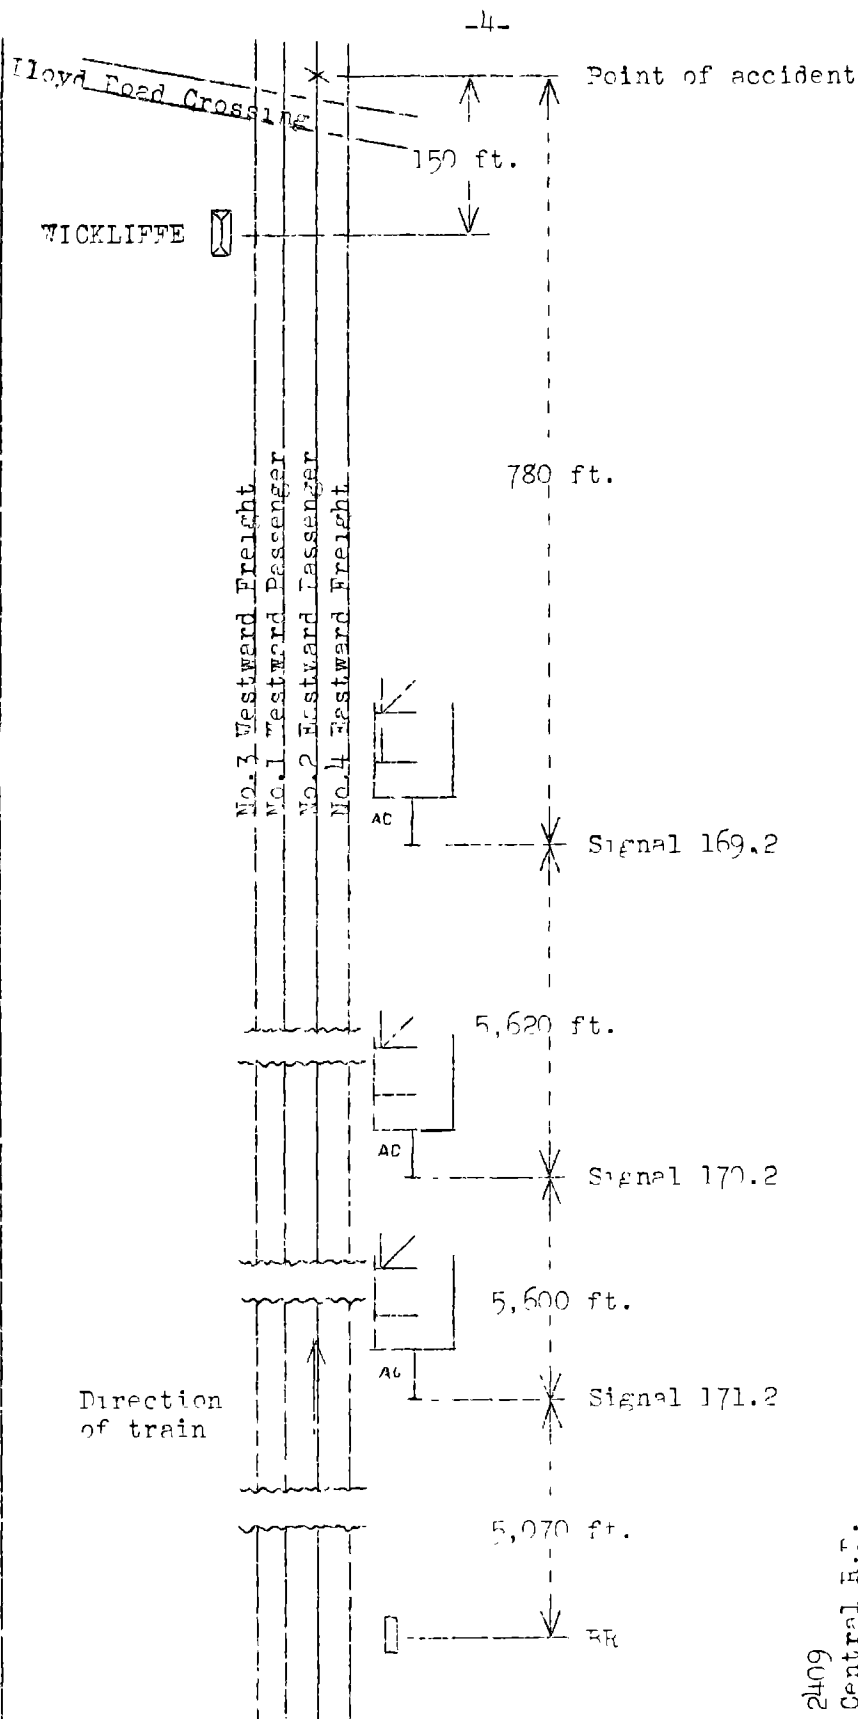
Inv. No. 2409
 New York Central R.R.
 Wickliffe, Ohio
 January 19, 1940

o Buffalo, N.Y.
8.75 mi.
o Bay View
160.32 mi.
o Wickliffe (P. of A.)
3.08 mi.
o BR
3.00 mi.
o Collinwood
9.96 mi.
o Cleveland, Ohio

X Point of accident
780 ft.
o Sig. 169.2
5,620 ft.
o Sig. 170.2
5,600 ft.
o Sig. 171.2
5,070 ft.
o Home Sig. BR
3,565 ft.
o Sig. 173.2
3,835 ft.
o Sig. 174.2
3,650 ft.
o Sig. 175.2
3,840 ft.
o Collinwood
