ACCIDENT ON THE
NEW YORK CENTRAL RAILROAD

YONKERS, N. Y.

APRIL 9, 1938.

INVESTIGATION NO. 2265

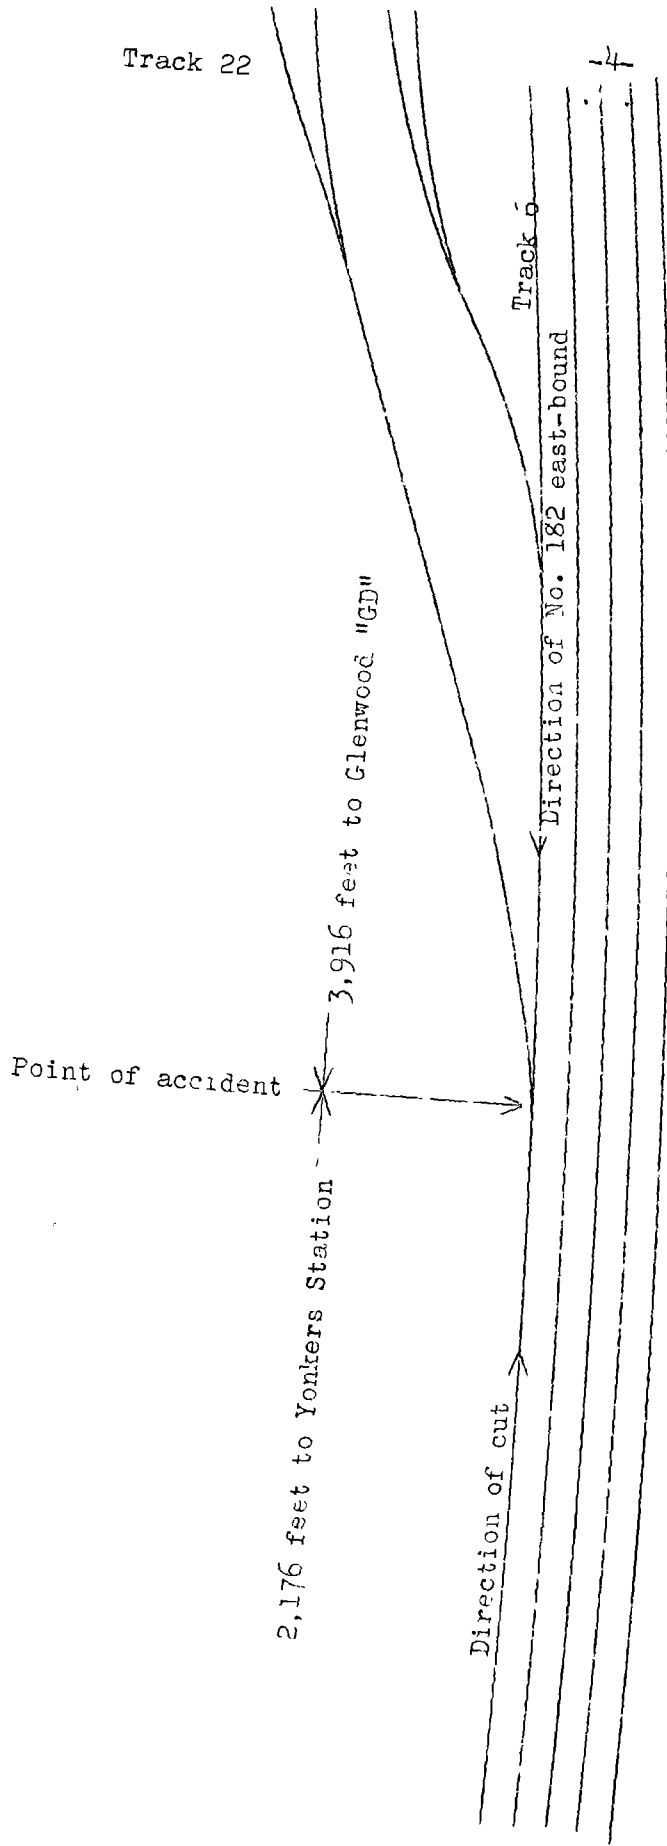
Inv. No. 2265
N. Y. C. R.R.
Yonkers, N.Y.
April 9, 1938

The first mark of derailment was a flange mark on top of the switch stop of the south switch point, 11 feet west of the point of the switch; this mark was followed by wheel and flange marks on the rails, joint-plates and bolts at the heel of the switch point between the switch point and the lead rail. Three feet farther on similar marks appeared between the north switch point and the stock rail of track 6. Flange marks continued along track 6 for 27 feet and then veered sharply to the north. Except for a bent metal switch-stop on the south point, the switch was not damaged, and the stock rails were in good condition. The switch stand and its connecting parts were also in good condition, and it was apparent that no adjustments had been made. Operation of the switch disclosed that the points fitted properly against the stock rails, and that the point would remain open about $\frac{1}{4}$ inch when the hand-throw lever was operated for movement into the lead track but was not latched in position. In this position the target light showed the proper indication for a turnout movement. Inspection of G.P.E.X. 738 disclosed that the center plates

This accident was caused by the separation of a switch point from the stock rail due to the throw lever of the switch stand being unlatched.
