RAILROAD ACCIDENT INVESTIGATION

Report No 3840

THE NEW YORK CENTRAL RAILROAD COMPANY

FEBRUARY 9, 1959

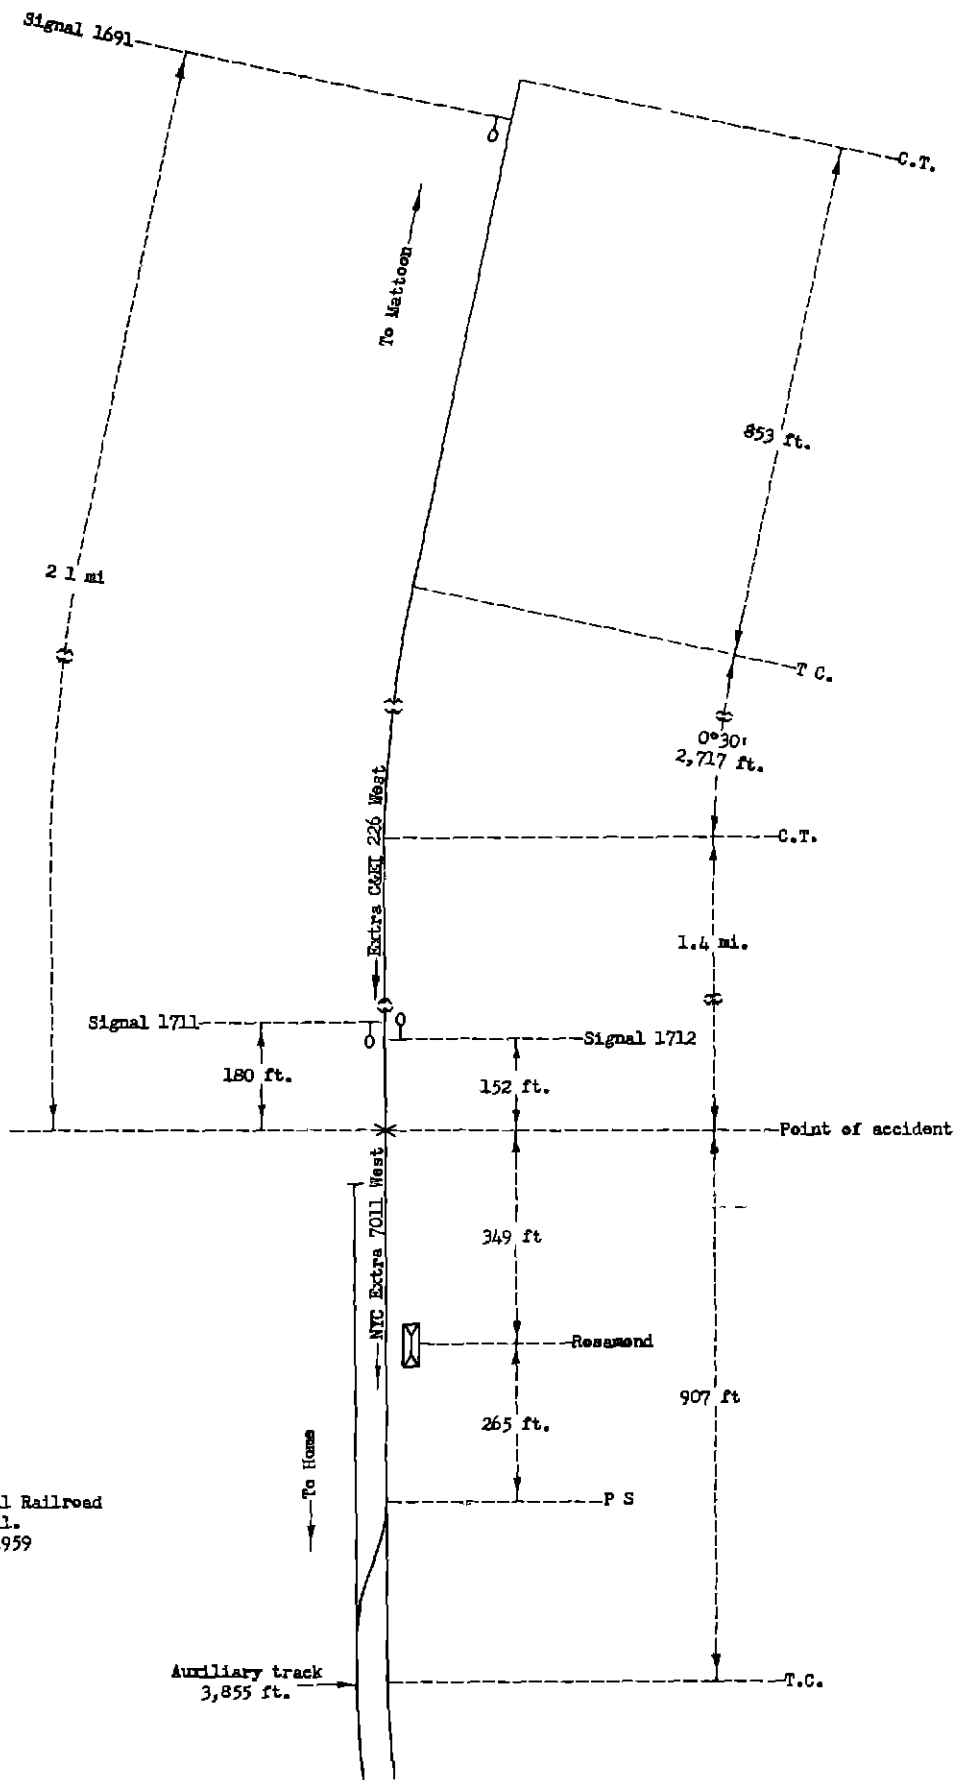
The New York Central Railroad
 Rosamond, Ill.
 February 9, 1959

The accident occurred on the main track at a point 4.2 miles west of Pana and 349 feet east of the station at Rosamond. From the east there are, in succession, a tangent 853 feet in length, a 0°30' curve to the left 2,717 feet, and a tangent 1.4 miles to the point of accident and 907 feet westward. The grade in the vicinity of the point of accident is 0.41 percent ascending westward.

Controlled signal 1691 and automatic signal 1711, governing westbound movements on the main track, and automatic signal 1712, governing eastbound movements on the main track, are located 2.1 miles, 180 feet, and 152 feet, respectively, east of the point of accident. These signals are of the color-light type and are approach lighted. Aspects applicable to this investigation and the corresponding indications and names are as follows:
