RAILROAD ACCIDENT REPORT

REAR-END COLLISION OF
NEW YORK CITY TRANSIT AUTHORITY
SUBWAY TRAINS 142NL AND 132NL
BROOKLYN, NEW YORK
JULY 3, 1981

NTSB-RAR-82-2

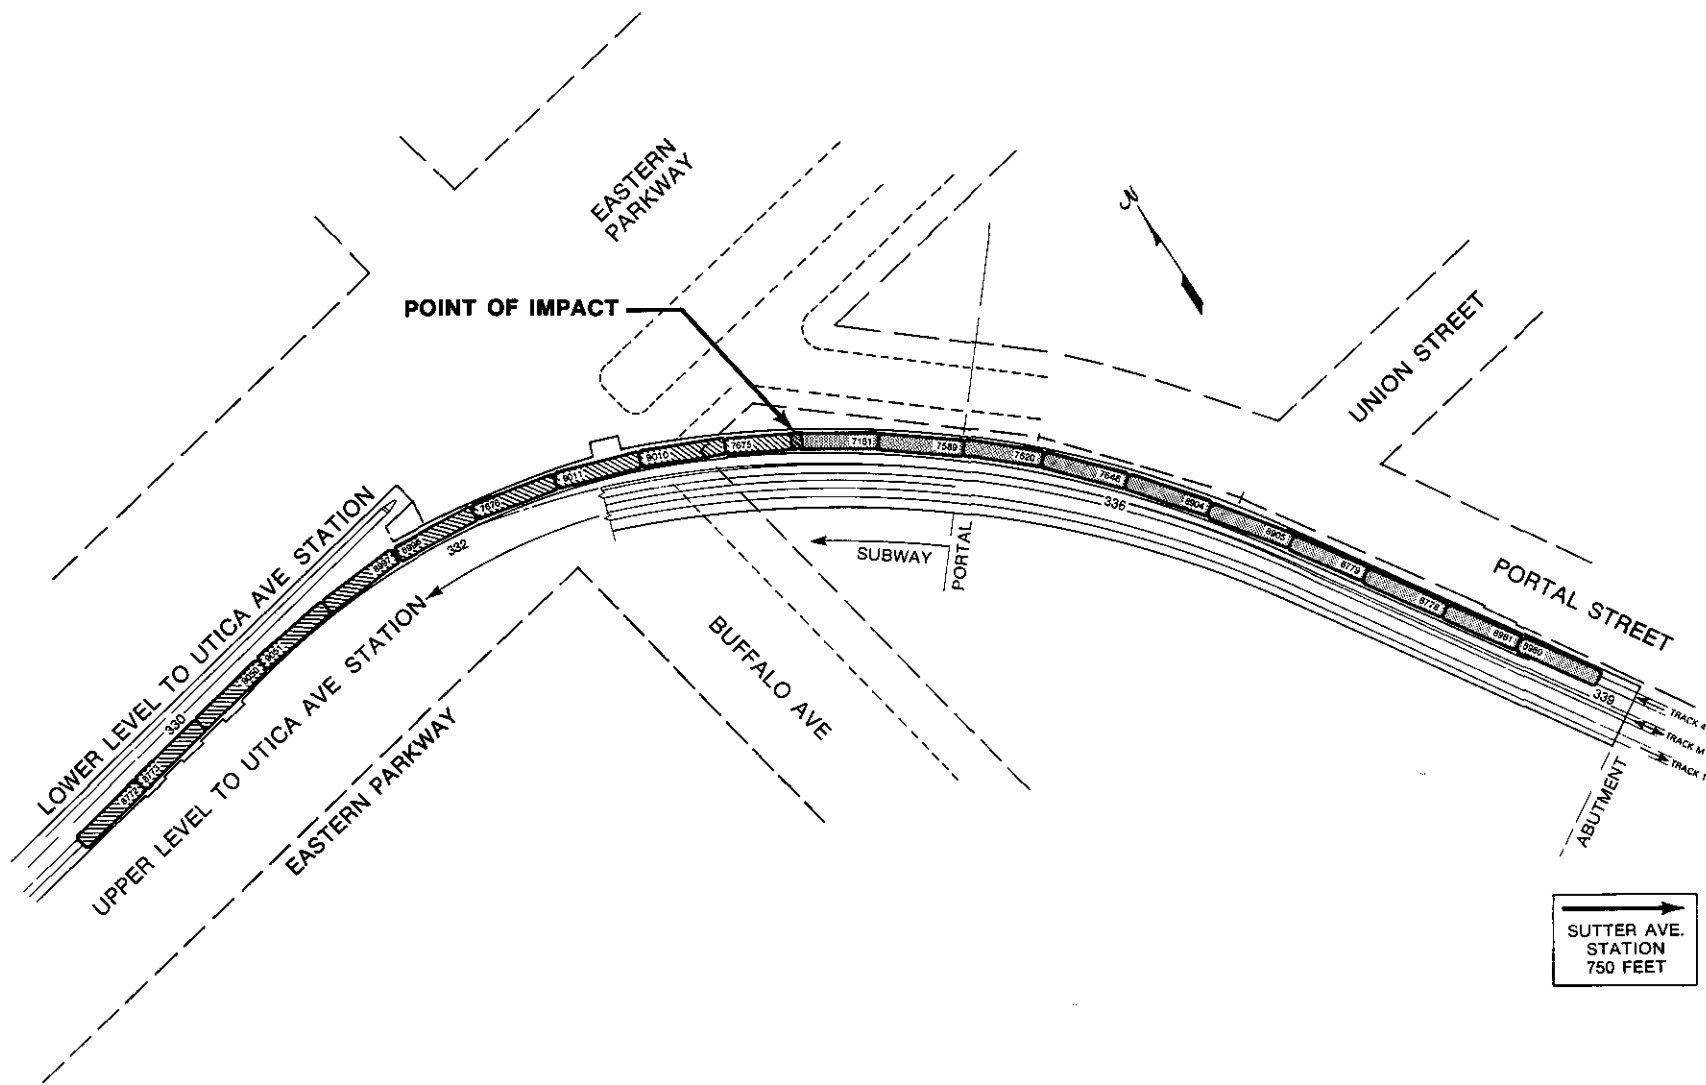
Figure 2.--Plan view of accident site.

A few minutes earlier, at 1:34 p.m., the motorman of train 122NL, 3/ a 10-car train northbound from New Lots Avenue to White Plains Road, had radioed to the command center that the signals were dark at the Utica Avenue interlocking. This was the command center's first indication of the signal problem. At 1:36 p.m., the motorman of train 132NL, also a 10-car subway train northbound from New Lots Avenue, had reported by radio that the signals were dark as the train moved from Saratoga Avenue to Utica Avenue. (See figure 1.) The motormen of trains 122NL and 132NL said later that they were flagged through the Saratoga Avenue Station by signal department employees. At the time of the 1:36 p.m. report, train 132NL was stopped and standing at the first signal inside a tunnel which began 1,100 feet north of the Sutter Avenue Station. (See figure 2.)

The New Lots extension is on an elevated structure that extends from New Lots Avenue to the portal of the subway tunnel 1,100 feet north of the Sutter Avenue Station. There are six stations in the 2 1/3 miles from the New Lots Avenue Station to the tunnel portal. A northbound train leaving the Sutter Avenue Station descends from the elevated structure and while approaching the tunnel portal enters a 9°52' right-hand curve, and then enters the tunnel on a 9°22' left-hand curve. The collision occurred in the tunnel on the 9°22' left-hand curve. (See figure 2.)

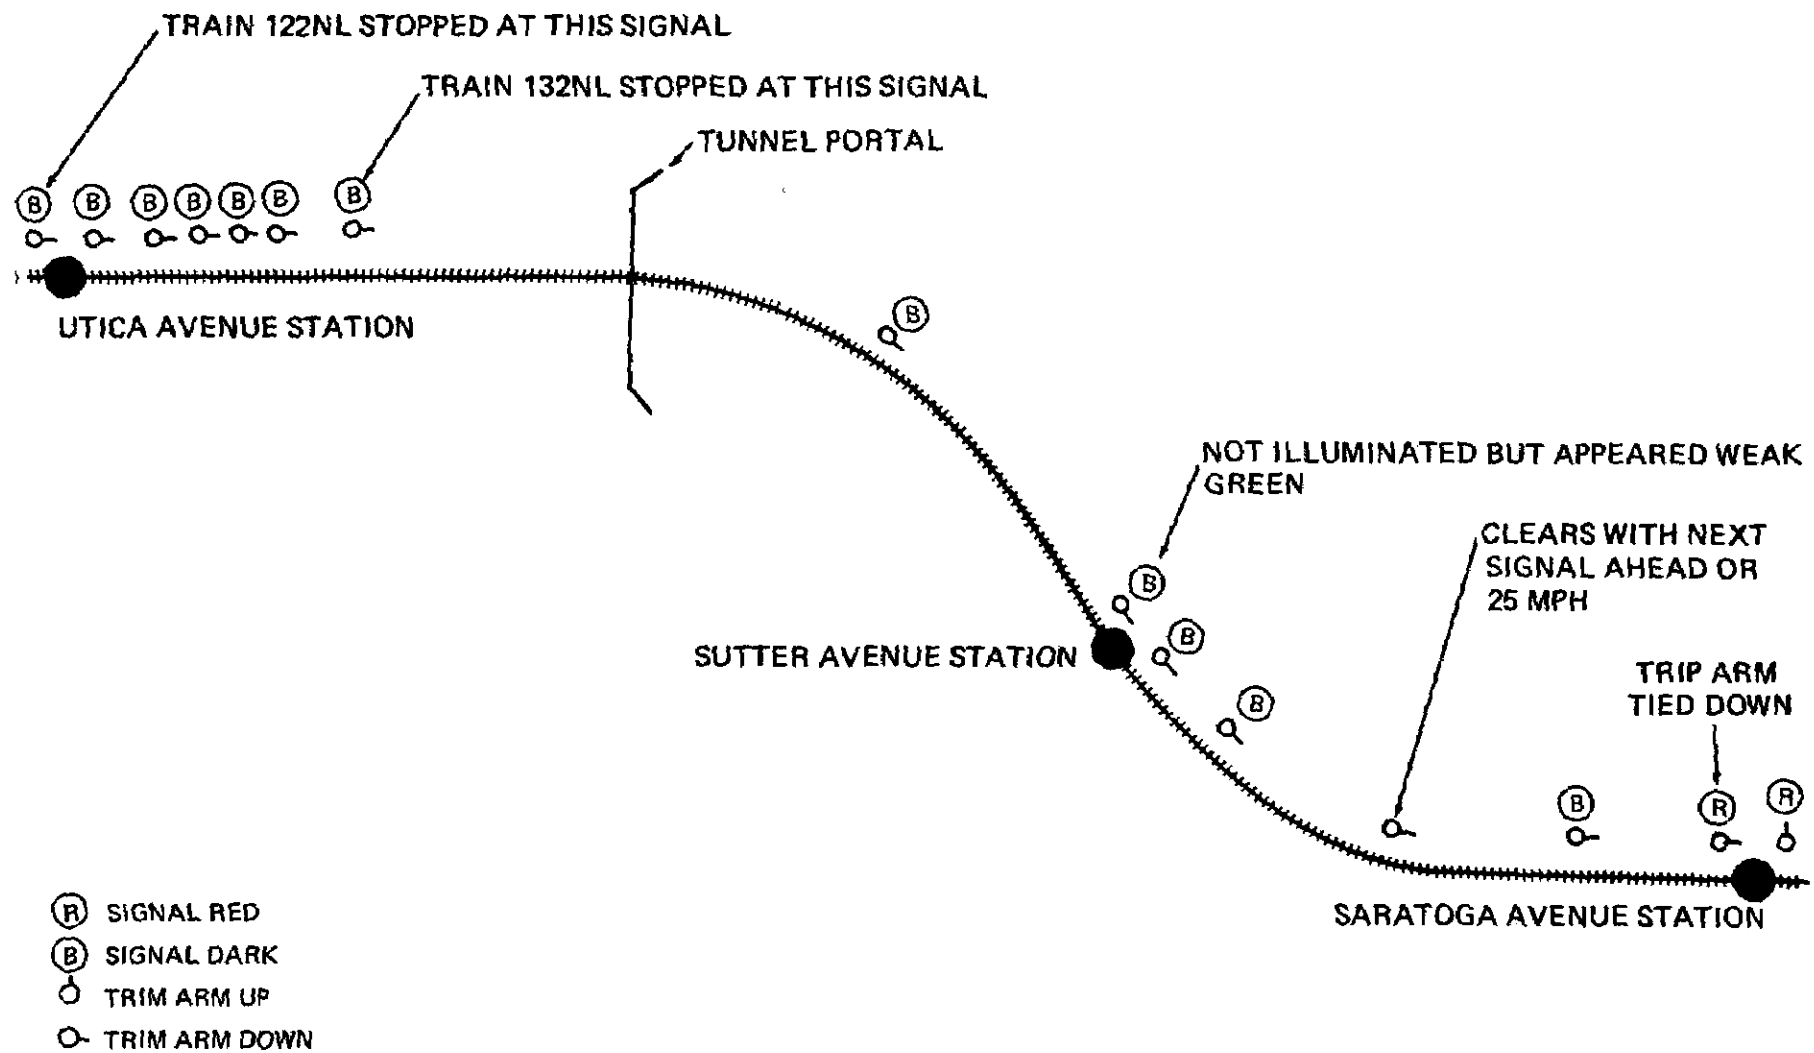
Figure 3.—Display of signals and position of trip arms as train 142NL was traveling from Saratoga Avenue Station.

A postaccident inspection by NYCTA personnel revealed that the signals were dark from the Saratoga Avenue Station to Nostrand Avenue. They did note that the signal on the north end of the Sutter Avenue Station appeared to be displaying a dim green indication. The signal was opened and the lamp was found to be not illuminated. It was determined that the green lens was reflecting sunlight. Subsequent to the accident the NYCTA signal department applied a longer sunshield to this signal. This postaccident inspection also found that the trip arm at the north end of the Saratoga Avenue Station was tied down.

Train 142NL was flagged through the red signals at Saratoga Avenue by an employee of the signal department, and because the trip arm on the north end of the station was tied down and because of the dark signals from the Saratoga Avenue Station to the point of collision, it was not necessary for the motorman to stop the train at each dark signal to cause the trip arm to fall into the nontripping position. In fact, the motorman may have believed that the block ahead was clear because the trip arm was in the down position and the signal at the north end of the Sutter Avenue Station appeared to be green. He also may have thought that the trip arm had been put down by signal department employees to indicate that the track ahead was clear. Since none of the operating employees involved in this accident, including command center personnel, understood that the trip arms did not rise automatically to the up or stop position when signals failed in this area, it is doubtful that the motorman of train 142NL understood that fact. It is also unlikely that he heard the communications from trains 122NL and 132NL to the command center concerning their being stopped because of dark signals, since he would have been boarding his train at the New Lots Avenue Station about that time. He may have heard only the radio transmission from the command center trainmaster to key by automatic signals and to use extreme caution. All these circumstances may have led the motorman of train 142NL to believe that the track ahead was clear. After the train departed the Sutter Avenue Station and approached the tunnel entrance, the motorman must have assumed that the track was clear and failed to maintain a diligent lookout ahead.

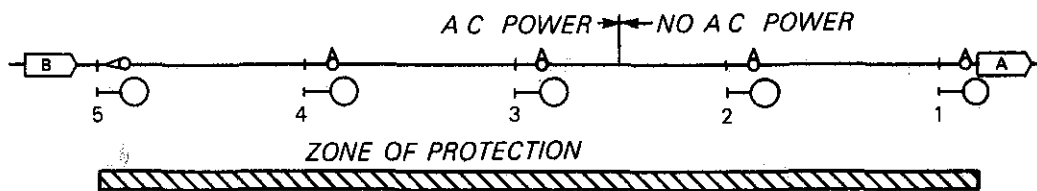
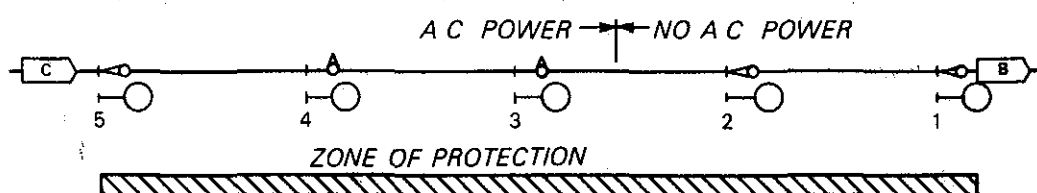
Figure 5.—Original IRT train control signal system and trip arm diagram.

The original IRT train control system was designed so that when a portion of the system became deenergized, the two signals immediately before the deenergized area would display red and the trip arms would raise. The third signal before the deenergized area would display yellow. In the deenergized portion, the signals would be dark, but the trip arms adjacent to the signals would not necessarily be in the raised position; rather they would remain in the position, either up or down, that they were in immediately before the loss of power. (See figure 5.) The modernized train control system, designated by the NYCTA as the prevalent TA train control, is used on the major portion of the NYCTA subway system. As portions of the original IRT train control system are replaced, the prevalent TA train control system is being installed. The prevalent TA train control system is similar to the original IRT train control system except that (1) when a portion of the system is deenergized, only the signal immediately before the deenergized portion is red--with the trip arm up, and (2) in the deenergized portion all the signal lights are dark and all the trip arms raise to the stop position. (See figure 6.) The signal color light aspects and signal indications are the same on the New Lots to White Plains Road line even though both the original IRT train control system and the prevalent TA train control system are used on various sections of this line.

Interviews with the train crewmembers and command center personnel indicated that they did not know that, because of the design of the original system, it was possible that all trip arms in the area of the accident would not move to the up or stop position when the signals were deenergized. The NYCTA engineering department is aware of the differences in the two systems and has an ongoing modernization plan to replace the original IRT system. The NYCTA superintendent of signals testified on August 5, 1981, at the public hearing held in connection with this accident that the portion of the New Lots line from New Lots Station to Sutter Avenue Station is being modernized and the work should be completed in 1983. He also said that the new signal system for the portion of the New Lots line where this accident occurred was in the design stages, and that he believed funding would be requested in the fiscal year 1983 capital budget. If this occurred, the work could begin in 1983. The modernization program described at the public hearing indicates that the northern portion of the line from 180th Street through the White Plains area would be planned for completion in the year 2001 or 2002.

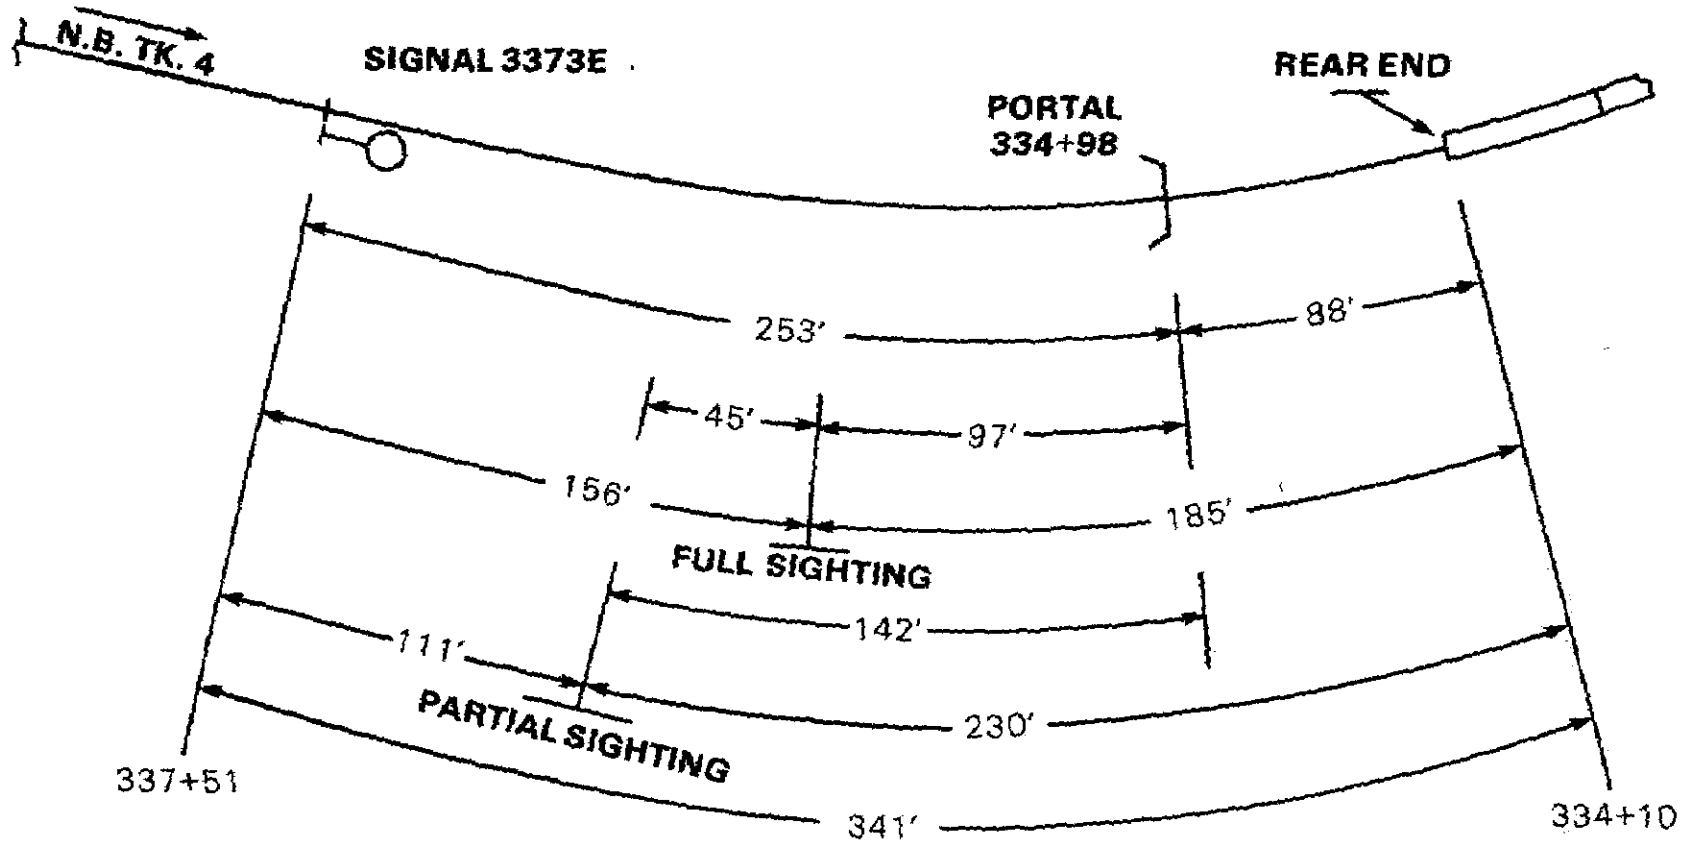
APPENDIX C
SIGHT DISTANCE TEST RESULTS

On July 11, 1981, a test train was assembled for a test run to observe site conditions and stopping distances. The weather on the day the test train was operated was bright and sunny as compared to a light overcast on the day of the accident. The train proceeded on the schedule of train 142NL. The preceding train was stopped at the location train 132NL had been struck, and its left rear light was turned off. The signals were deenergized from the Saratoga Avenue Station to Nostrand Avenue. The motorman of the test train was instructed to proceed, to "key by" all automatic signals, and to stop when he first sighted the standing train ahead. After leaving the Sutter Avenue Station, the motorman operated the test train at a speed of approximately 5 mph and brought his train to a stop when he sighted the stopped train ahead. The last car of the stopped train first became identifiable to the motorman of the test train when he had closed to a distance of 185 feet and was able to see the lights of the car in the dark tunnel, at which time he brought the train to a stop in 20 feet. (See appendix C.) After the test train stopped, observers walked back to a point 230 feet to the rear of train 132NL, from where they could see partially the right corner of the last car.

As the train descended from the elevated section toward the tunnel, and came to the point where the train ahead would have become identifiable at 185 feet as indicated in the test at 5.0 mph, the motorman of train 142NL moving at 12.7 mph would have had 9.9 seconds to respond to the emergency. Because he did not react and apply the brakes, he must have been distracted. Because he had been observed by the signal foreman with his head out of the side window of the cab and it was a warm day, he simply may have been attempting to cool off. Also, he may have been looking out to observe the cars in his train if he suspected something was wrong with the equipment. But for whatever reason, it is apparent from the lack of any braking or slowing of train 142NL that the motorman was not looking ahead to observe conditions as required by NYCTA rules.
