RAILROAD ACCIDENT REPORT

DERAILMENT OF
NEW YORK CITY TRANSIT AUTHORITY
SUBWAY TRAIN
DEKALB AVENUE STATION
BROOKLYN, NEW YORK
MAY 15, 1985

NTSB/RAR-86/01

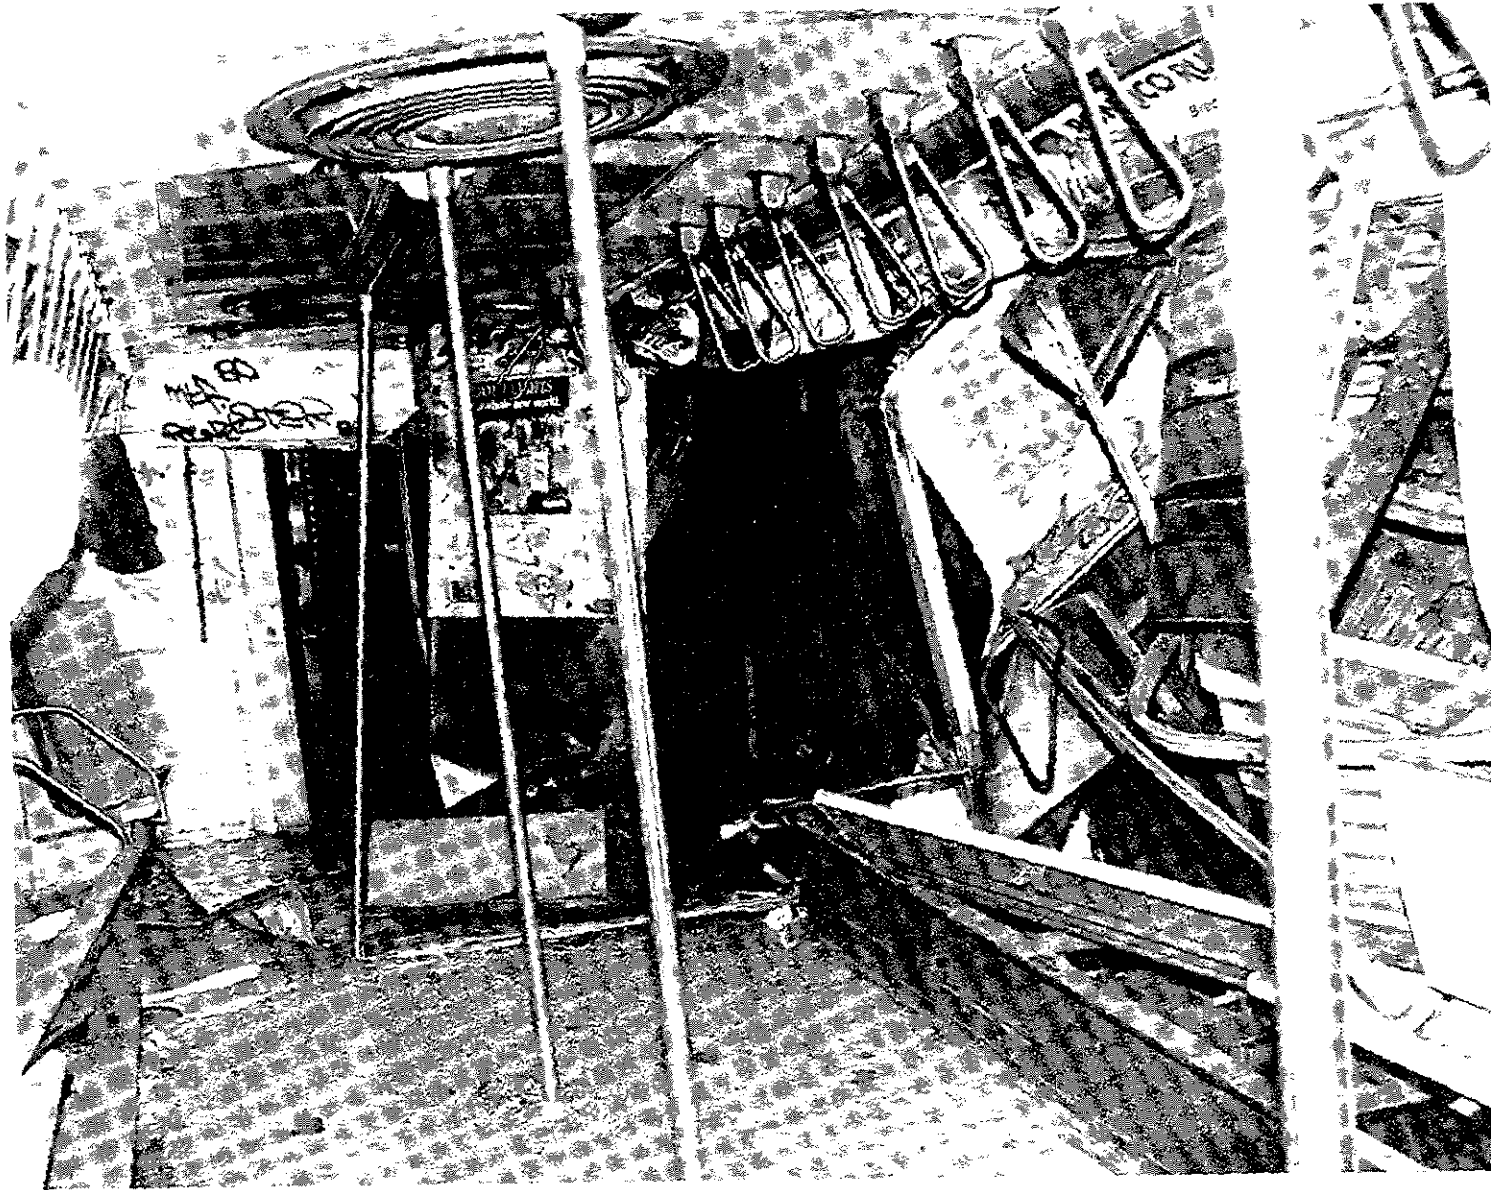
As a result of the impact with the track separation wall, 20 feet of the right sidewall of the derailed second car was torn and wedged between the car and the wall. The right-front corner of the car was crushed, and the roof was buckled 6 inches downward. The floor of the car was buckled 2 feet upward. Seats along the portion of the torn side wall were destroyed. (See figure 3.) Damage to the car was extensive, beyond repair, and estimated at \$350,000. Damage to track and signal equipment was estimated at \$50,000.

Figure 3.--Extensively damaged second car in train.

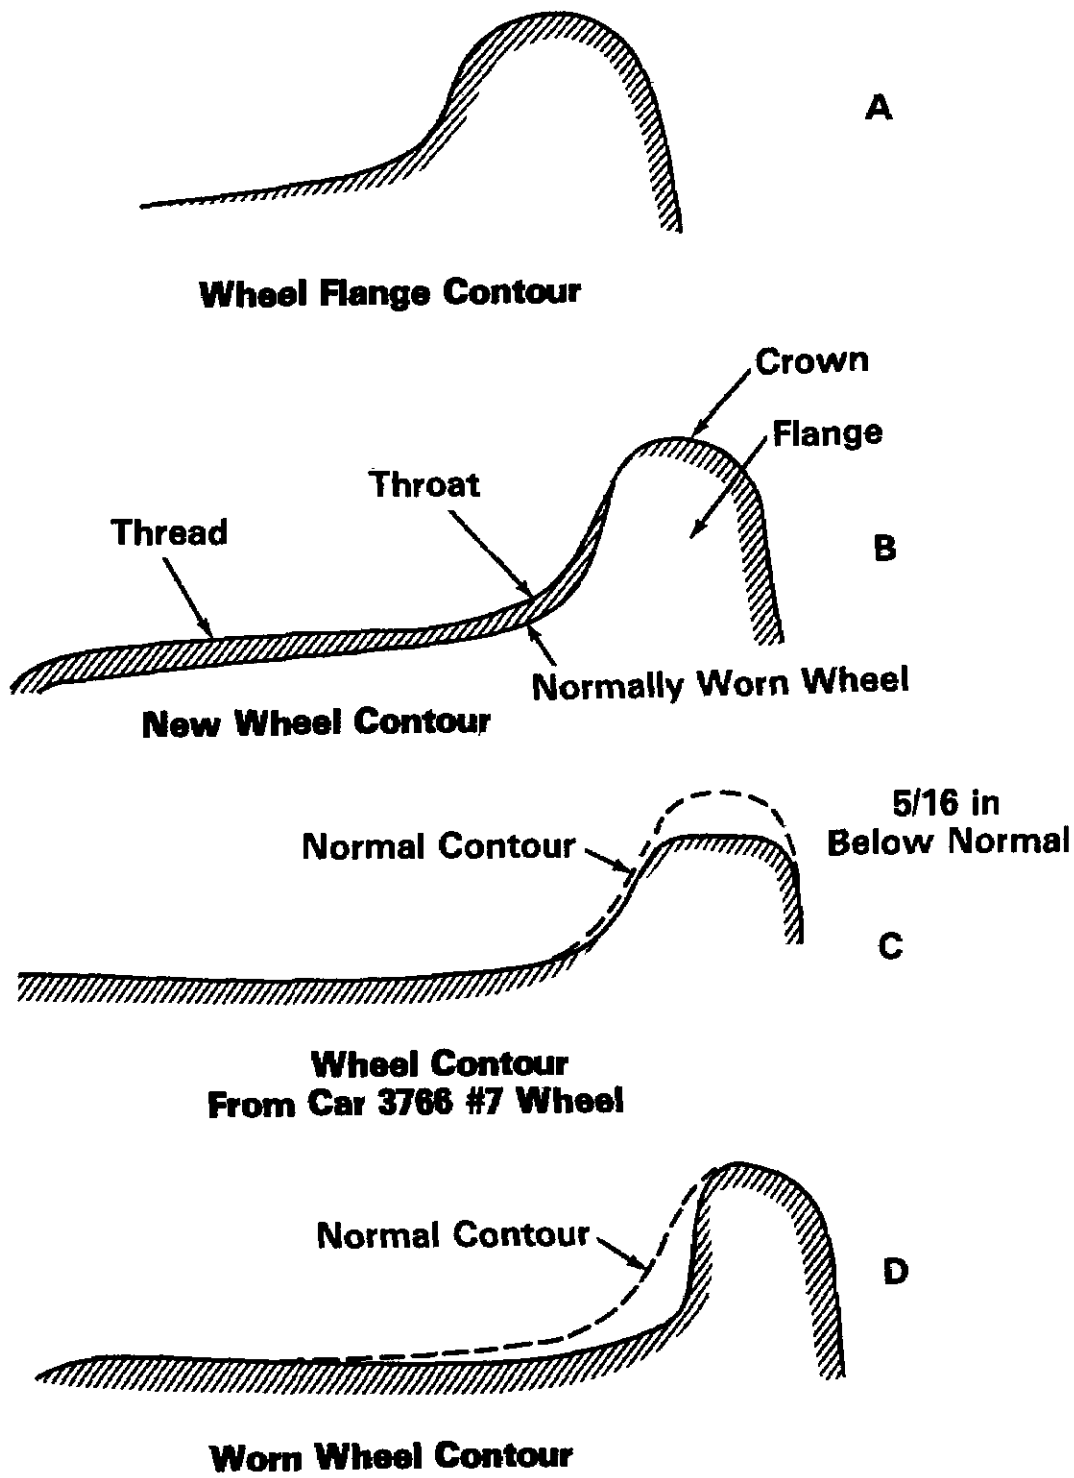
The postaccident inspection disclosed that the wheel flanges on all of the train's car wheels except one were normal. The flange of the No. 7 wheel on the derailed second car (the lead wheel of the second car and the first wheel to derail) was worn to a flat surface that was approximately 1/8 inch lower than the mate wheel on the axle. (See figure 4. Sketch C shows the unusual wheel wear found on the first wheel that derailed in this accident, sketch A shows a new wheel contour, sketch B shows the normal area of wheel wear, and sketch D shows a wheel with normal wear.) The cast-iron brake shoe at the No. 7 wheel location was worn down to the backing plate. The brake rigging, which was holding the brake shoe against the wheel, could not be removed; the brake rigging was dismantled to remove the brake shoe because the rigging was distorted. There was no indication that this condition was caused by the derailment. However, the wheel tolerances were within NYCTA maintenance standards.

Figure 4.-- Wheel flange wear on second car.

The No. 7 wheel, the lead wheel on the right side of the second car, had a flat surface on the flange. Thus, it had a greater opportunity to strike and go over the switch point than if it had been more rounded. The amount of wear on the wheel could not have occurred during the derailment but probably occurred over a period of time before the derailment. The brake rigging must have been binding and holding the brake shoe against the wheel as indicated by the brake material being worn off and the steel backing plate contacting the wheel. This steel backing plate in contact with the wheel caused the wearing away of the flange of the wheel and created the flat surface on the flange. This flat surface struck the exposed switch point and went up and over the switch point and derailed. Had the wheel had a more rounded surface, as did the wheels of the first car, it is possible that it would have pushed the switch point against the stock rail and followed the first car into the crossover. However, because of the loose condition of the stock rail, a derailment eventually would have occurred even if the wheel of a car showed no wear.

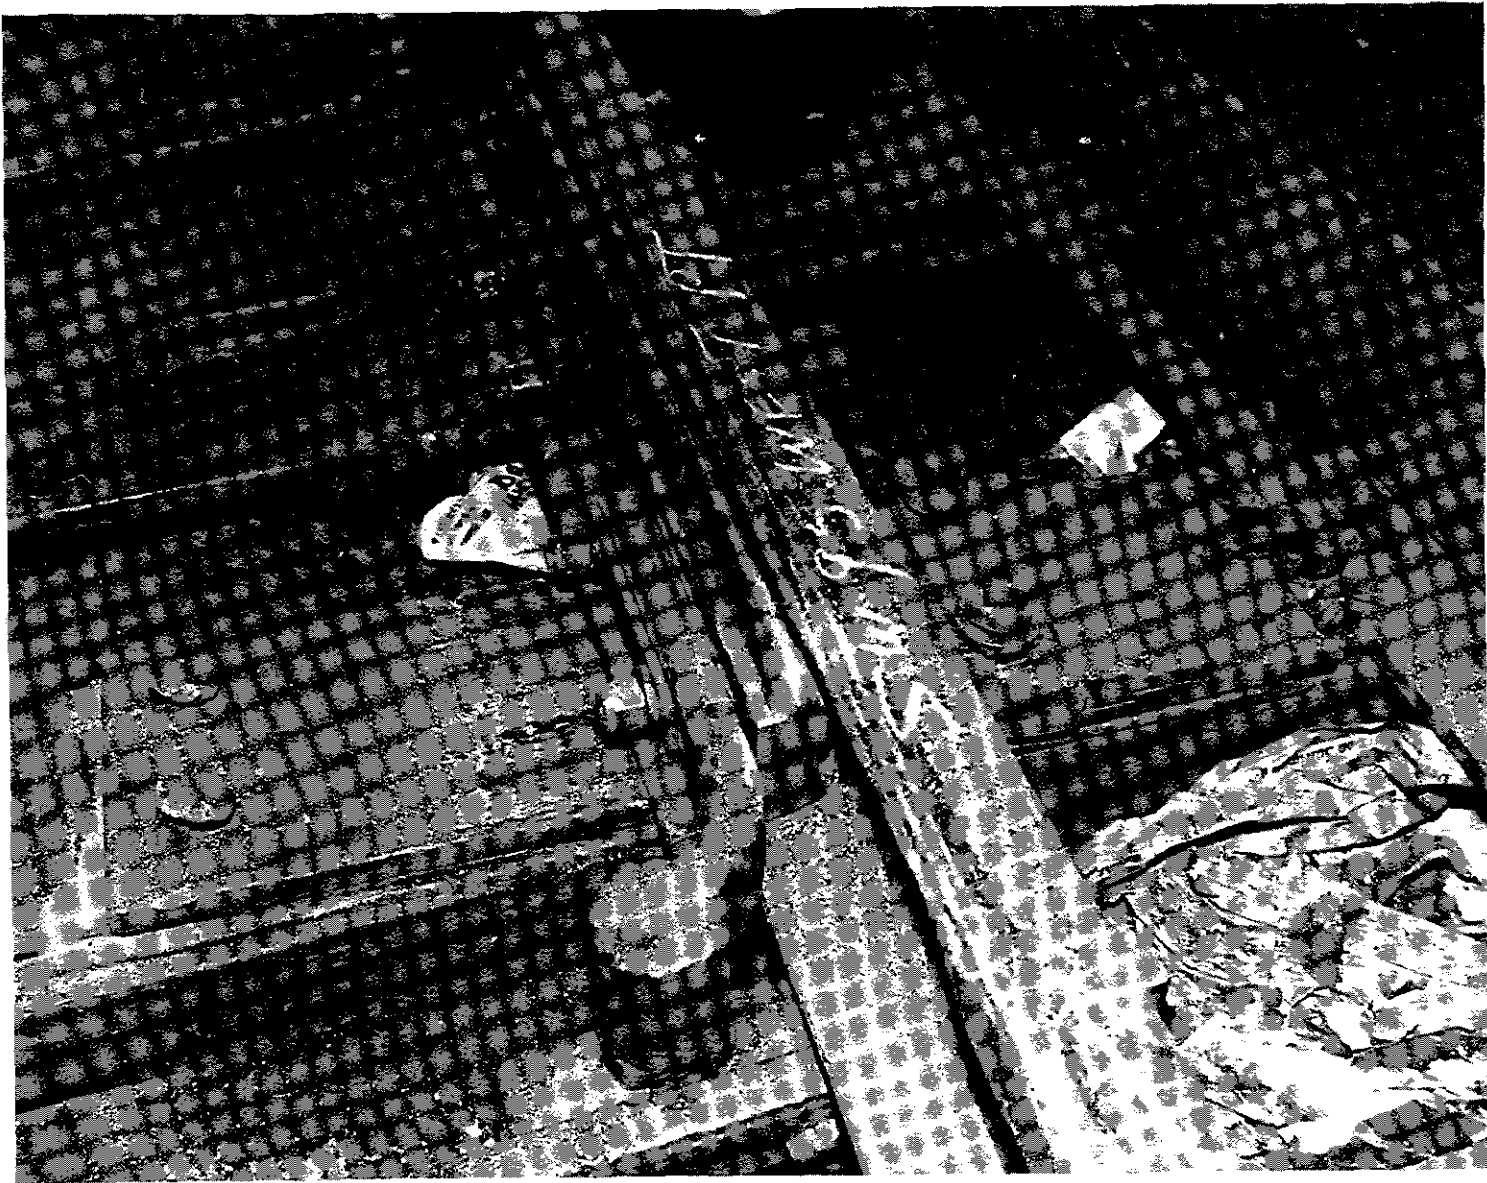
Figure 6.--Damaged switch point.

Failure to properly tighten and lock the stock rail braces and failure to properly gauge the track allowed the stock rail to cant, allowed the gauge to widen and move away from the switch point, and permitted the wheel to strike the switch point. Not only did the line supervisor fail to properly supervise his track personnel and conduct a thorough inspection, but his supervisor, the deputy superintendent, failed to detect the loose stock rail braces during his inspection of the track site. Both the actions of the line supervisor and the deputy superintendent indicate that the management oversight of the employees and supervisors is inadequate.

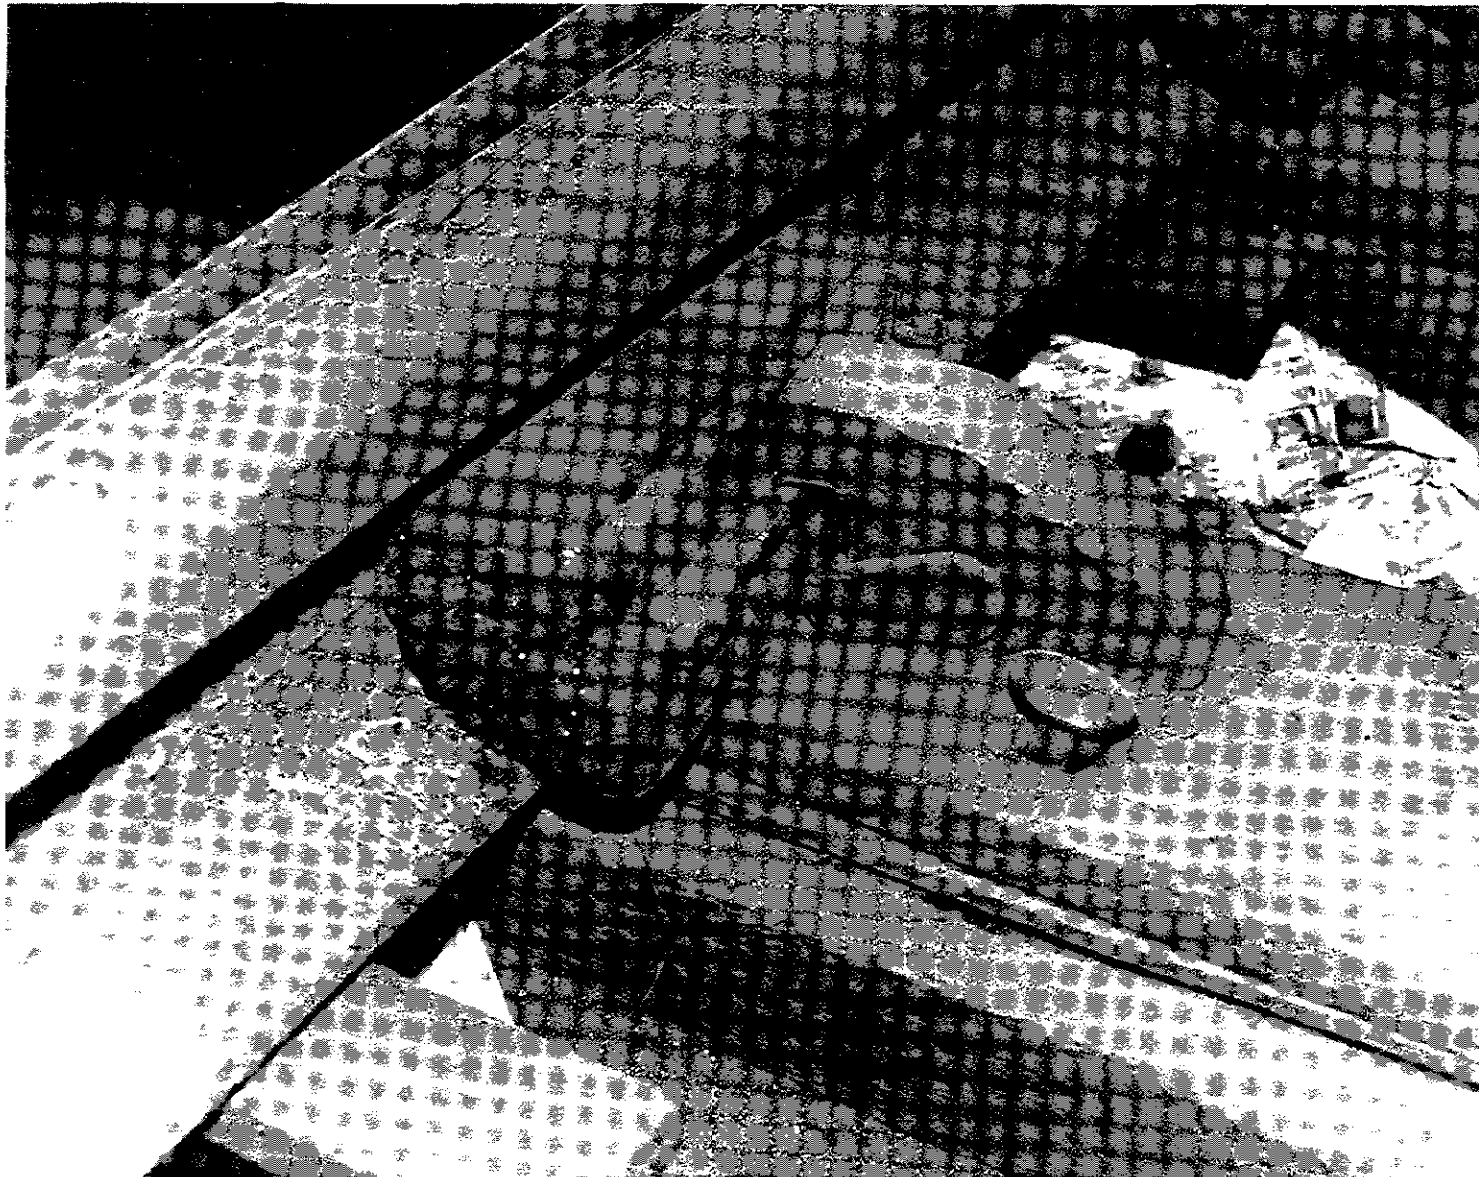
Figure 7.--Loose stock rail braces.

The investigation revealed that the stock rail in the replaced rail sections involving the switch of the crossover had not been seated properly when it was replaced in the old tie plates. Also, the west stock rail braces were loose, two west stock rail braces were missing, and two spikes were missing on the gauge side of the rail. Each of these conditions allowed the loose stock rail to move as several trains traveled through the crossover and on the straight normal route so that the stock rail took a set and was sitting on top of the tie plate risers and would not reseal in the tie plates because of the set. Because of the position of the stock rail, a gap was created between the switch point and the stock rail which exposed the switch point so that the worn wheel of the second car in the accident train struck the switch point and derailed. If either the capital improvement division foreman or the track maintenance foreman had waited to observe the first train over the replaced track, the loose condition of the stock rail would have been noted and corrections could have been made, thus avoiding the accident.

NYCTA personnel straightened the Nos. 1, 3, and 4 switch rods damaged in the derailment and tightened the loose stock rail braces. The switch machine was cranked manually to the reversed position and locked. An opening of 7/16 inch was measured between the switch point and stock rail. The switch point could be forced open an additional 1/8 inch because of the lateral movement in the switch rod clips.

The west stock rail was placed in its proper position after the stock rail braces were removed and the missing track spikes were installed in the No. 1 tie S-plate. The switch throw of the west switch point measured 4 1/4 inches; however, the switch point could not be adjusted to the 4 1/4-inch limit because this limit was beyond the switch machine travel.

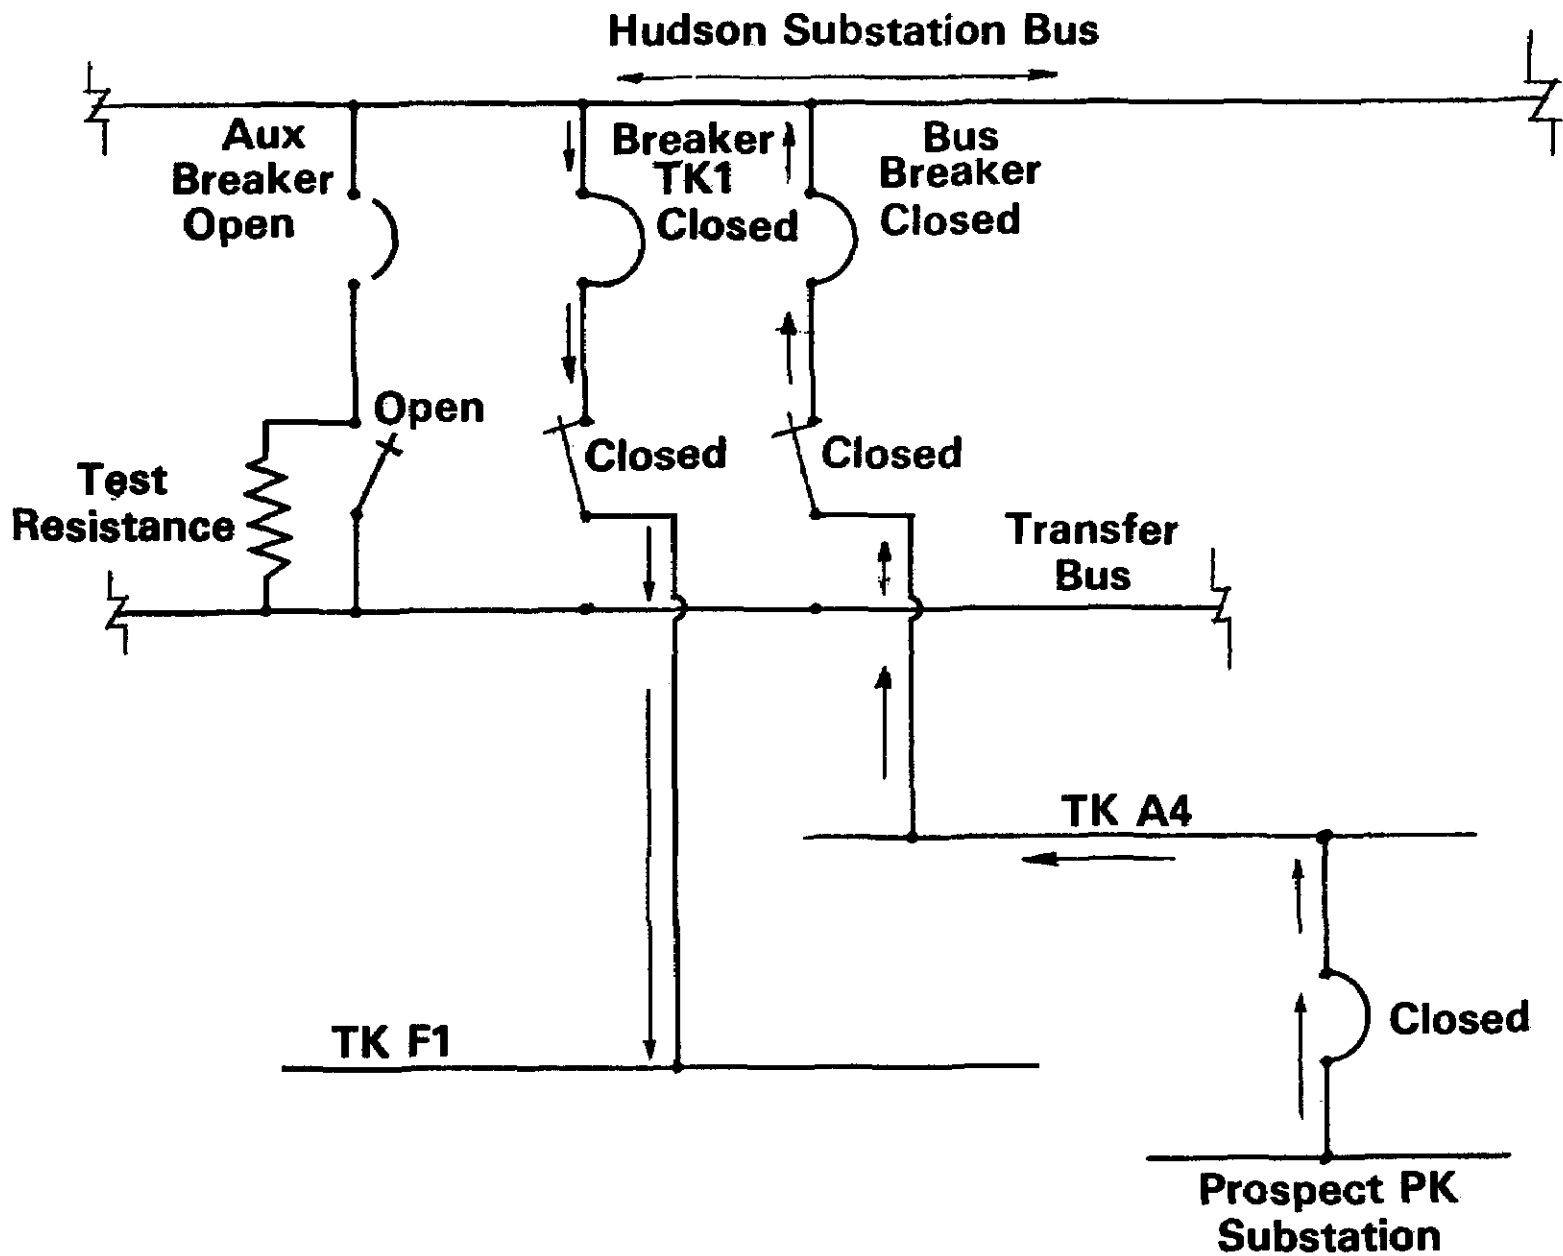
When the train departed the Dekalb Avenue Station About 10:11 a.m.

Figure 8.--Current path.

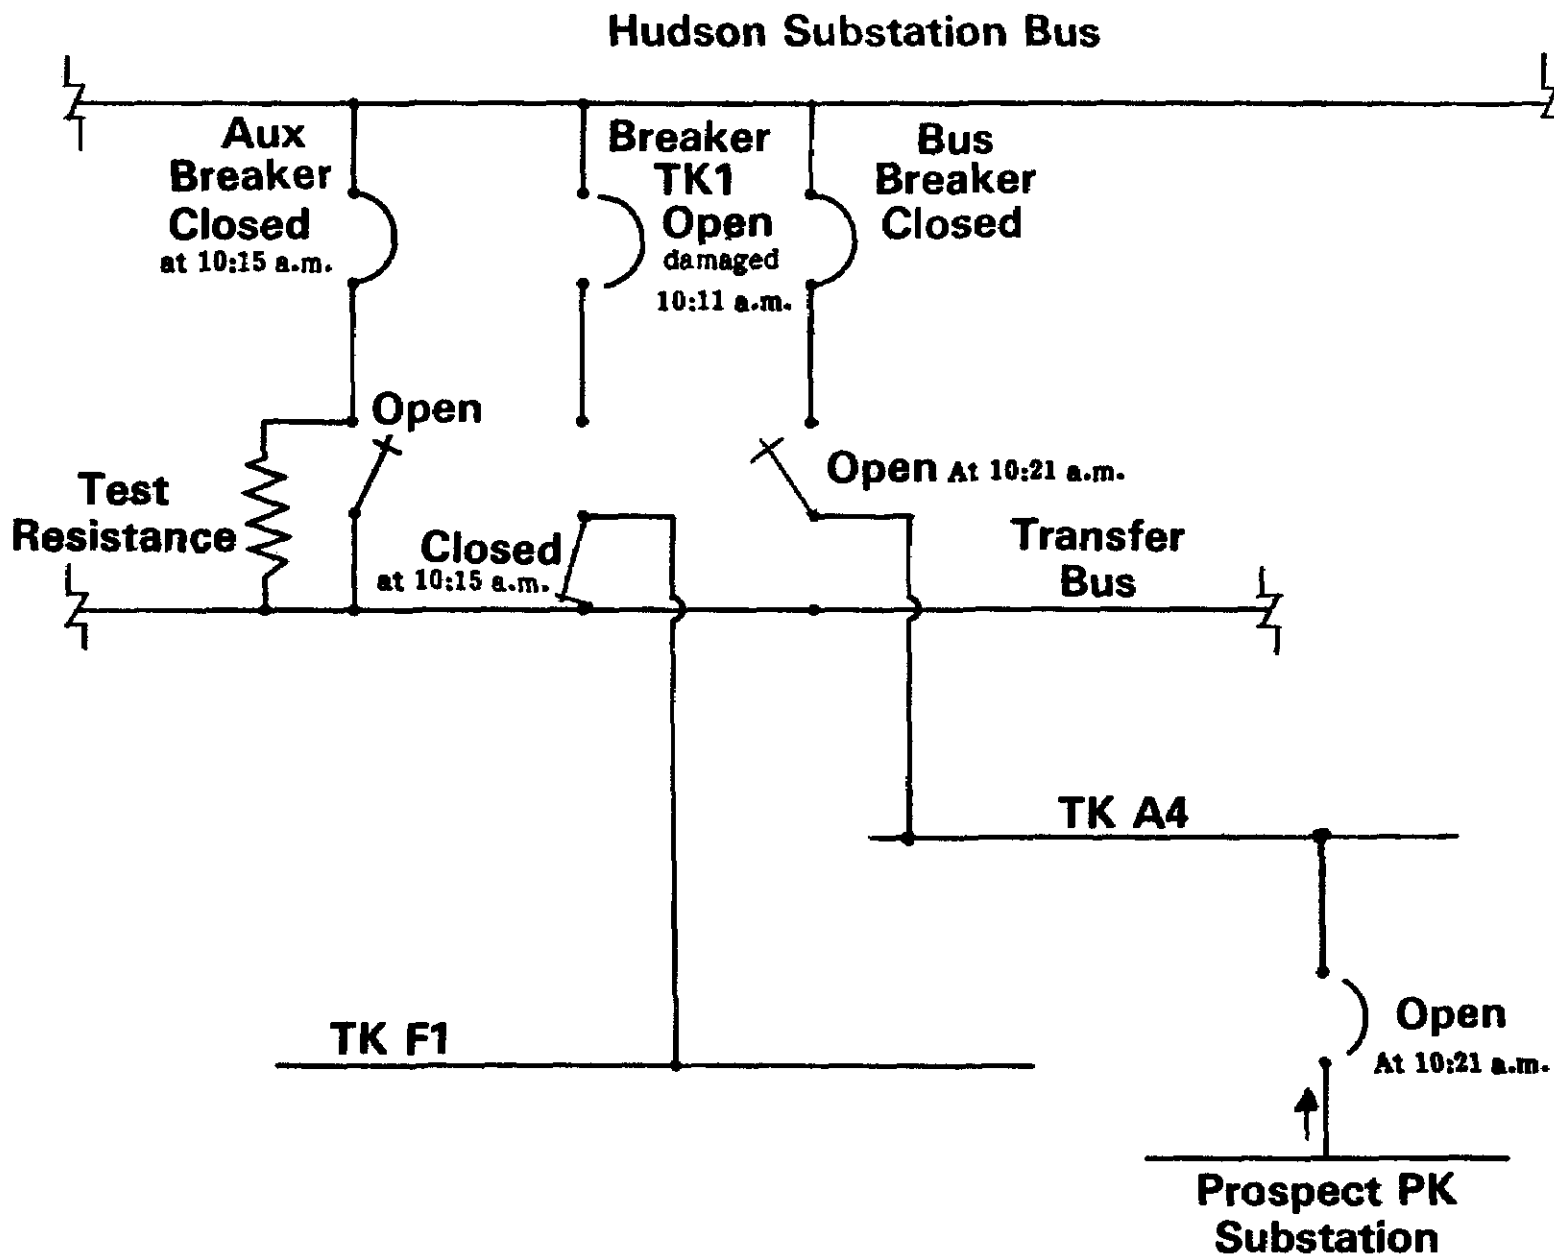
At 11 a.m. the power maintainer was relieved by another power maintainer, while the 600-volt third-rail power was still off. The power maintainer being relieved at 11 a.m. had failed to open the auxiliary breaker and the transfer bus switch, and he did not tell the power maintainer coming on duty that they were still closed.

When power maintainer came on duty at 11 a.m.

Figure 9.--Current path.

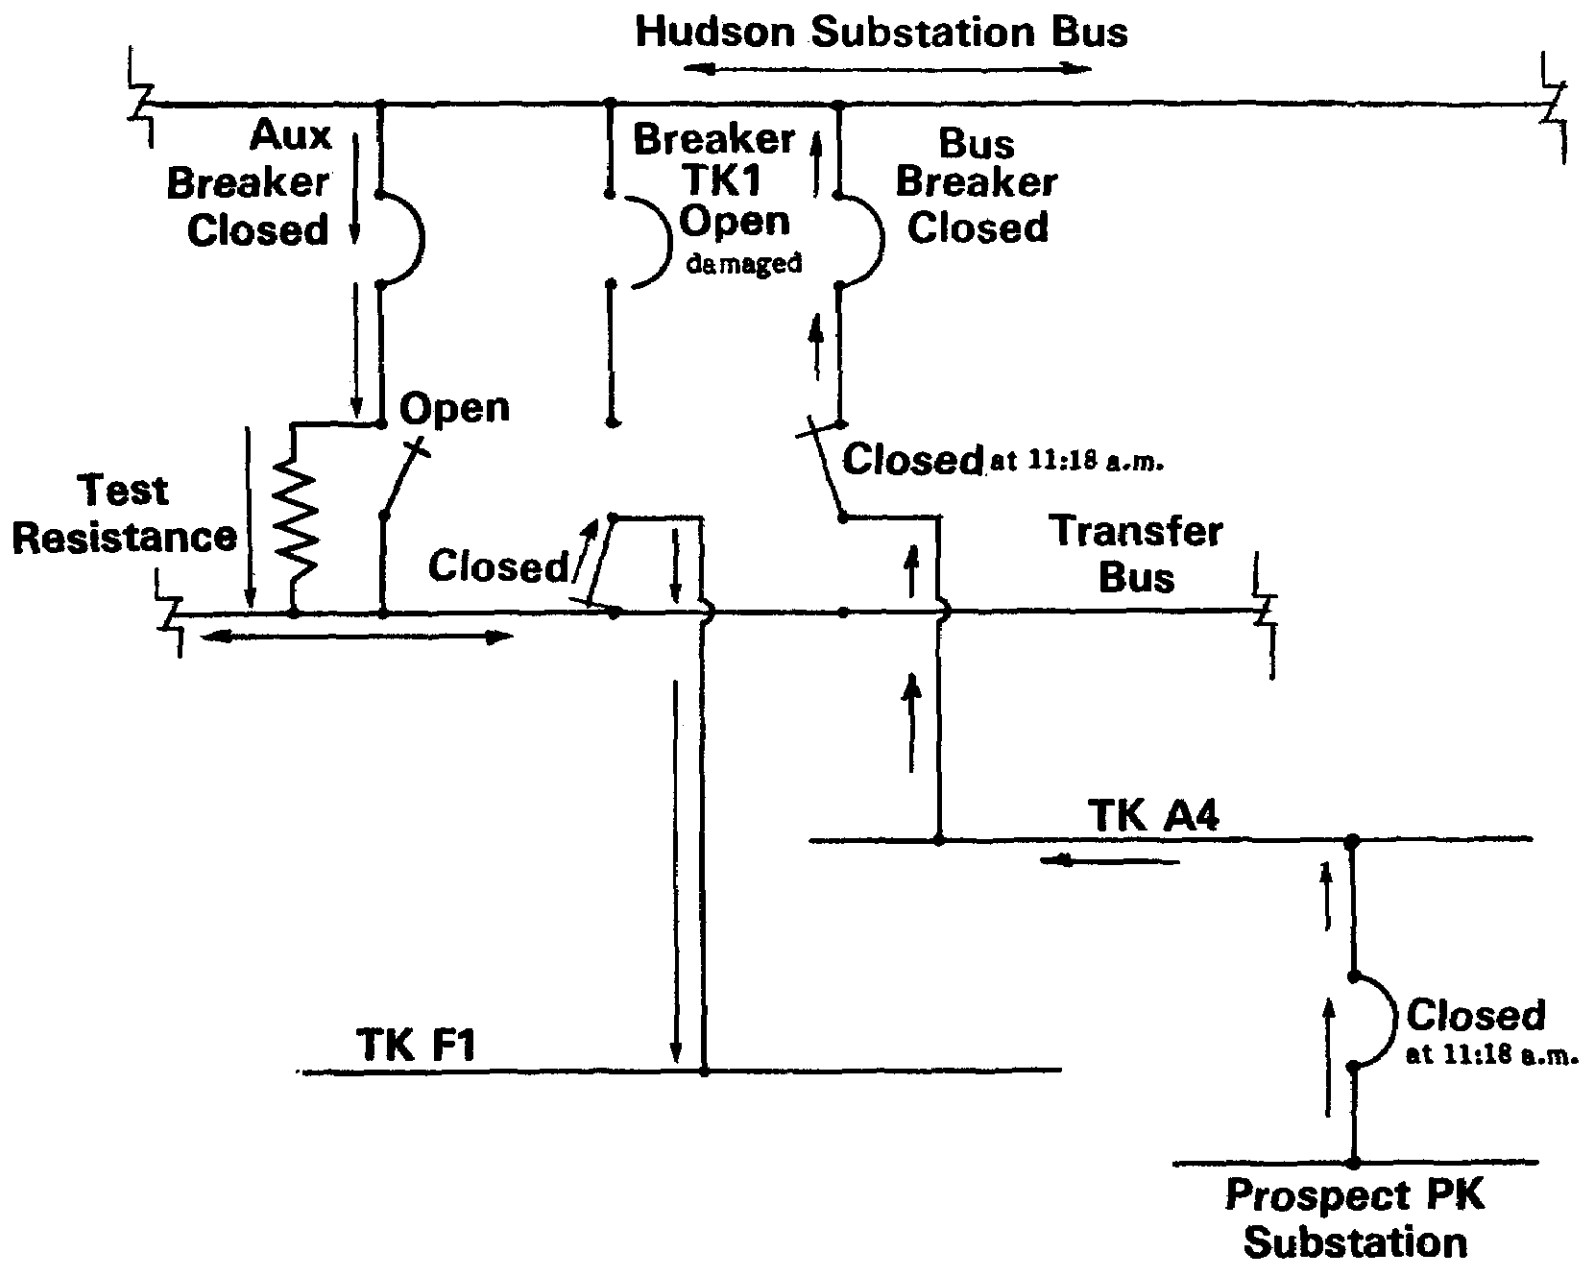
The power maintainer who came on duty at 11 a.m. was working a relief position, and his assignment required him to work at six different substations. When he reported for duty, an assistant supervisor accompanied the power maintainer as he checked out the position of switches and the status of the loss of power at the substation. The assistant supervisor explained to the maintainer that an overload had damaged the breaker for track No. F1 and that the auxiliary breaker had been closed so that it could be available for restoring power; however, the knife switch was left in the open position. The power maintainer learned that a train had derailed and that was the reason for the power shutdown. The system operator called the power maintainer at 11:18 a.m. and instructed him to restore power, which had been off since the derailment, to the undamaged tracks and designated the switches to be closed; the assistant supervisor only watched through the window as the power maintainer went to close the switches. The assistant supervisor said that he did not see the power maintainer close the switches because he could not see the power board from that position. The power maintainer closed the switches as instructed to energize all the undamaged tracks but did not open the auxiliary breaker because the knife switch was open. The system operator said that he only intended to energize the third rail to track No. A4 and all the other undamaged tracks for train movements, and that the switches he instructed the power maintainer to close would have accomplished that task. However, the auxiliary breaker which had been closed by the previous maintainer had a test resistance loop built into the system around the knife switch which allowed the 600-volt power to bypass the knife switch and energize the third rail at the accident site. (See figure 10.)

when power was restored at 11:18 a.m.

Figure 10.--Current path.
