# NATIONAL TRANSPORTATION SAFETY BOARD

## RAILROAD ACCIDENT REPORT

**DERAILMENT OF  
NEW YORK CITY TRANSIT AUTHORITY  
SUBWAY TRAIN  
NEW YORK, NEW YORK  
DECEMBER 12, 1978**

NTSB-RAR-79-8

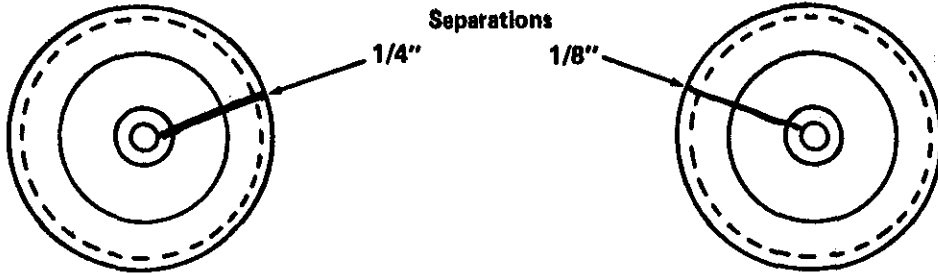
Figure 2. Broken wheels from the December 12, 1978 derailments.

After the December 12, 1978, derailment, two wheels on the same axle of the sixth car were found broken. Metallurgical tests revealed that the wheels broke because of a thermal crack in the flange of each wheel that extended through the rim and plate and into the hub. The cracks expanded and permitted each wheel to become loose on the axle. Both wheels were discolored by heat. (See figure 2.) The wheels had been inspected 1 1/2 days earlier.

Tests were conducted on the fractured wheels from the December 12, 1978, derailment in the National Transportation Safety Board laboratory. Oxidation on the fractured wheel rims and overheated zones on the flanges indicated that the rims of the fractured wheels had been excessively heated. The fracture on one of the wheels stemmed from a fatigue crack in the flange area. Weld material applied subsequent to the fracture had totally obscured the fracture area on the other wheel. A radial microsection prepared near the fracture at a location that was removed from the area of welding disclosed several overheated zones along the flange surface. The largest zone consisted of untempered martensite with varying amounts of fine-grained pearlite, and was located in the fillet where the flange blended into the tread. Martensite forms upon cooling from a temperature above approximately 1,350° F. The width of this area on the mounted section was approximately one-half inch. Its total width, however, is unknown, because the area extended beyond the mounted flange portion. The maximum depth of the overheated area was 0.04 inch.

Another major overheated area was found closer to the top of the flange. This area measured 0.09 inch wide and 0.015 inch deep and consisted largely of untempered martensite. An extensive amount of flowed metal accompanied the overheated area suggesting that the overheating condition was produced by contact wear with another surface. Much of the flange surface outside of the two major overheated areas contained a thin layer of flowed metal and/or a very thin overheated layer of untempered martensite indicative of excessive heat.

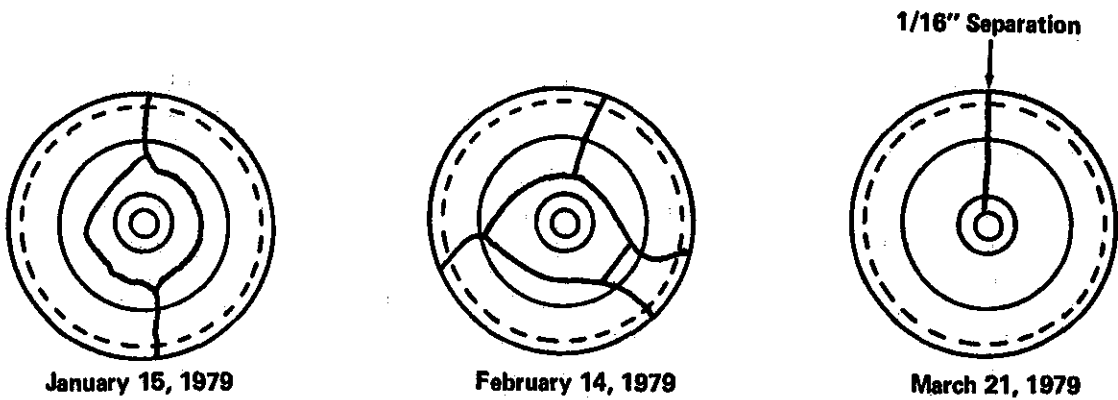
Figure 3. Broken wheels from three subsequent derailments.

After the January 15, 1979, derailment, a wheel that had broken into three pieces was found on the fourth car. Investigators determined that the wheel broke because of a thermal crack which originated in the flange. The crack extended through the rim and into the wheel plate where it went around the circumference of the plate and joined another thermal crack which extended through the rim and flange. The wheel was also discolored by heat. (See figure 3.)

After the February 14, 1979, derailment, a wheel that had broken into five pieces was found on the seventh car. Investigators determined that the wheel broke because of a thermal crack that originated in the flange. The crack extended through the rim and into the plate and went around the full circumference of the plate. It also broke through the rim and flange at three other locations. (See figure 3.) The wheel had been inspected 18 days earlier.

After the March 21, 1979, derailment, a broken wheel was found on the first car. Investigators determined that the wheel broke because of a thermal crack in the flange. The crack extended through the rim and plate and into the hub. The wheel then became loose on the axle. The wheel was also discolored by heat. (See figure 3.) The heat discoloration was a red color which extended from the flange and rim into the plate. The wheel had been inspected 4 days earlier.

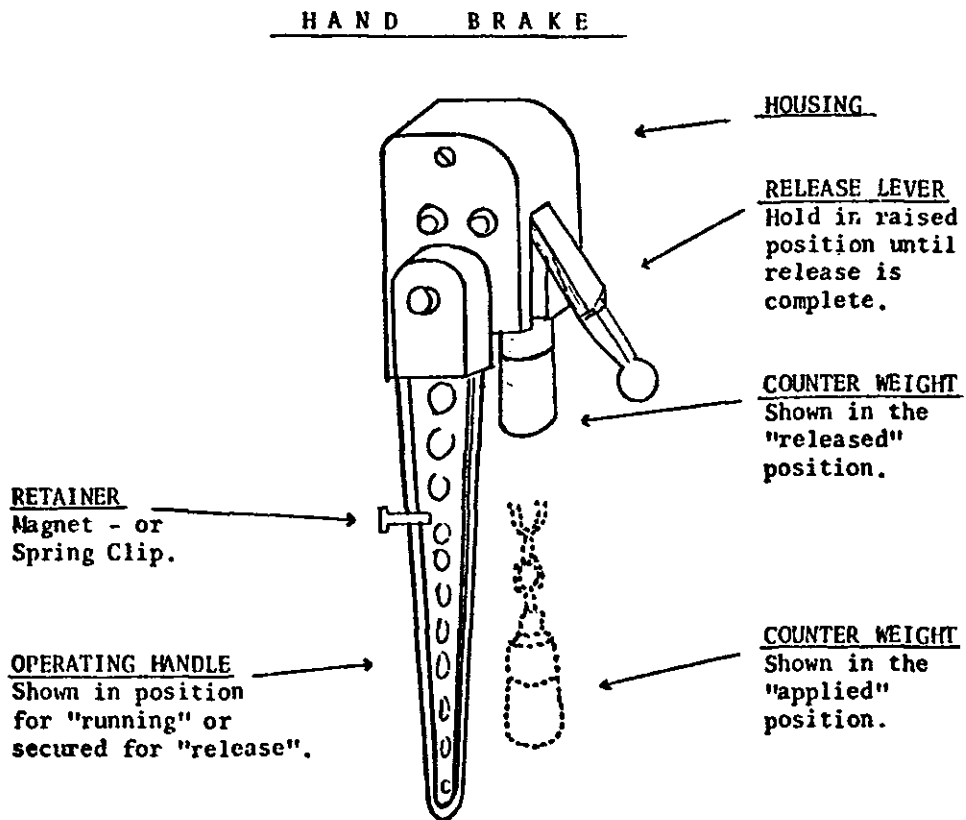
Figure 4. Peacock Handbrake Used on NYCTA Subway Cars.

lever to set the brakeshoes against the wheels. This condition of the handbrake could not be determined by looking at the counterweight through the opening in the handbrake housing. This partially applied brake would not release if the release lever was operated.

Although crewmembers were seen checking handbrakes either manually or by operating the brake release lever during the 5-day observation, no one made a visual inspection by walking around his train; therefore, any slack in the brake chain would not have been detected. Therefore, the Safety Board concludes that the subway cars involved in these accidents were permitted to operate with handbrakes partially applied — a condition which created a brakeshoe drag condition that caused the wheels to overheat and fracture.
