# NATIONAL TRANSPORTATION SAFETY BOARD

## RAILROAD ACCIDENT REPORT

DERAILMENT OF  
NEW YORK CITY TRANSIT AUTHORITY  
SUBWAY TRAIN IN THE  
JORALEMON STREET TUNNEL  
NEW YORK, NEW YORK  
MARCH 17, 1984

NTSB/RAR-85/07.

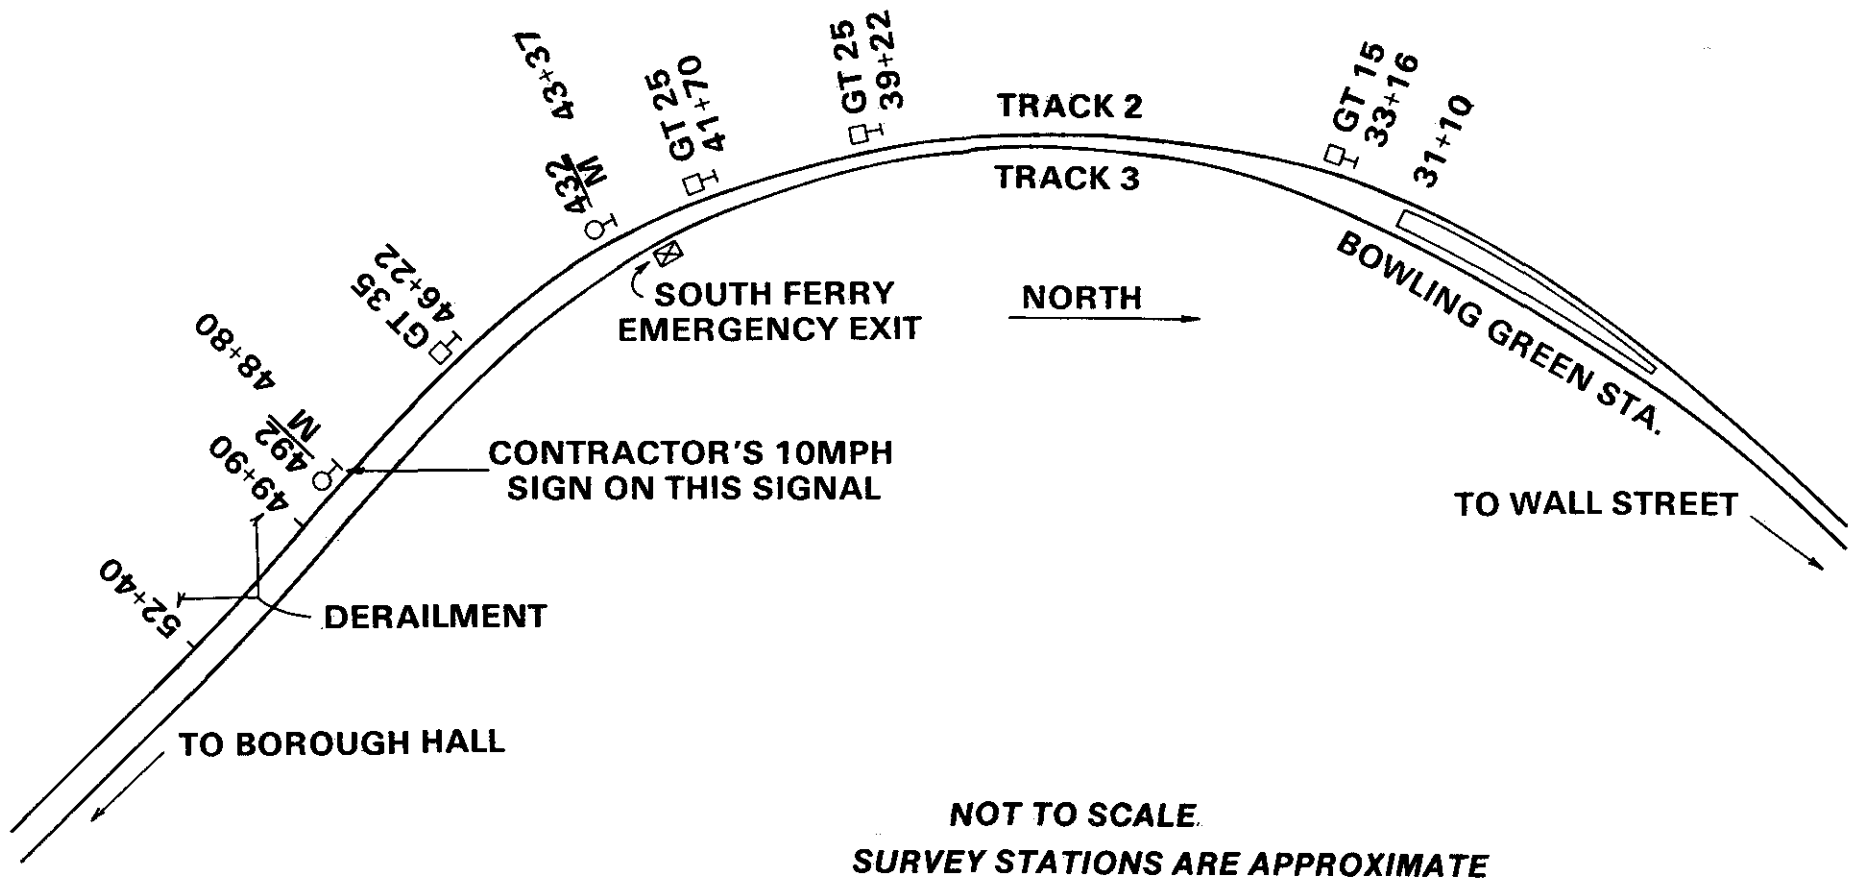
Figure 1.--Diagram of track showing relative locations of signals and appurtenances in the Joralemon Street tunnel.

Proceeding southward from Bowling Green Station, the train went around a left curve down a 2-percent grade for about 1,000 feet and then down a 3-percent grade for 900 feet to the point of derailment. Several hundred feet before the derailment point, the track curved slightly to the right. The derailment occurred near the end of that right curve. (See figure 1.)

As trains moved southward on the No. 2 track from the Bowling Green Station, they encountered skeletonized track at the following locations (see figure 1):

<u>Survey stations</u>	<u>Distance</u>
Sta. 41+50 to 41+82	32 feet, both rails
Sta. 43+50 to 43+77.5	27.5 feet, one rail 19 feet, other rail
Sta. 49+50 to 50+33	83 feet, one rail 77 feet, other rail
Sta. 52+00 to 52+62.5	60.5 feet, one rail 62.5 feet, other rail

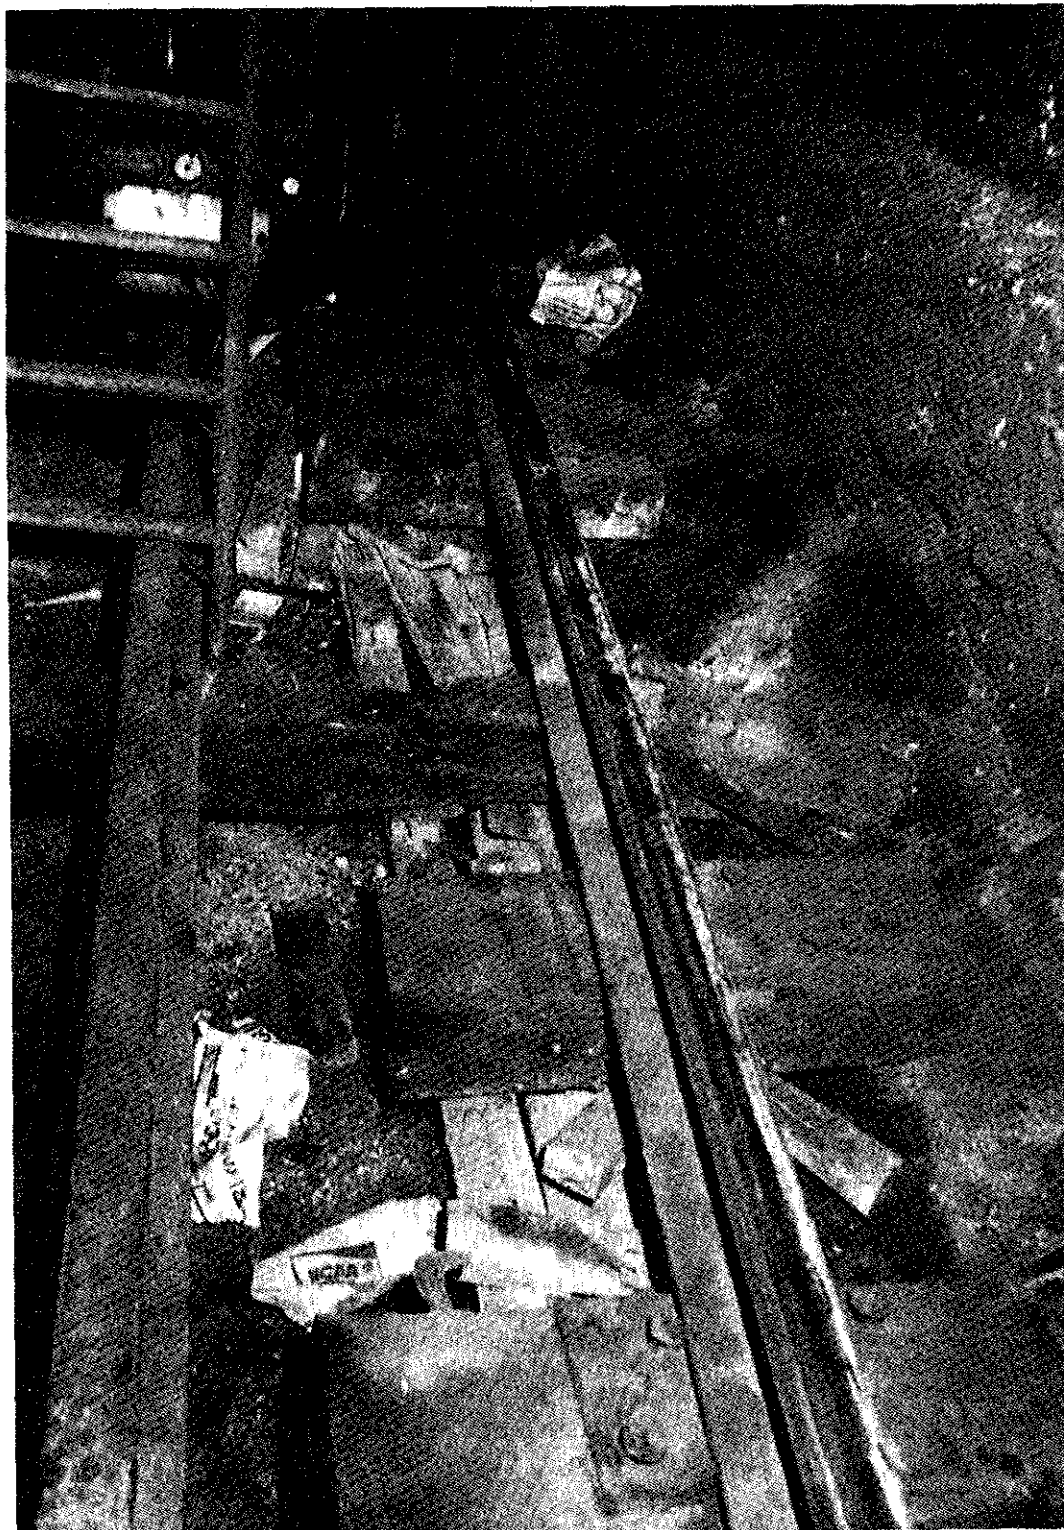
Figure 2.--Broken cross-tie and contractor's shoring, including wedges, at the derailment site.

Investigators determined that the first derailment mark was made by a brake trip cock on the lead truck of the seventh car that struck the west rail near survey station 49+90 when the truck's wheels dropped inside the gage and overturned the east rail. (See figure 1.) Investigators determined that the crossties in the area were deteriorated and that a crosstie which had decayed internally failed in tension under the west rail at that point. (See figure 2.) The train moved 200 feet beyond the first derailment mark, and the lead car of the train stopped at survey station 54+96. The destruction of the track was such that the exact prederailment profile of the track could not be determined. None of the shoring material failed because of deterioration or excessive vertical loads before the derailment. However, some of the wedges and shoring which had no derailment marks had shifted.

The investigation revealed that the crossties in the skeletonized track at the accident site were deteriorated and that a decayed crosstie had failed under tension at the point of derailment. The crosstie failure under tension could have been caused only by lateral movement of the rail. The skeletonized track had not been shored up according to NYCTA standards or to acceptable engineering standards. Based on an examination of the debris in the way of the disrupted track at the derailment site, including the presence of undamaged shoring material and wedges, and because loose shoring was found under skeletonized track north of the derailment site, the Safety Board concludes that the track at the accident site had not been adequately supported by the contractor making the track repairs. The weight and vibration of the accident train moving over the insufficiently shored-up track, especially since it was moving at a speed of more than 10 mph and the engineer had applied the brakes to slow it, would have caused shifting and failure of the shoring, lowering of the rail, shifting of weight to the outside rail in the curve, the outward movement of the rail by lateral wheel loads, and the failure of the crosstie. Any slack action that might have accompanied the braking could have accentuated the lateral loads. After the crosstie failed, nothing held the track gage for the span of more than 16 feet between the two crossties adjacent to the broken crosstie. Since the track was not secured well against lateral movement, the rail moved enough to allow the wheels of the last four cars of the accident train to drop inside the track gage.

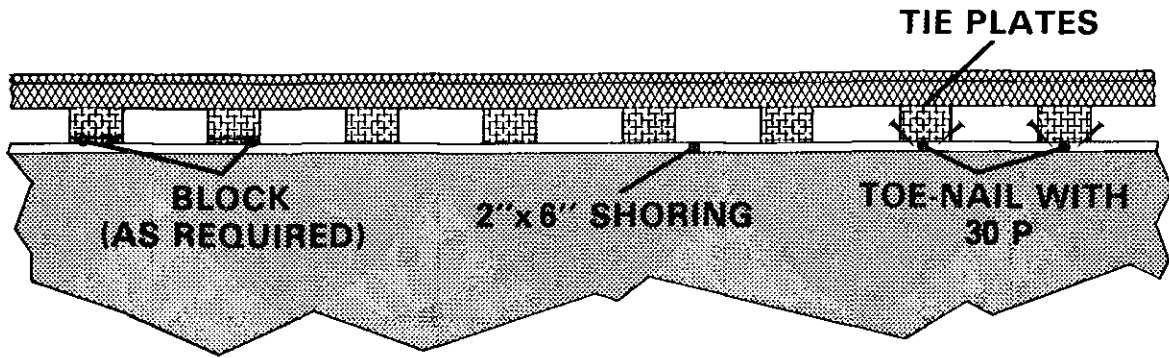
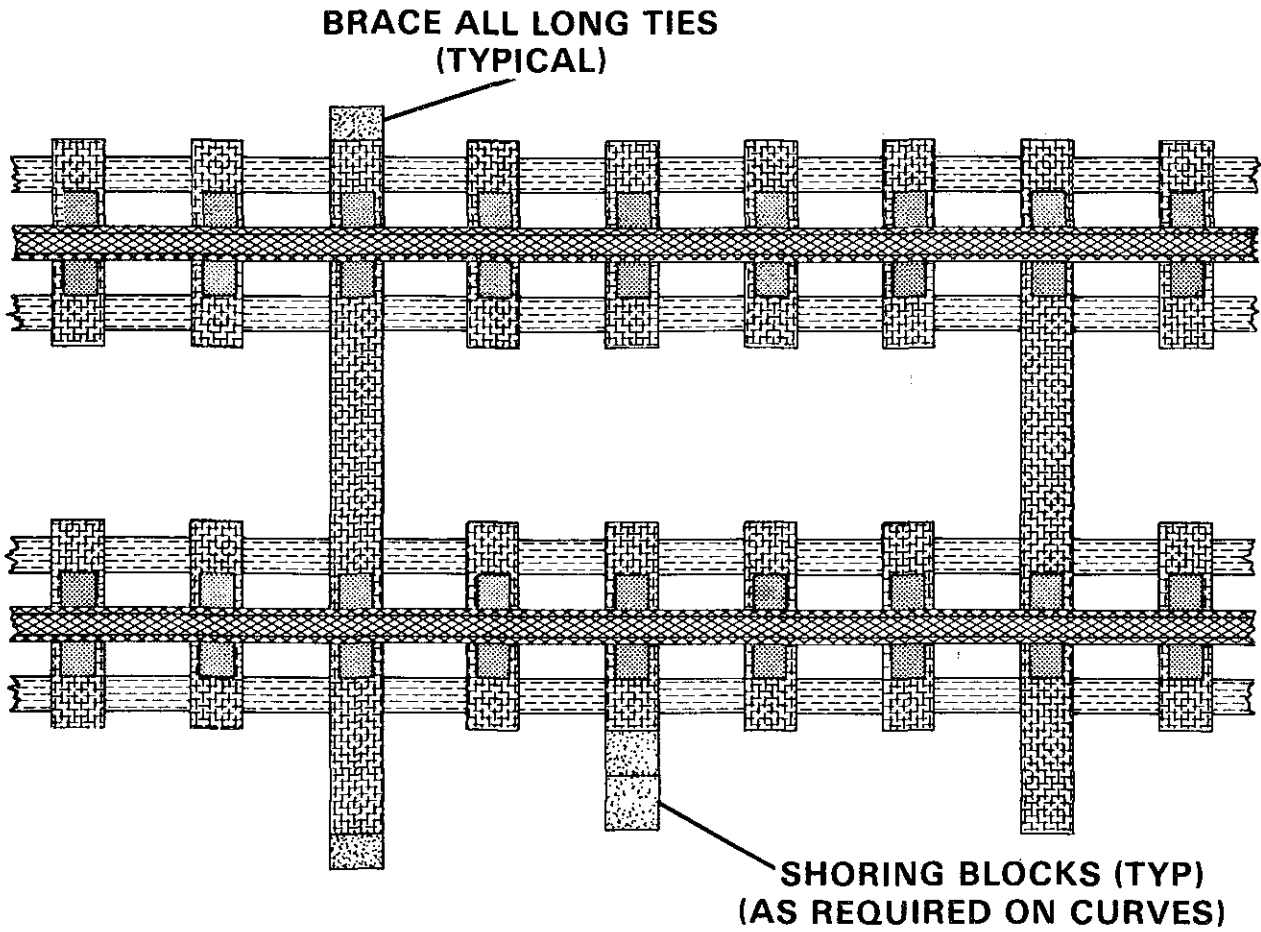
Figure 4.--NYCTA skeletonized track support system.

As noted earlier, standards for shoring up skeletonized track over which revenue trains would operate had been published by the NYCTA Track and Structures Department. The Superintendent of the NYCTA Track Division had issued a memorandum on November 20, 1981, that reiterated a prohibition against the use of wedges in shoring up track to be used in revenue train operations. (See figure 5.) Neither of these documents were part of the additional work order under which the track work was being done, and both the contractor and the contract inspectors said that they were not aware of the documents.
